**Integrity Home  
Inspection &  
Testing LLC**

# Property Inspection Report

LOCATED AT:  
100 Year Old Home  
Our Town, Nebraska 68888

INSPECTED ON:  
Wednesday, January 27, 2016

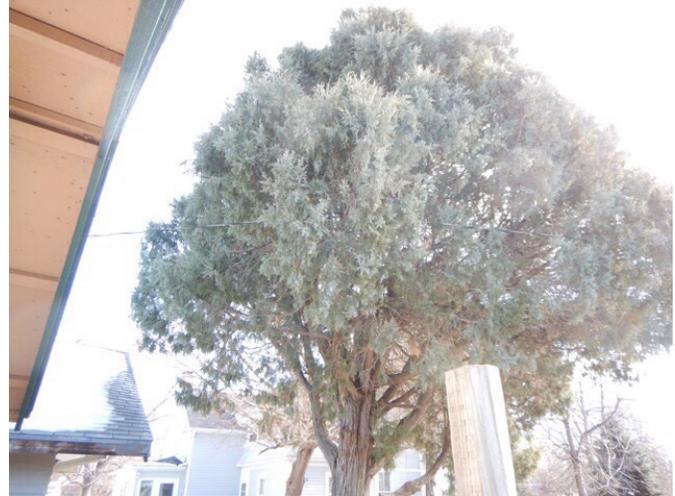
### SERVICE DROP

17: - The overhead service wires are deflected by the neighbors tree. We recommend the trees be trimmed clear of the wires or the service be reconfigured. To reduce shock hazard during this procedure, the work should be coordinated with the utility provider.

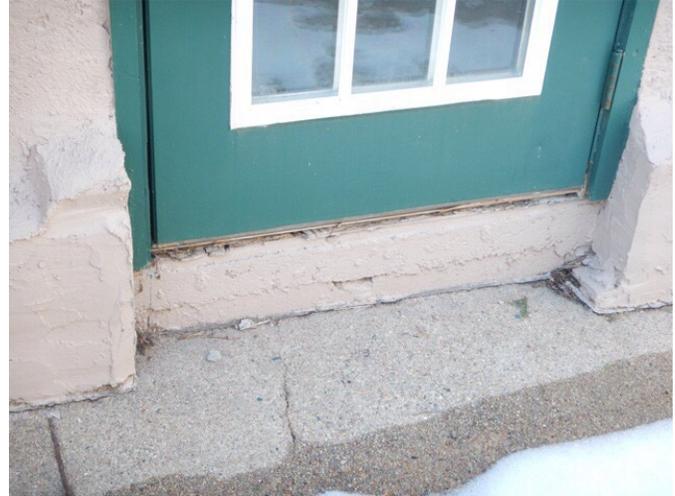
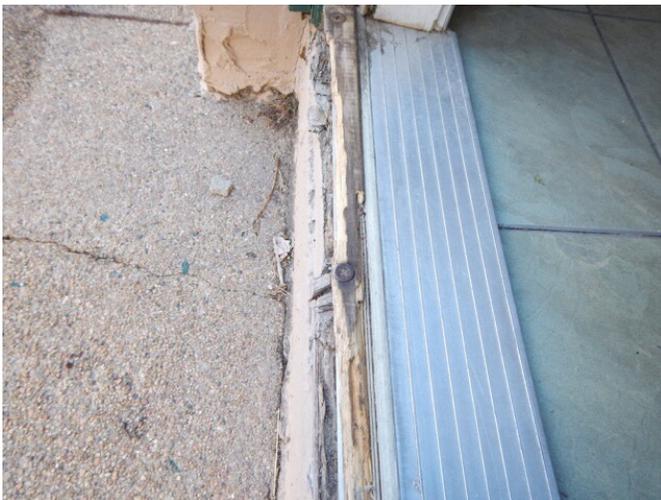
**20:** - The exterior doors appear to be properly installed and generally in serviceable condition, with exceptions noted below.

Note: The wood under the east laundry room door sill plate is showing dry rot. We recommend repairs or an upgrade.

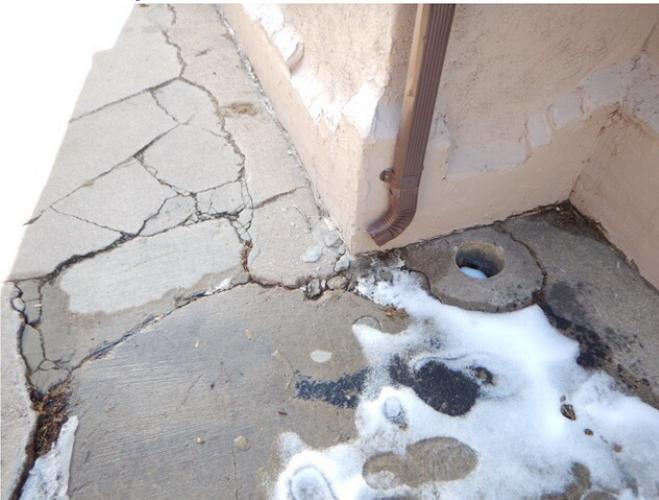
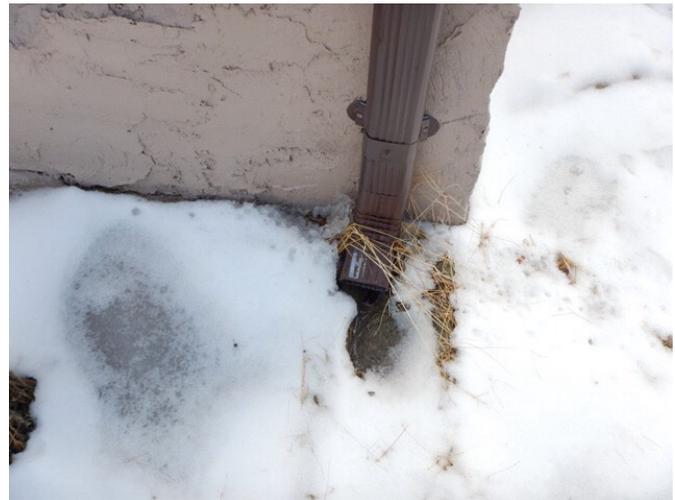
**25:** - Runoff water from the roof discharges next to the house. We recommend the downspouts be routed sufficiently away from the structure to prevent puddling, pooling, and saturation of the soil around the building.

**26:** - Recommend adding downspout extensions to move water away from the foundation wall. Keep all downspouts extended 5-6 feet and maintain the grade near the foundation wall to slope away approximately 1" for every 6 feet.

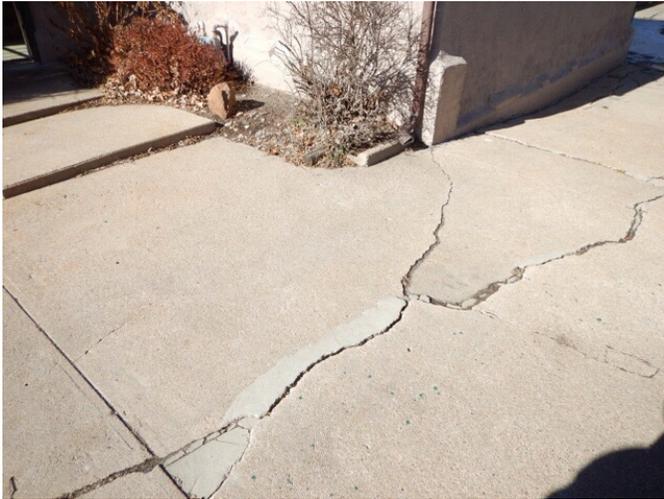
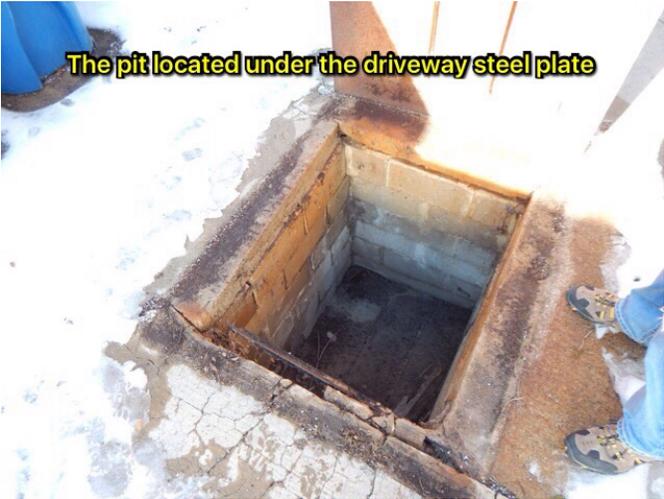
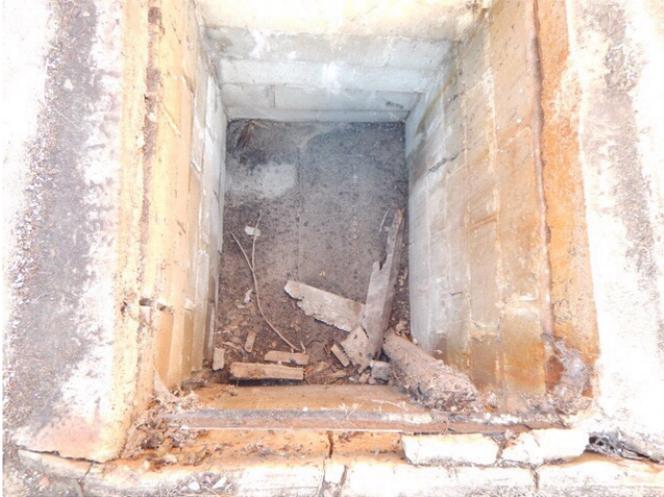
**DRIVEWAY**

**27:** - The driveway appears to be properly installed and is generally in good condition, with exceptions noted below.

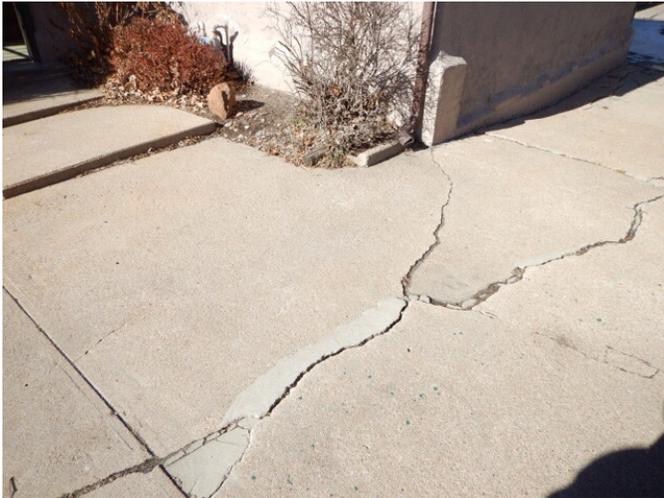
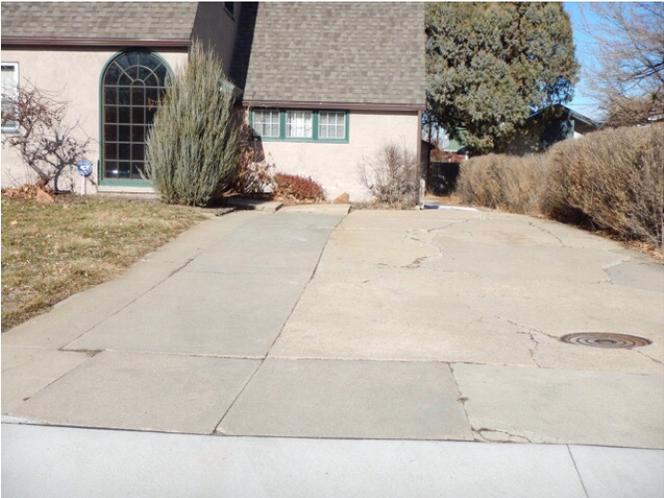
**28:** - In our opinion, the major cracks in the driveway cannot be filled, sealed, or repaired effectively. We recommend that you budget for future replacement of the driveway.

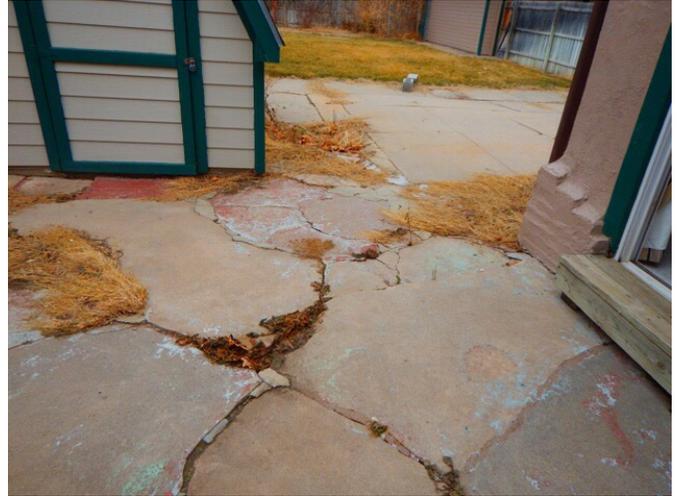
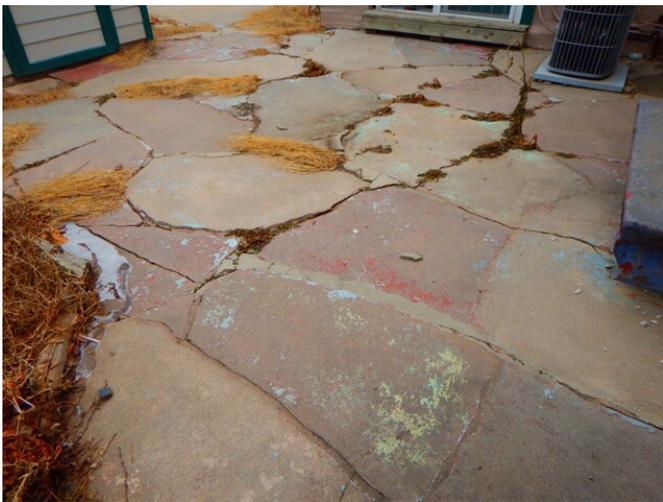
## PATIO SURFACE

**30:** - The concrete patio surface has cracked and/or settled to the point that trip hazards exist and, in our opinion, it is no longer serviceable. We recommend it be removed, repaired, or replaced.

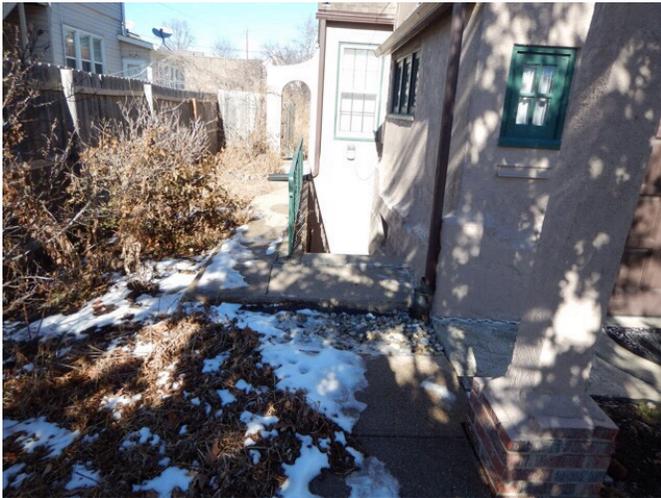
## HAND RAILS

**33:** - The posts for the railings at the west basement entry are setting in open holes allow water entry and rusting the metal. The railing wobbles due to the size of the hole but appears to be sturdy enough to resist a person's weight. We recommend that the railings be reinforced or replaced in accordance with present standards.

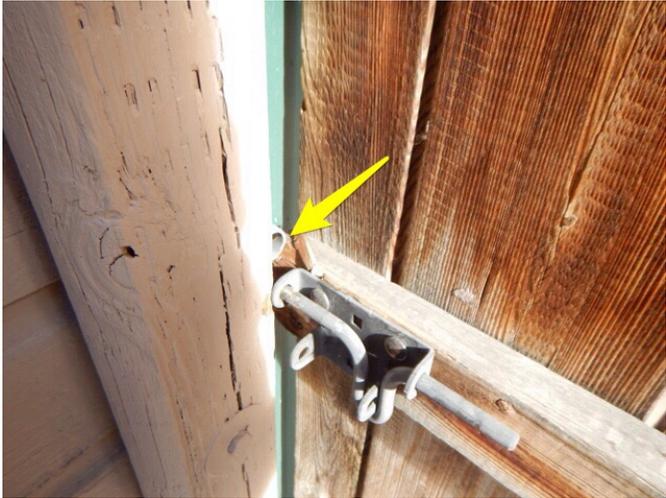
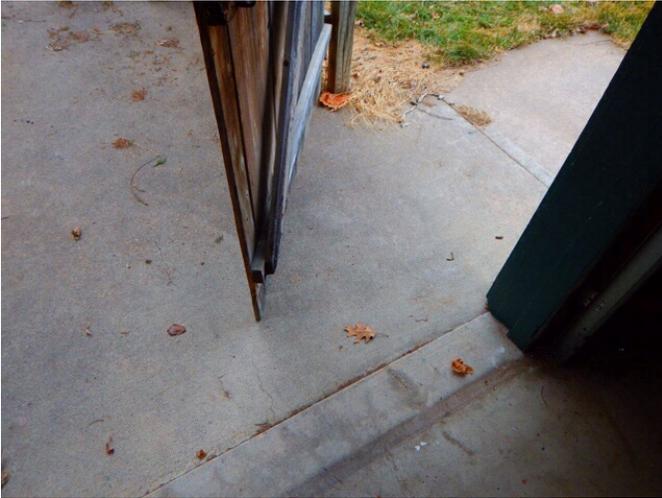
**GATES**

**36:** - The gates show signs of wear/deterioration and the need for maintenance.

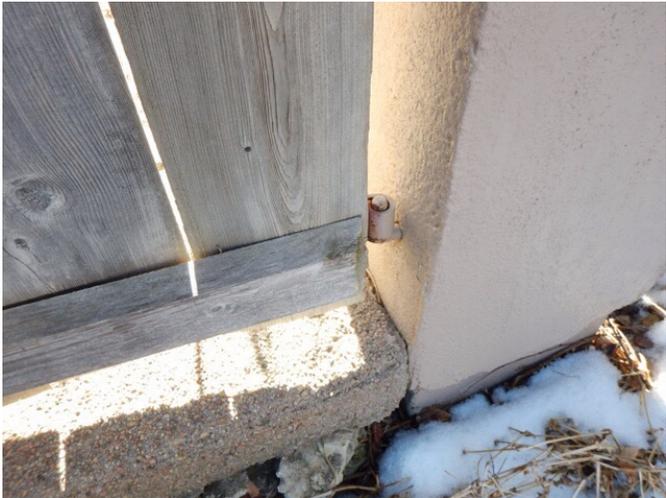
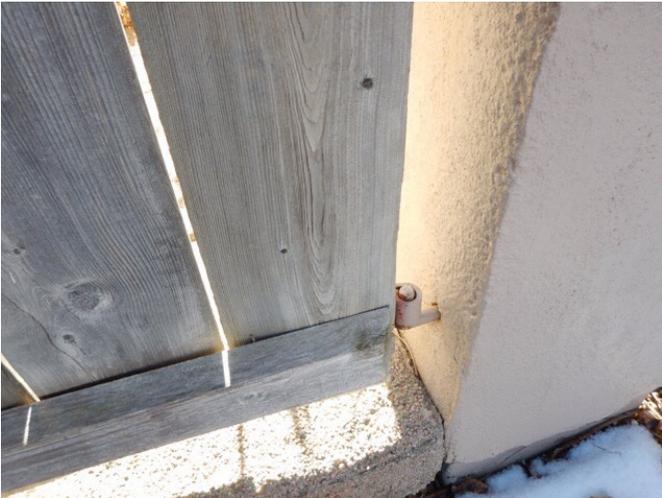
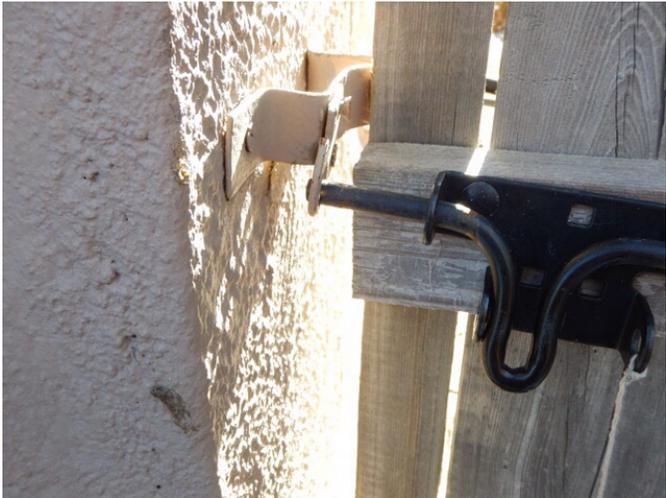
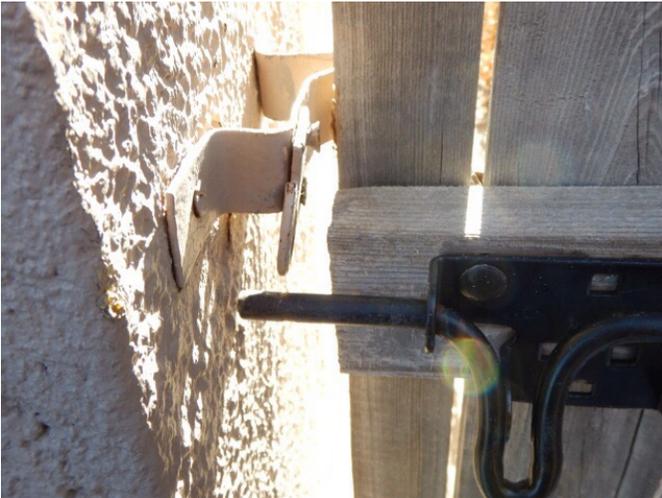
**37:** - The gate at the garage drags on the driveway and is difficult to operate. The gate at the west side of the home needs to be raised to latch properly. The lower right hinge is loose at the post. We recommend repair or replacement.

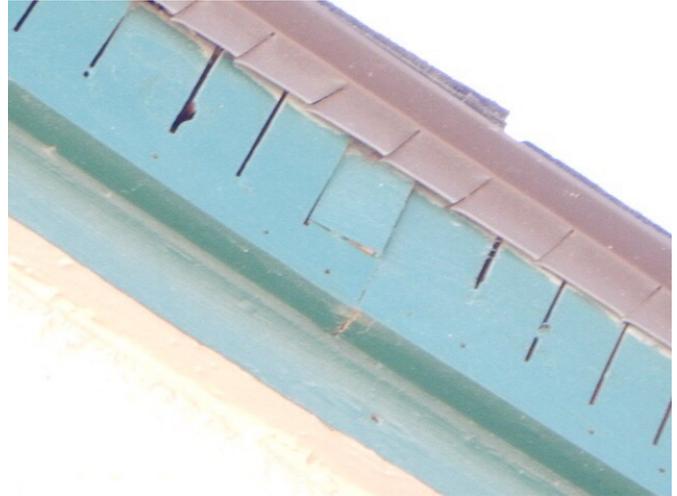
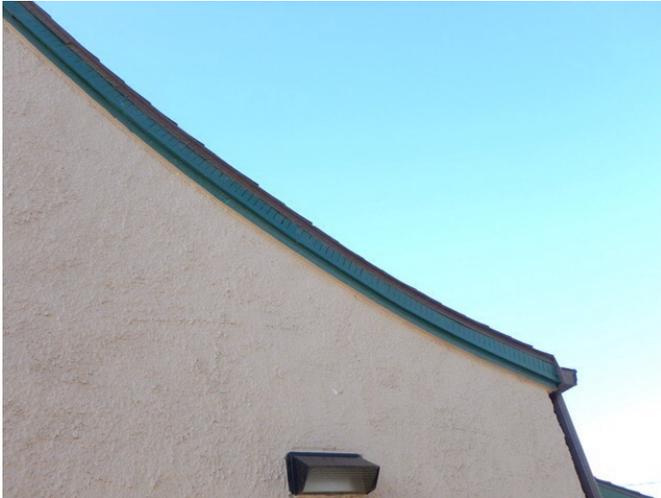
## FASCIA

**40:** - The fascia appears to be properly installed and generally in good condition, with exceptions noted below. Note: The wood used on the arched fascia was cut to allow the wood to bend. When the paint is upgraded recommend sealing the openings to prevent moisture entry.

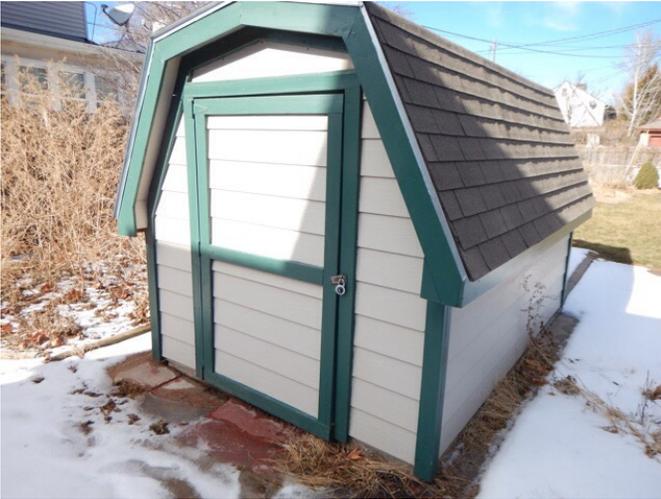
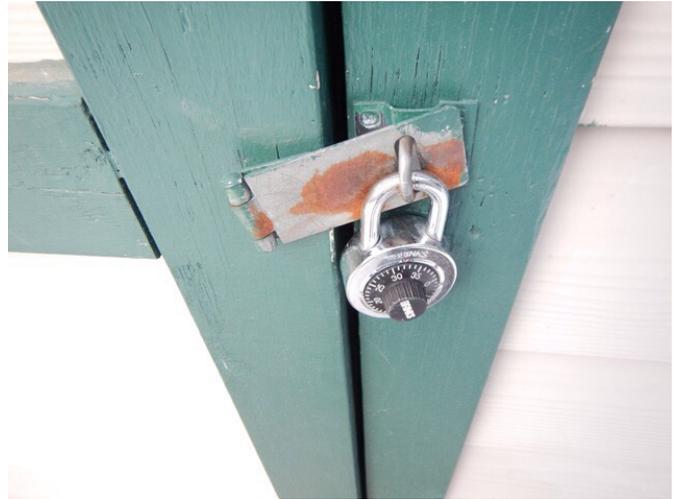
**43:** - The accessory structure on this property, although looked at, was not fully inspected and is not included in this report. The entry door was locked at the time of the inspection.

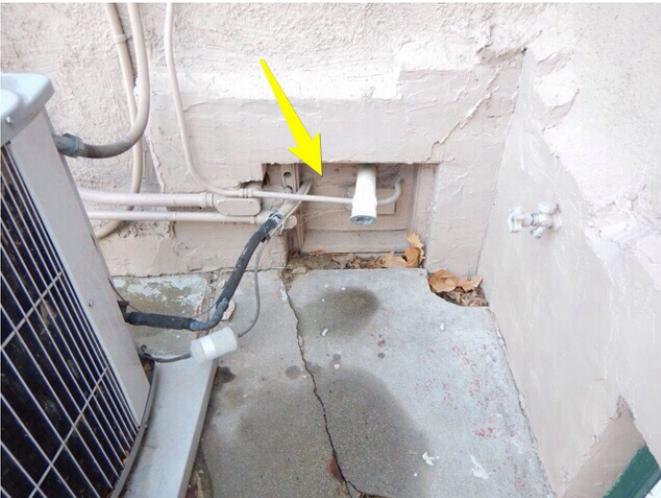
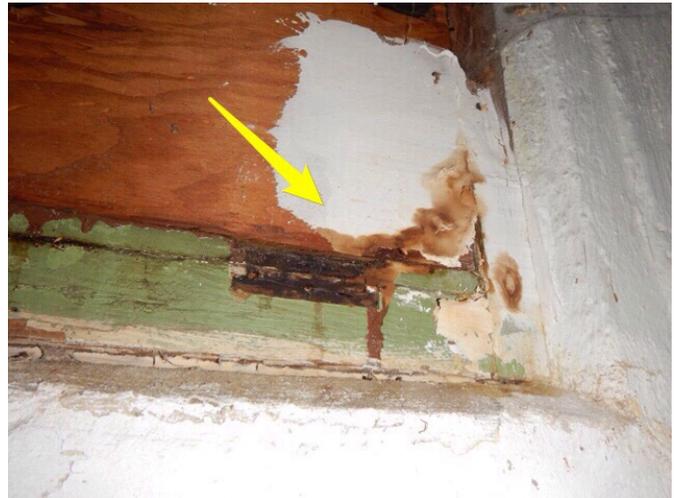
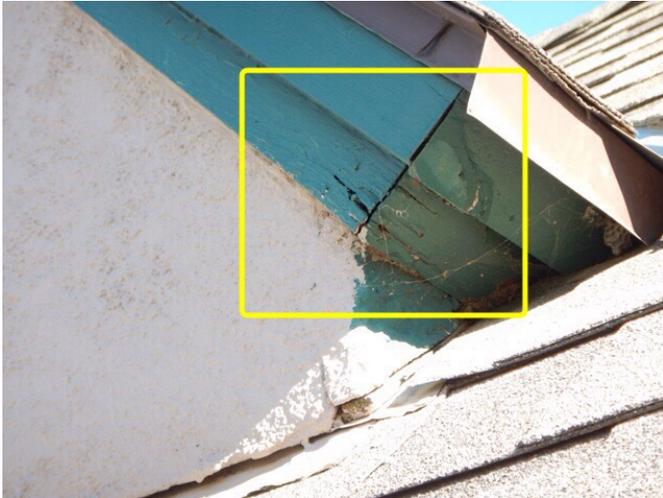
**44:** - There are areas where exterior features are in need of attention. These conditions suggest lapses in maintenance. We make no attempt to list all cosmetic flaws but, do suggest attention to items relating to function and safety.

Note: At the west exterior wall behind the air conditioner is a removed and sealed basement window. The is evidence on the interior of moisture entry at the base of this window. Recommend upgrading the caulking to prevent moisture entry.

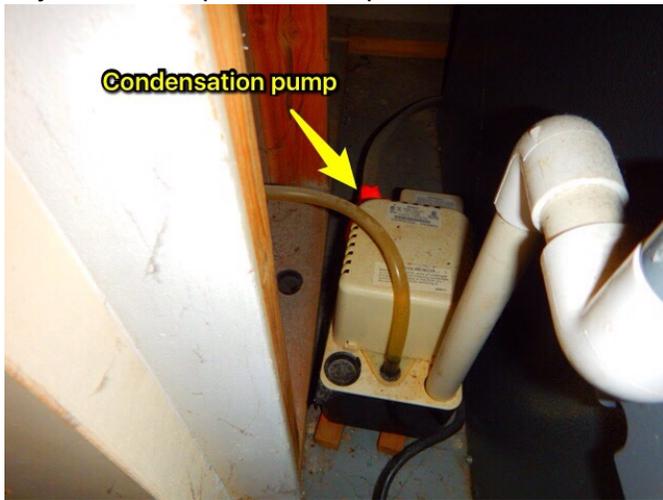
**60:** - The condensation from the air conditioning coil drains into a condensate pump. The water is pumped into a plumbing drain because a floor drain is not provided. The condensate pump and related equipment are beyond the scope of this inspection.

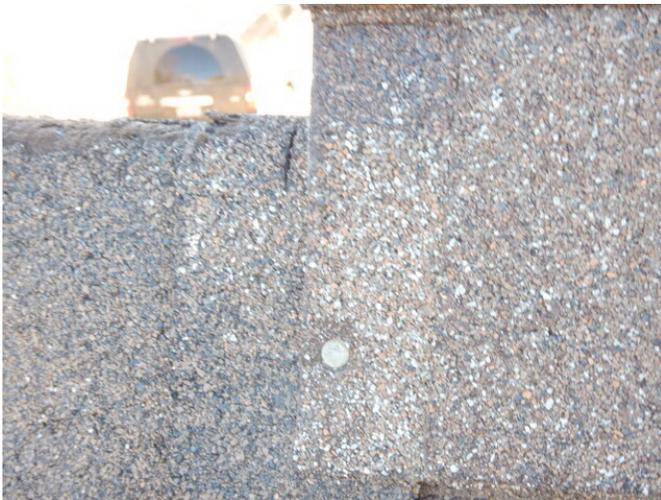
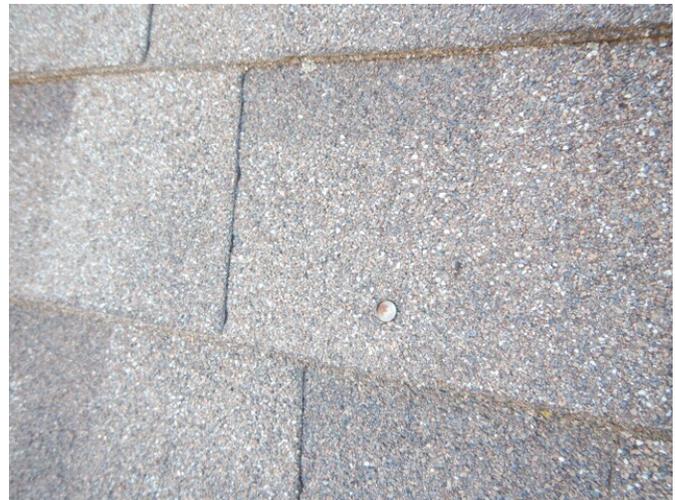
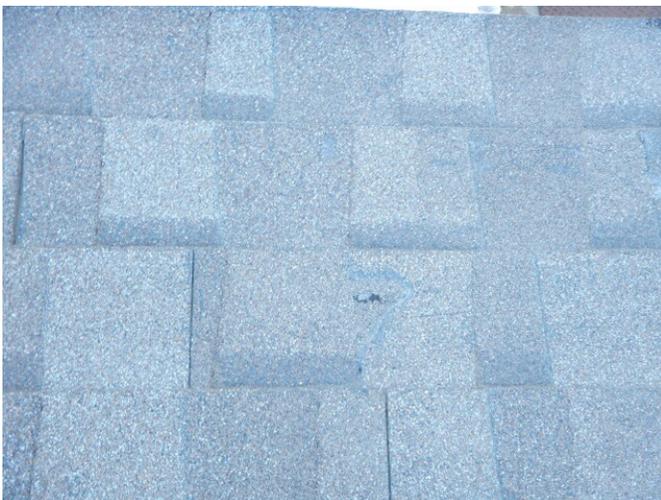
**87:** - The ridge shingle fasteners are exposed. This is not the recommended method of installation and indicates that the roof may have been installed by a non-professional. No problems were noted and no action is recommended.

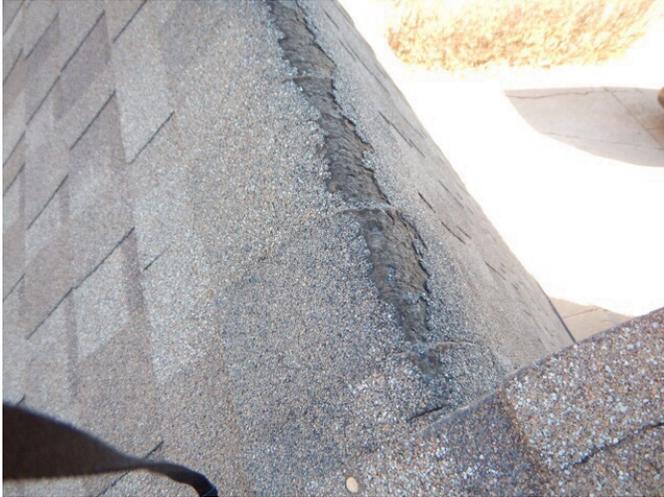
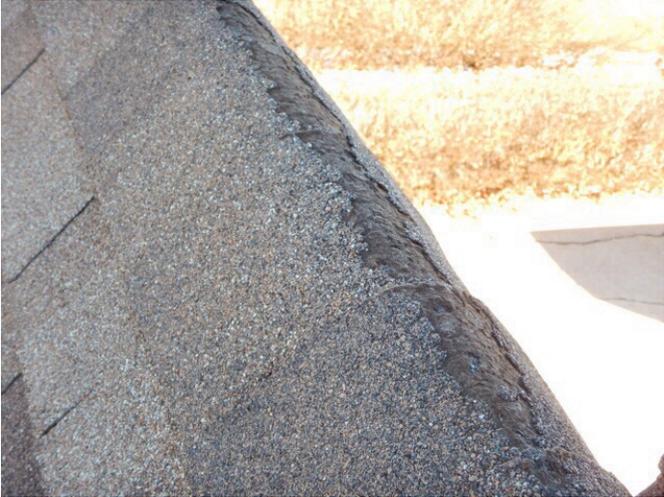
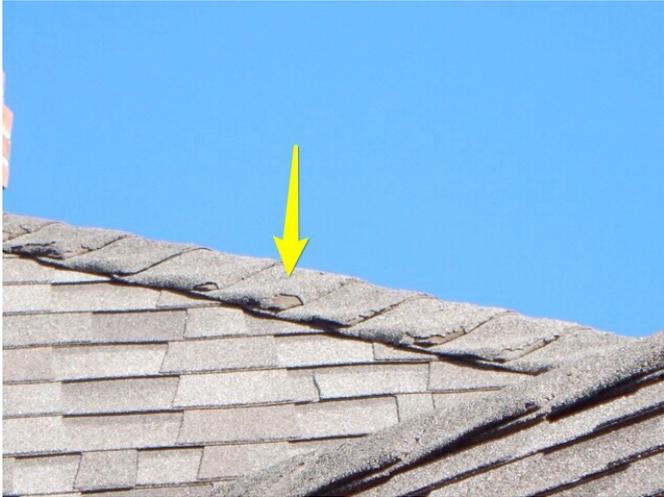
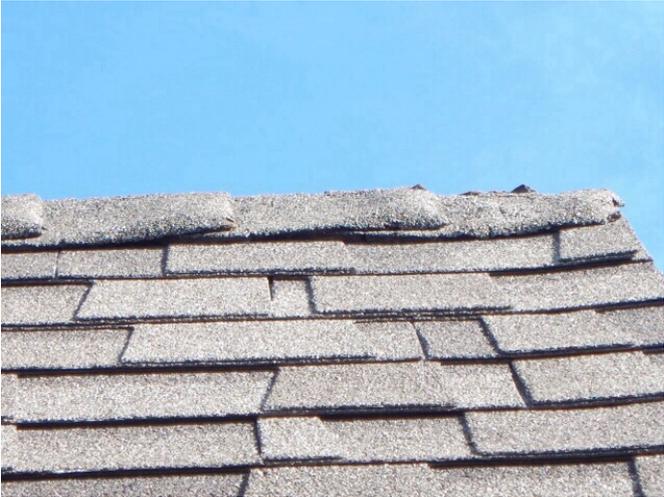
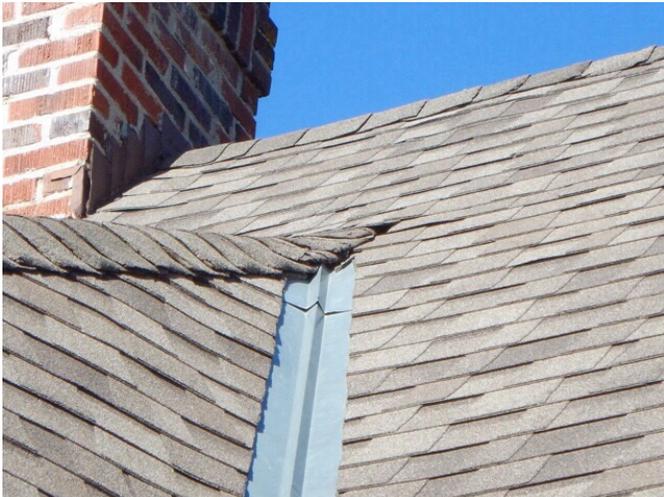
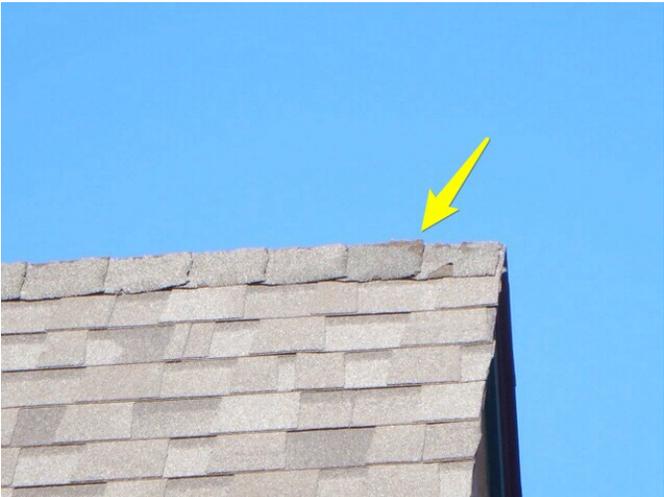
**88:** - Portions of the surface is showing granular loss, cupping and curling. The shingles are also showing minor surface cracks. These are normal signs of aging and no action is needed at this time.

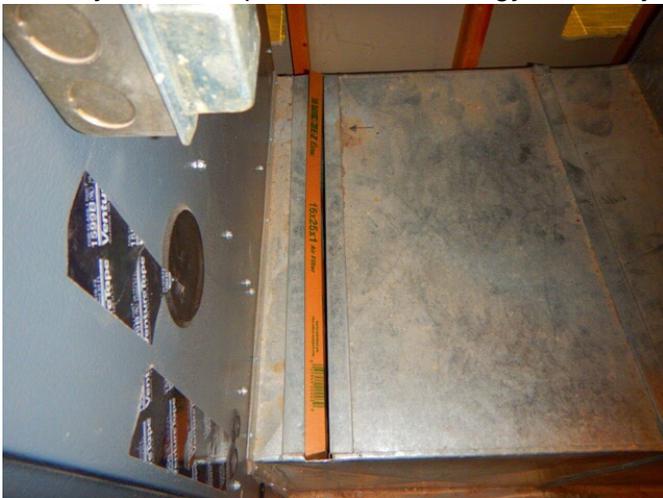
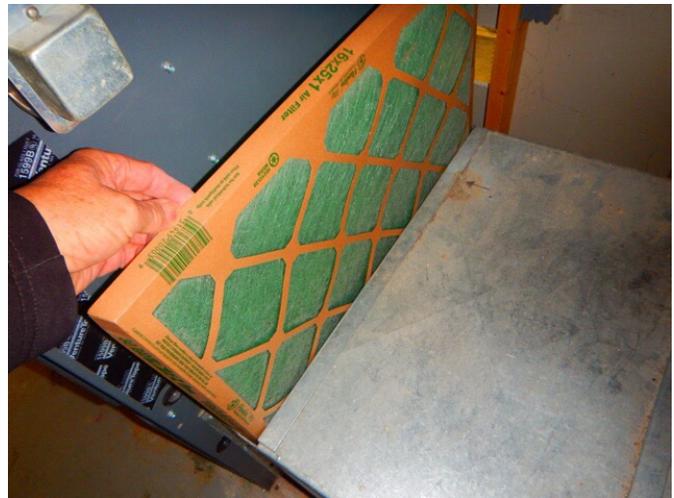
118: - A filter door is not provided. We recommend installing filter door or cover to decrease air loss, unfiltered air entry and to help increase the energy efficiency of your home.

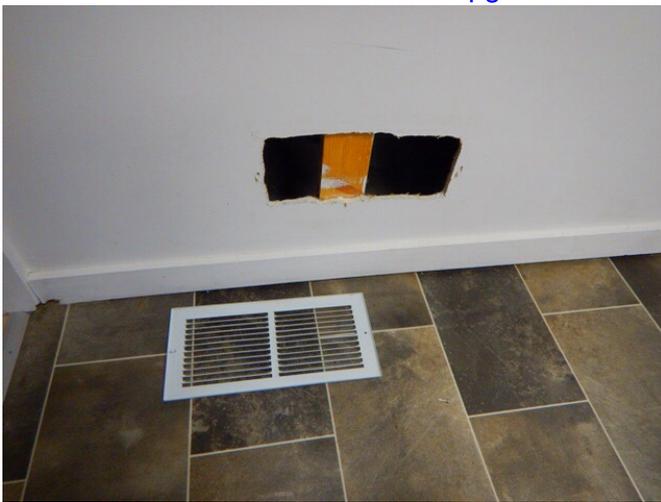
Note: One of the return air vent plates at the east furnace room wall fell off during the inspection. The connection to the wall needs to be upgraded.

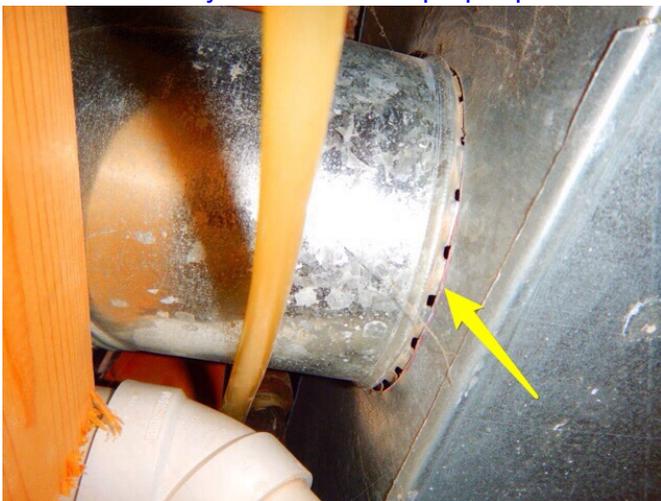
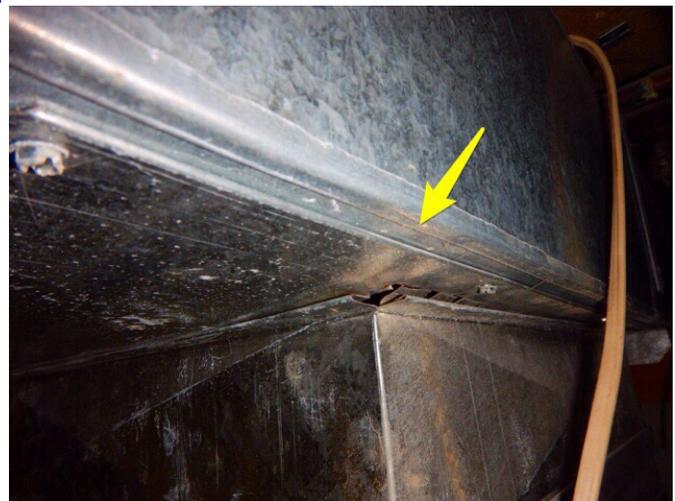
**125:** - Some of the connections on the ducts are poorly sealed. For maximum system efficiency, we recommend they be sealed with proper paste or foil tape.

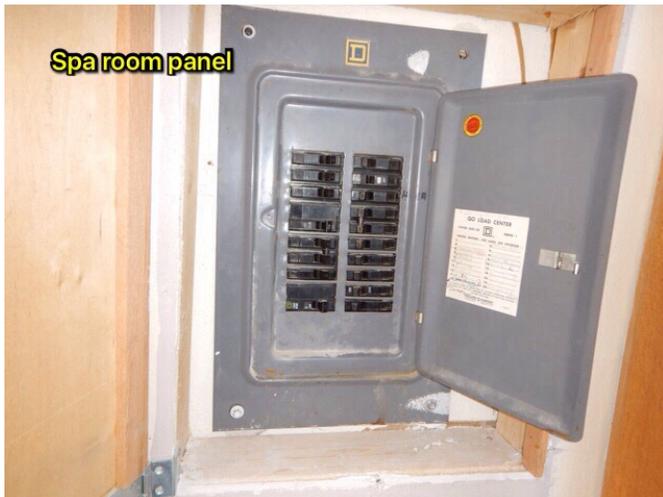
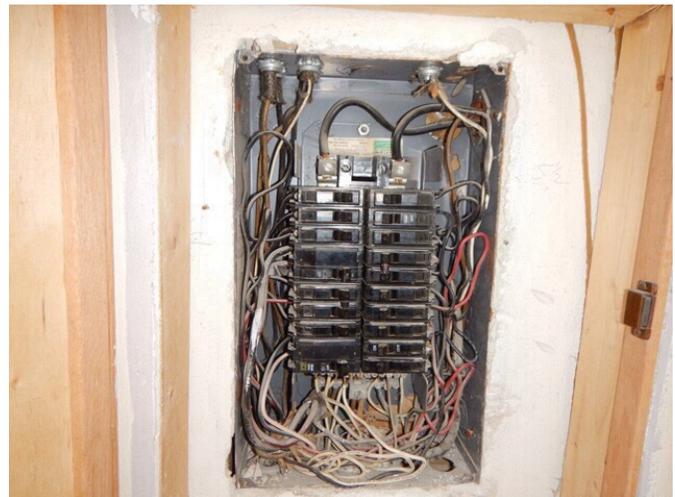
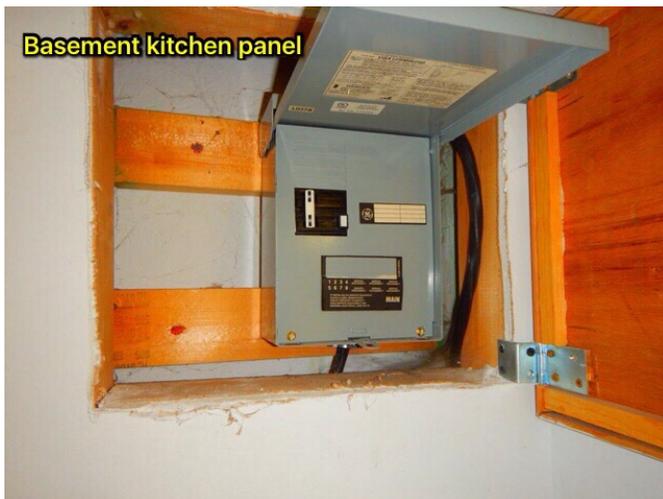
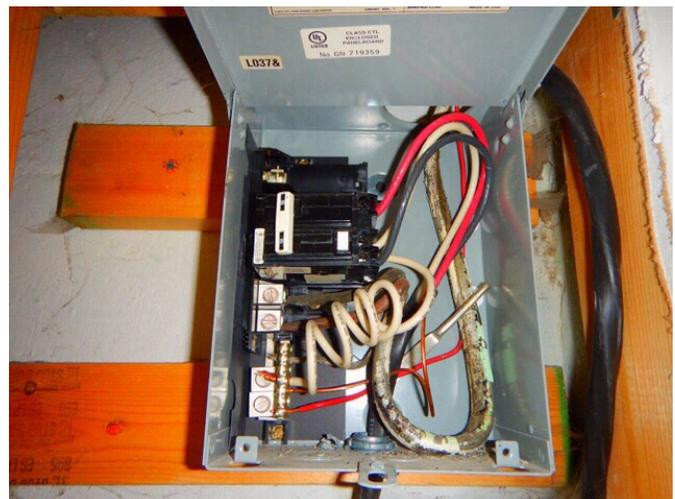
**180:** - An additional distribution panel, or subpanel, is located in the spa room and a single breaker panel on the south wall of the basement kitchenette.

**181:** - The circuitry is not completely labeled in the spa panel. We recommend that each circuit be identified, allowing individuals unfamiliar with the equipment to operate it properly when and if necessary.

**182:** - The circuitry in the kitchenette panel is unlabeled. We recommend that each circuit be identified, allowing individuals unfamiliar with the equipment to operate it properly when and if necessary.

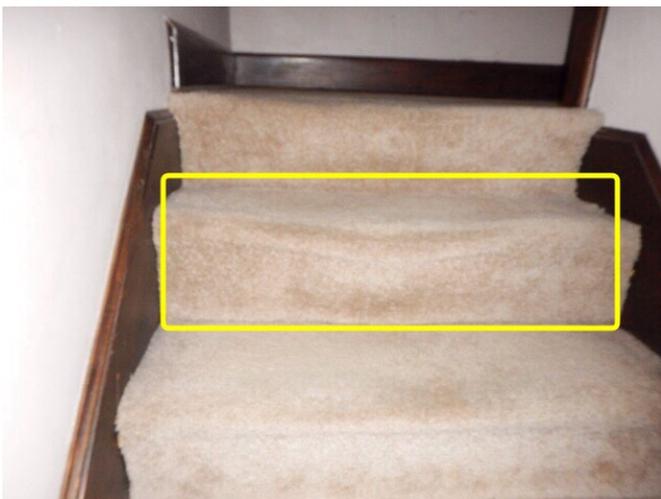
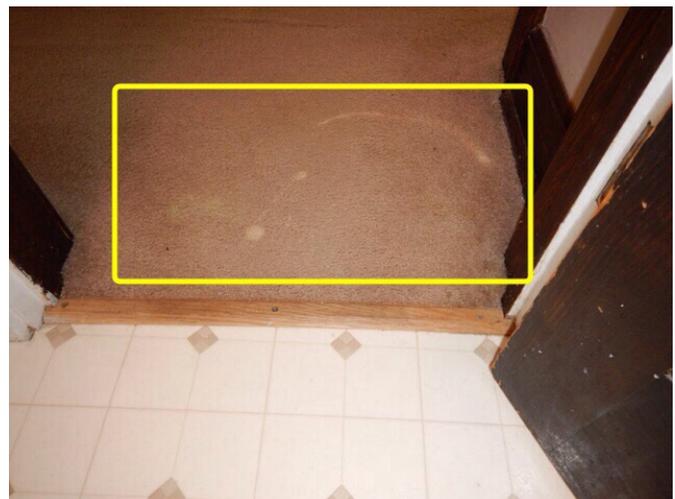
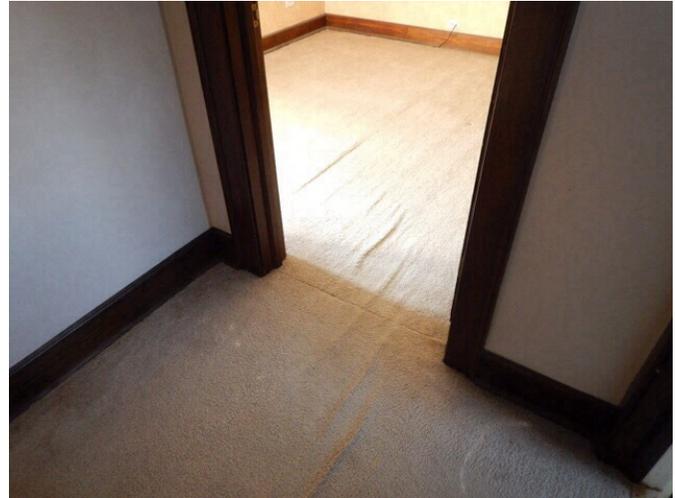
**213:** - The floors have a good appearance and are in serviceable condition, with exceptions noted below.

**Note:** At the entrance to the second floor bathroom the carpet appears to have a bleach type stain. The carpet is also wrinkled at several locations.

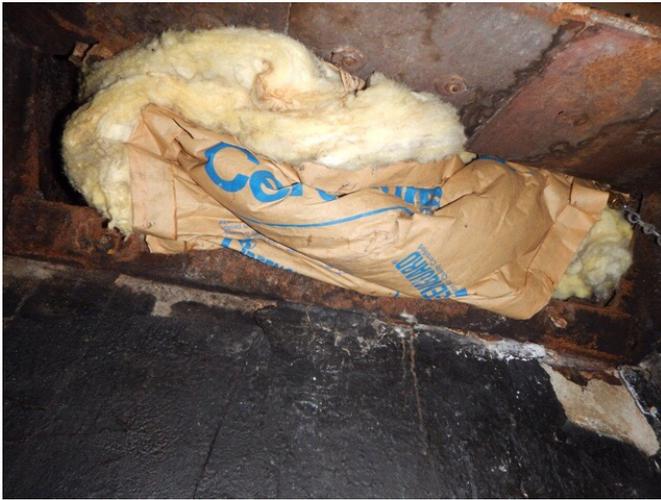
**220:** - At the time of the inspection insulation was packed at the damper opening. We believe it is unsafe to use the main floor fireplace. We recommend qualified personnel be retained to evaluate the fireplace and determine what corrective steps will need to be taken.

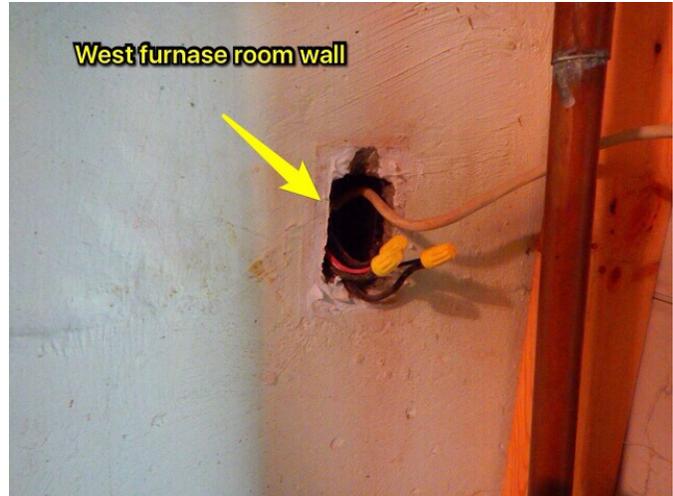
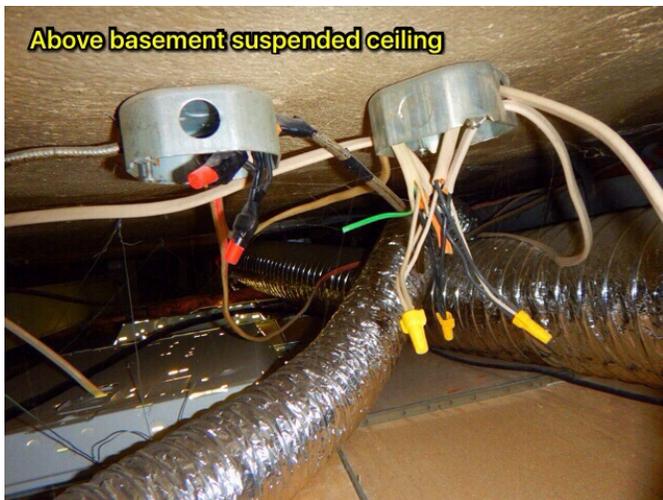
**232:** - Running splices, which are improper connections outside a junction box, were observed. We recommend connections be joined with approved connectors inside a junction box to prevent accidental contact or mechanical damage.

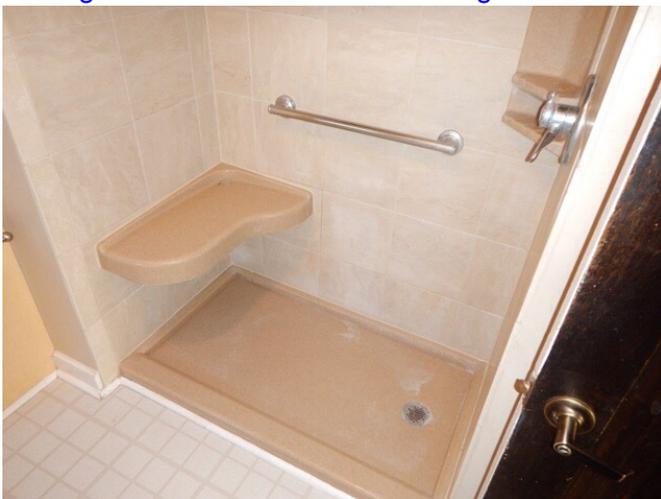
Note: When the shower was operated, the water drains off the seat and hit the top of the shower base pan leaking onto the bathroom floor. A larger base or smaller seat would have prevented this.

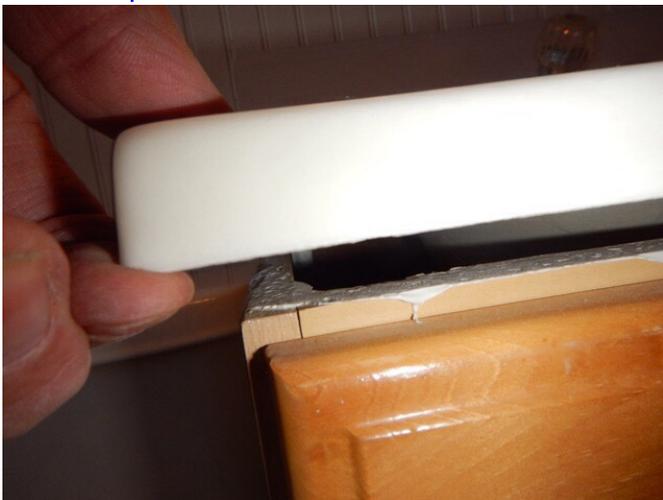
**306:** - The wash basin counter top has separated from the counter. We recommend it be resupported and/or sealed to prevent movement.

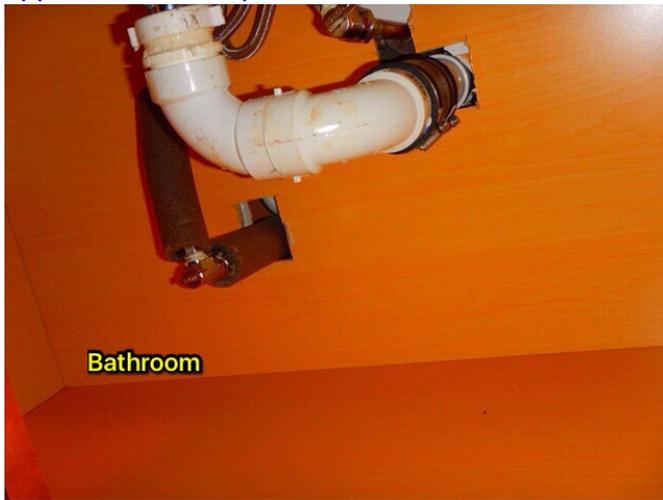
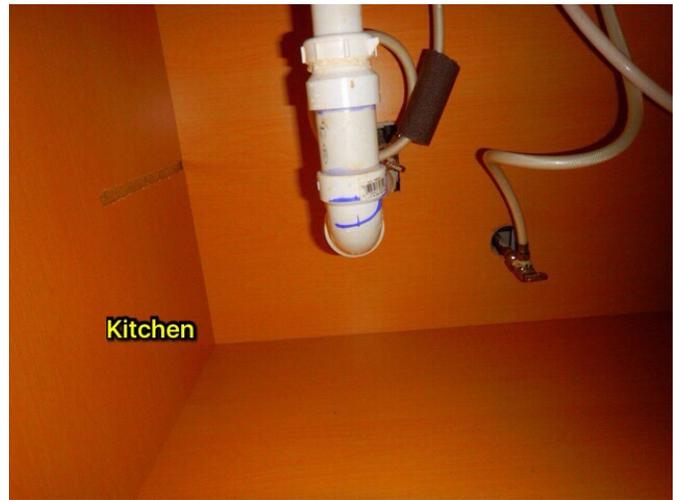
**325:** - There is no visible drain trap for the basement bathroom or basement kitchen sinks. This is not an approved configuration and is considered a significant defect and potential health hazard. We recommend an approved drain trap be installed.

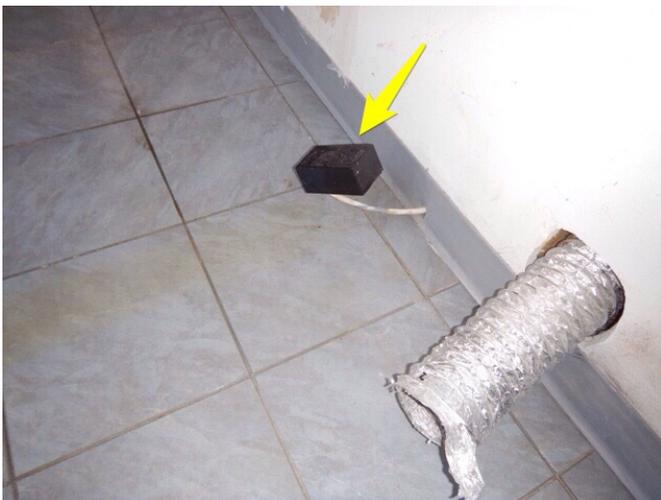
**341:** - [The dryer receptacle in this area is loose. For maximum safety we recommend that it be properly secured.](#)
