Property Inspection Report

LOCATED AT:
114 Year Old Home
Your town, Nebraska 68880

INSPECTED ON:
Monday, January 23, 2017

Inspector, Larry Karschner and Joshua Methe
Integrity Home Inspections & Testing LLC

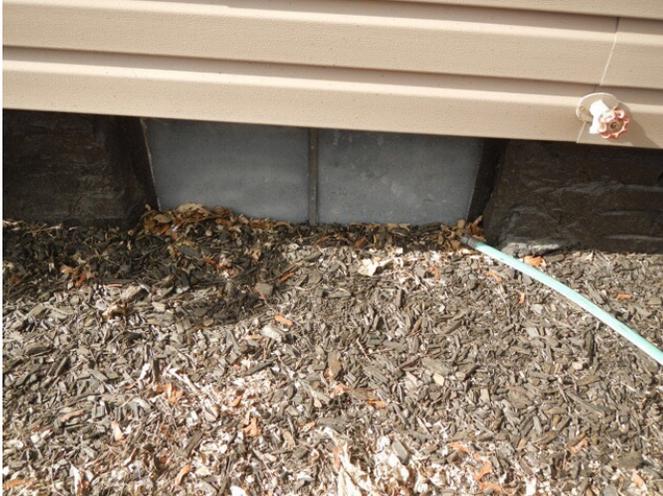
15: - We recommend window wells when the grading is level with the bottom edge of the basement window. The base of the basement windows should be a minimum of 4 to 6 inches above the finished exterior soil that touches the foundation. Also, window wells require a weather cover to prevent moisture entry and possible flooding.

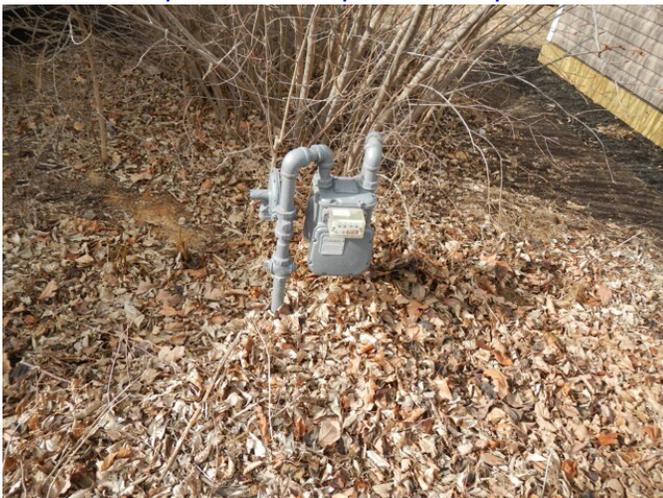
17: - The meter is unprotected and susceptible to vehicle damage. As a safety related upgrade, we recommend protection be provided to prevent damage.

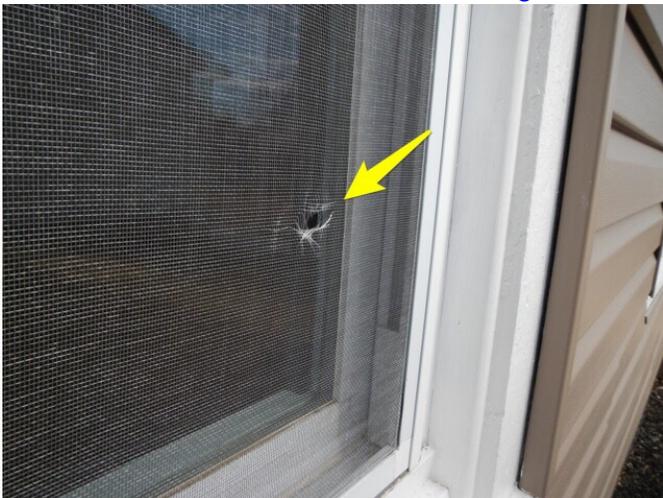
24: - [Several window screens are damaged. We recommend they be repaired or replaced.](#)

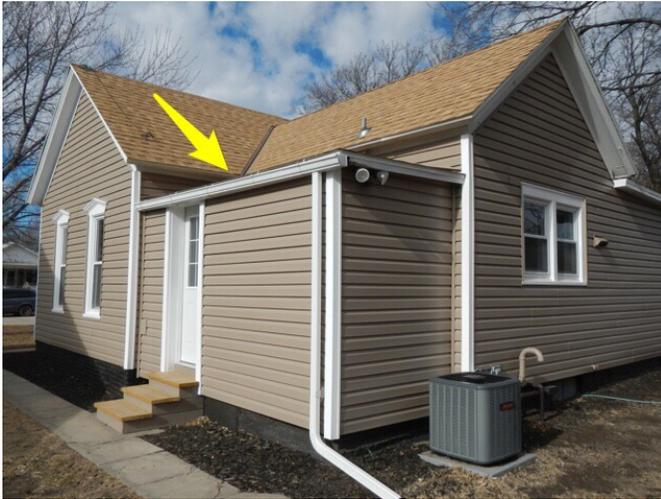
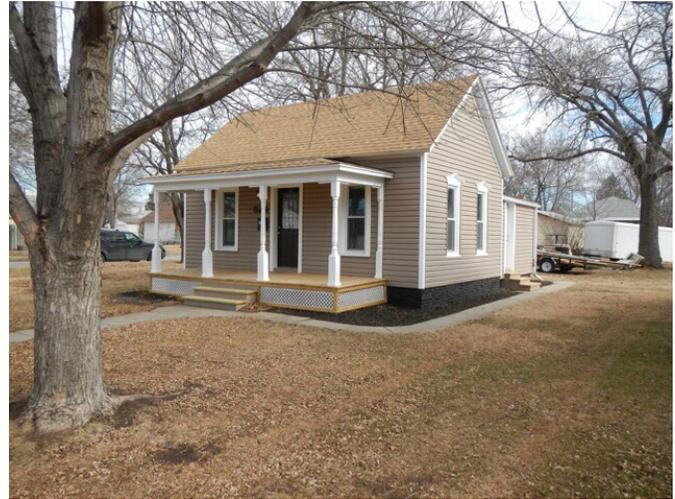
26: - The south gutter is in serviceable condition. Gutters are not provided where needed at the north and west side of the home.

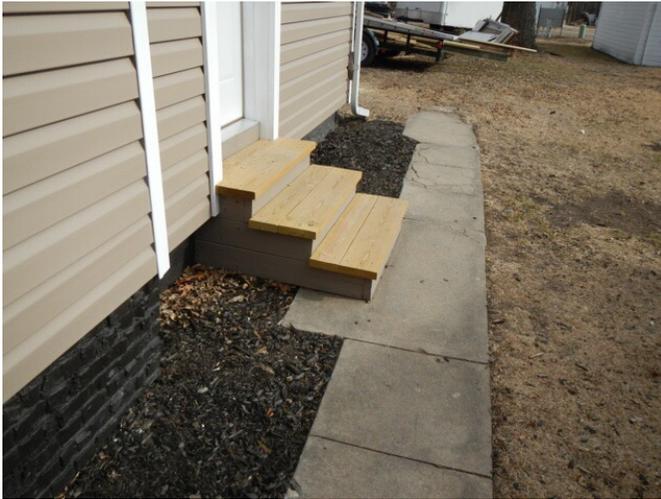
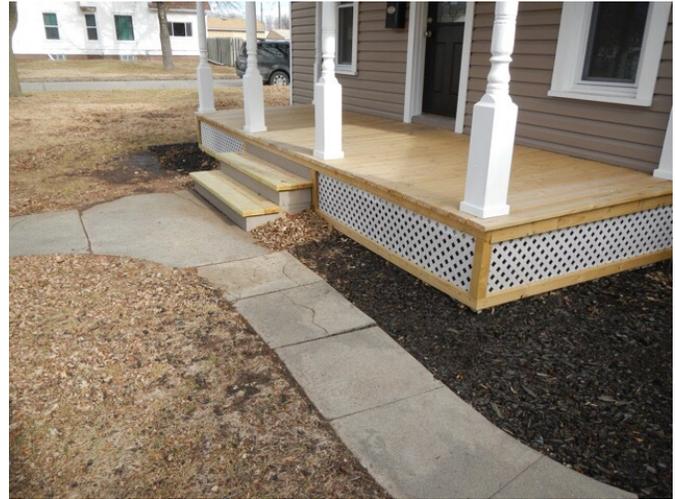
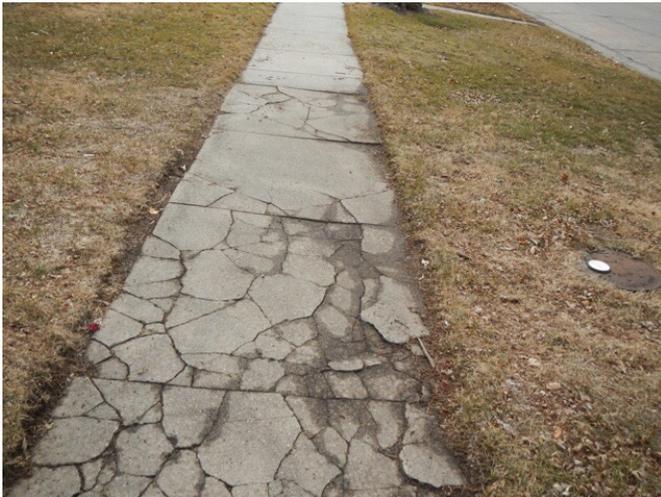
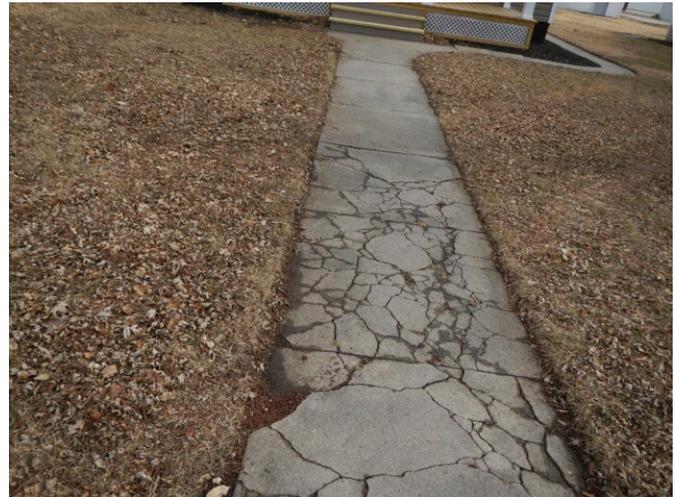
30: - There are cracks in the walkways, action would only be required when the cracks develop into trip hazards. Typically an uneven surface greater than 1/4 inch would be considered a trip hazard.

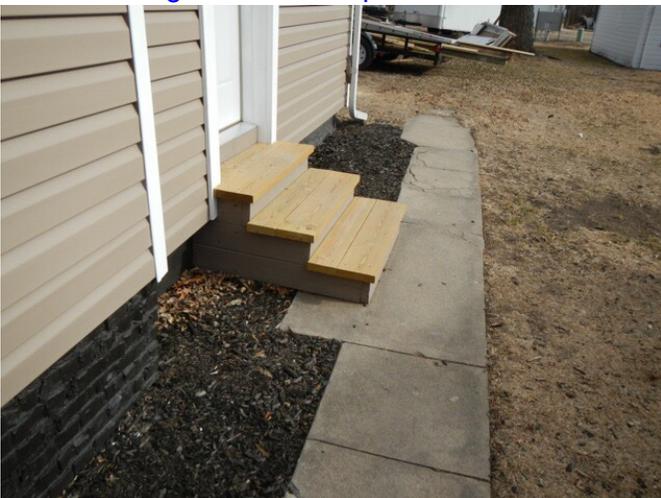
36: - There are no railings where needed at the south. As a safety measure, we recommend that railings be installed at all entry steps.

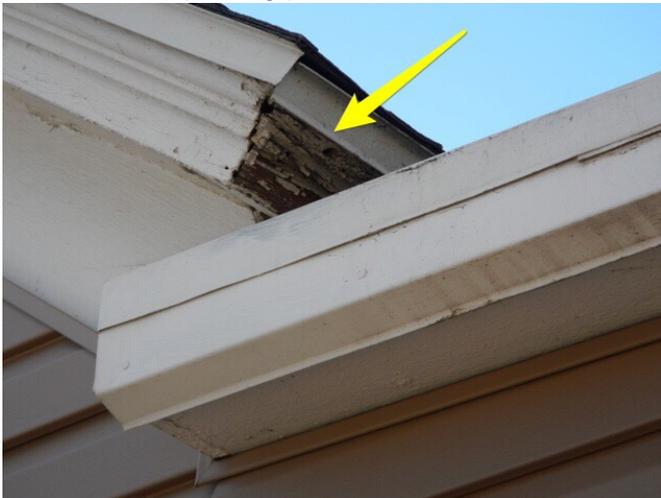
41: - There is peeling paint at SE corner. We recommend this area be prepared and refinished.

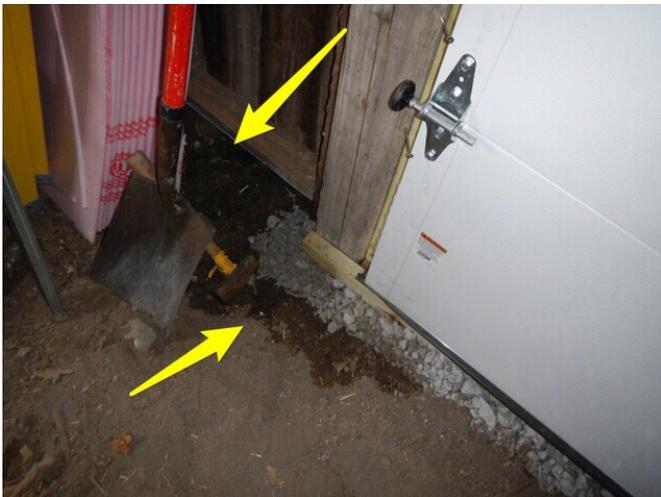
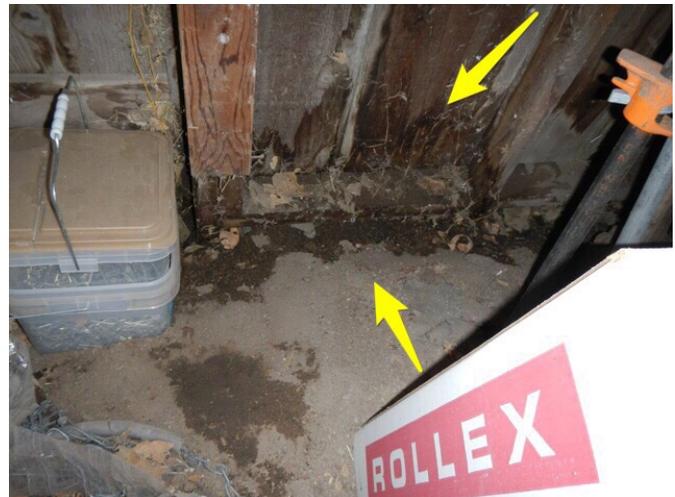
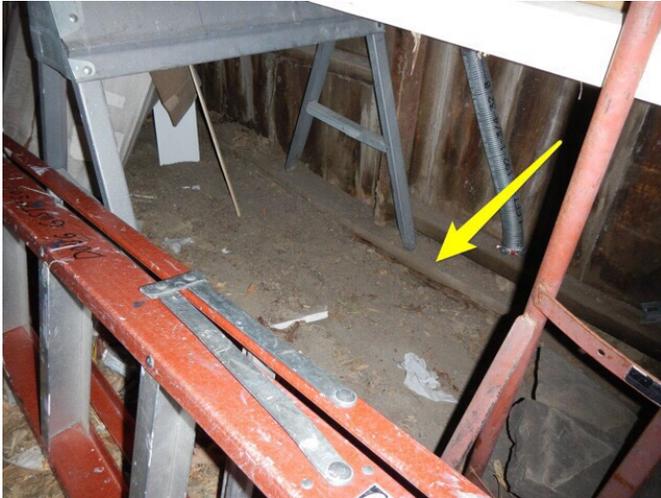
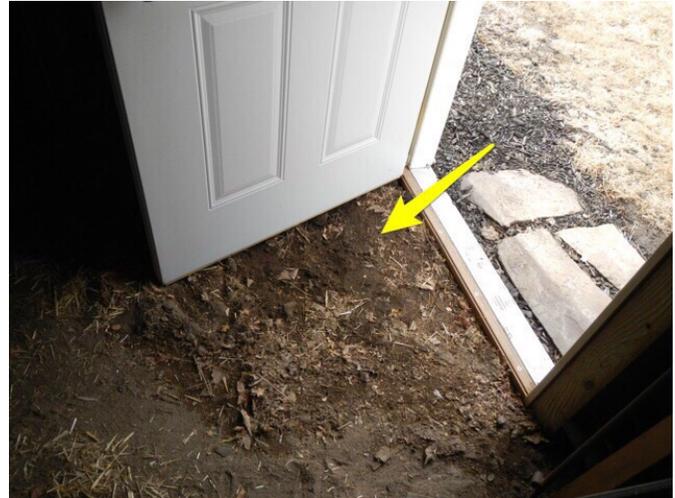
64: - In the areas where the wall framing is visible, all components appear to be properly installed and generally in good condition. There is evidence the garage walls were upgraded. At the time of the inspection the floor was wet near the exterior walls.

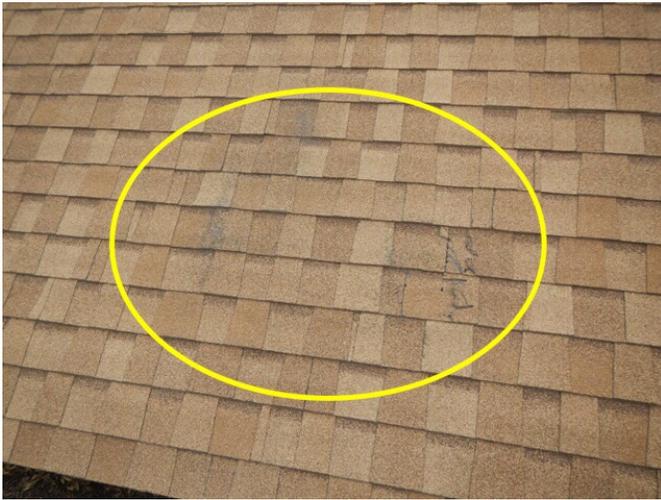
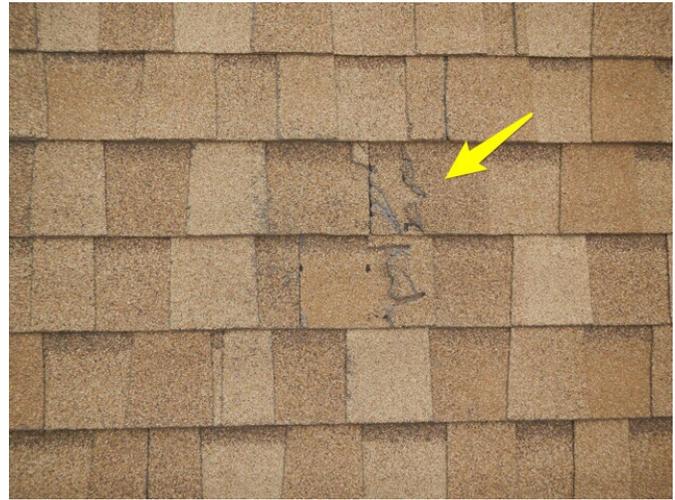
79: - Portions of the surface granulation are deteriorated and there are minor surface cracks developing. These are normal signs of aging and no action is needed at this time.
- At the north east old damage from tree branches was observed.

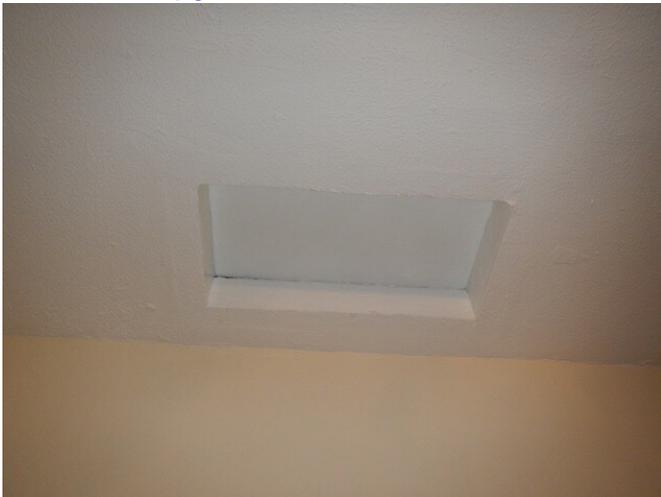
95: - [The attic access opening is a nonconforming size. The small opening makes it difficult to access the attic area. As an upgrade, we recommend consideration be given to installing a larger opening.](#)

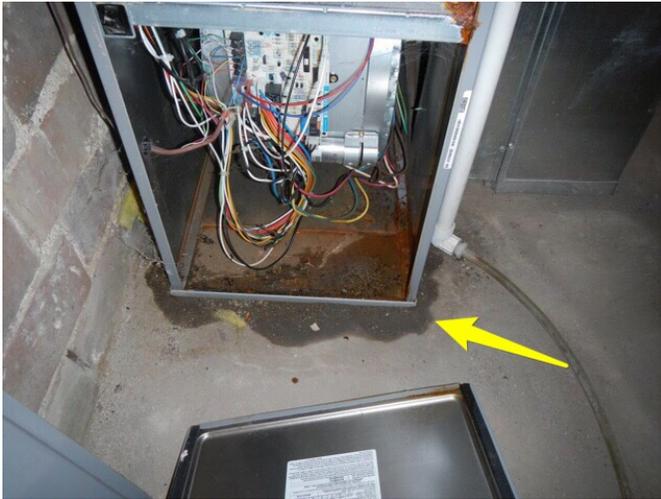
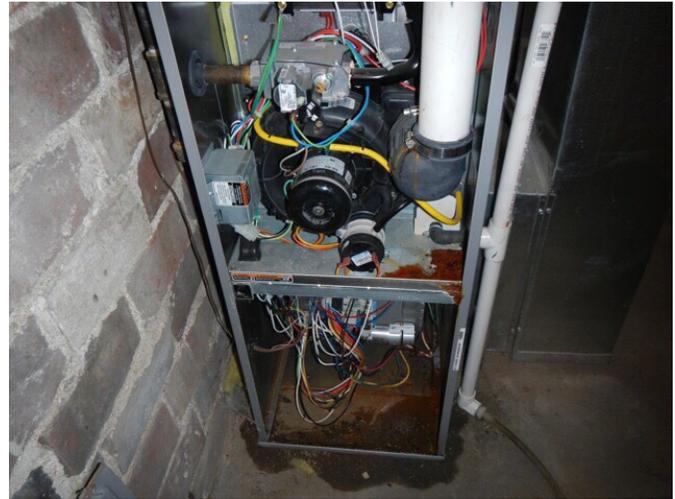
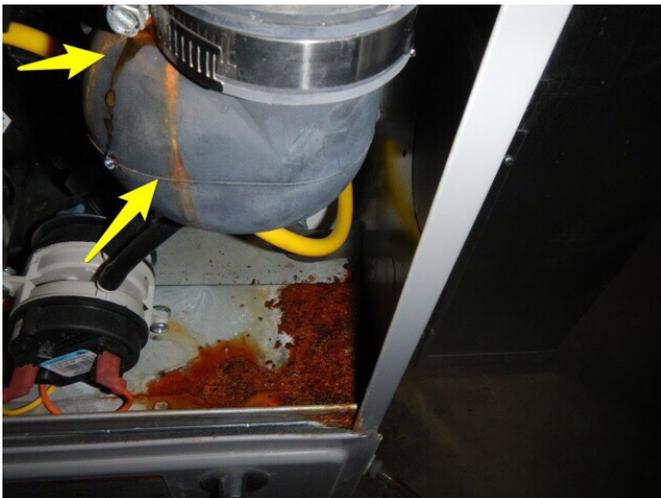
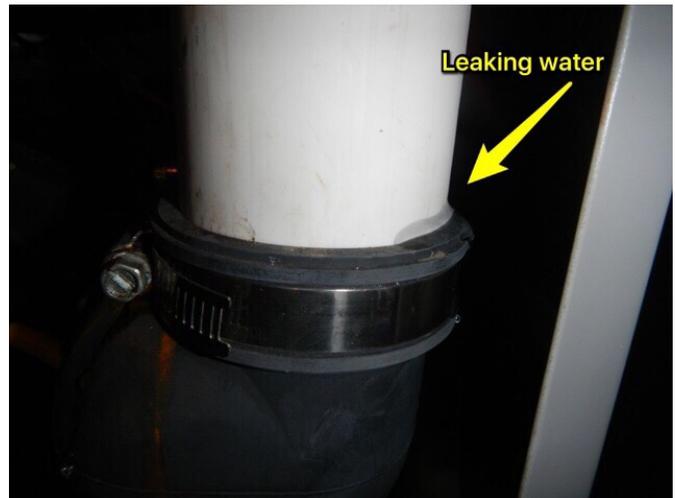
119: - The bottom of the plenum is setting on wet dirt and the metal floor is showing rust. We recommend the leak at the exhaust hose clamp be repaired. You should consult an experienced heating and air conditioning contractor for further evaluation and repairs.

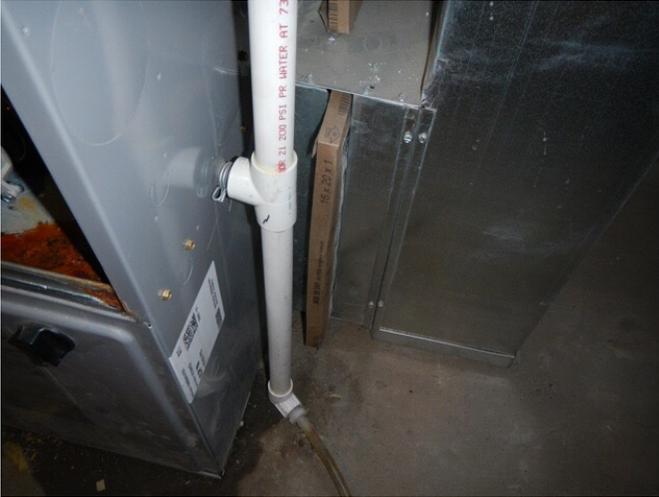
122: - The air filter is the wrong size and is allowing unfiltered air to pass by the filter and enter the furnace. We recommend a properly sized filter be installed.

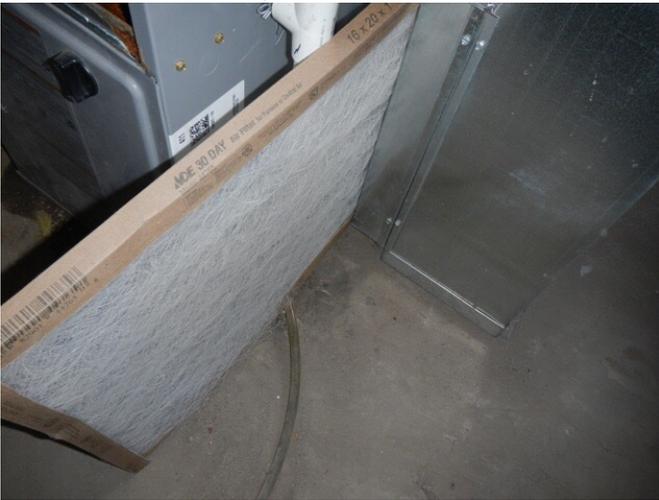
123: - The filter has accumulated debris which decreases its effectiveness and blocks air flow. This can dramatically decrease the efficiency of the heating system. We recommend the filter be removed, cleaned and replaced if necessary.

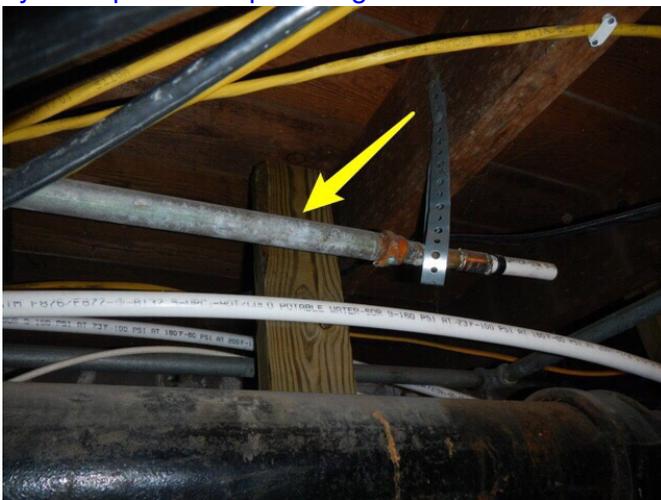
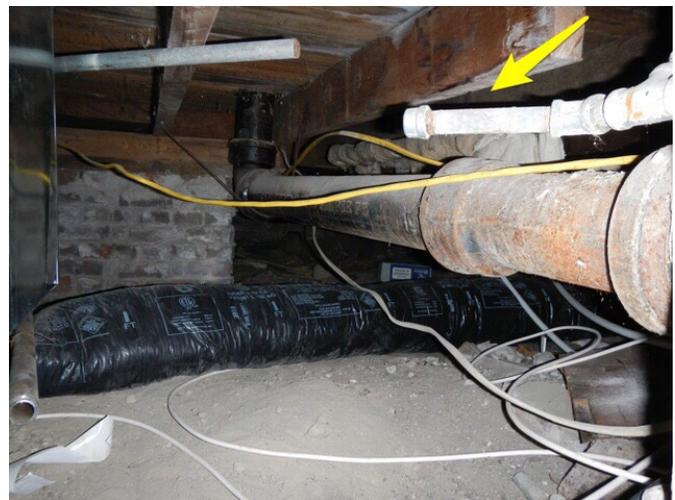
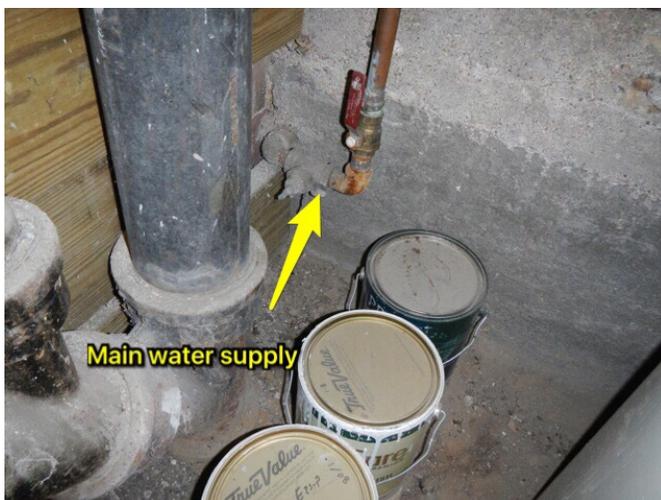
Note: Galvanized water pipes are known to rust and collect rust chips and minerals on the interior restricting water flow. This condition becomes worse over time and will eventually stop the proper flow of water. The seriousness of this condition cannot be evaluated without cutting a pipe open. Recommend further evaluation by an experienced plumbing contractor.

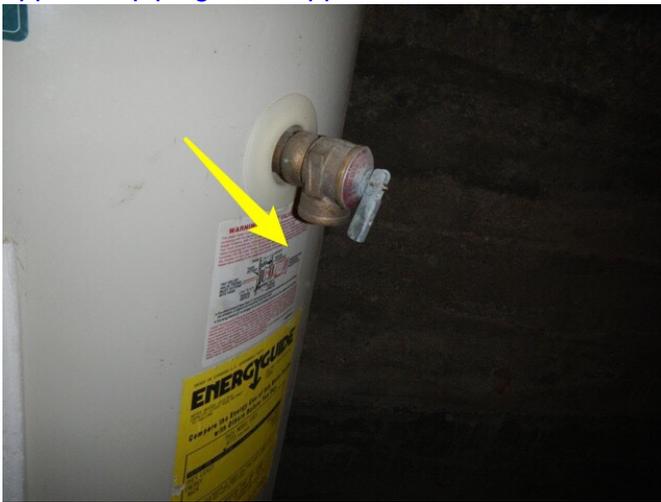
170: - [The temperature and pressure relief valve lacks a discharge pipe. We recommend the installation of approved piping to an approved location.](#)

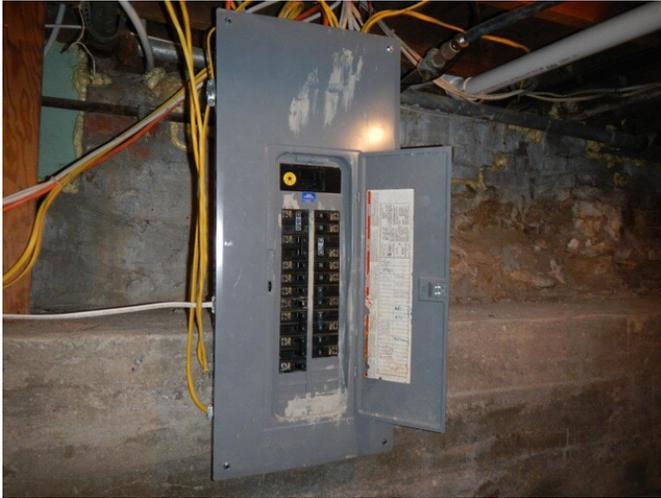
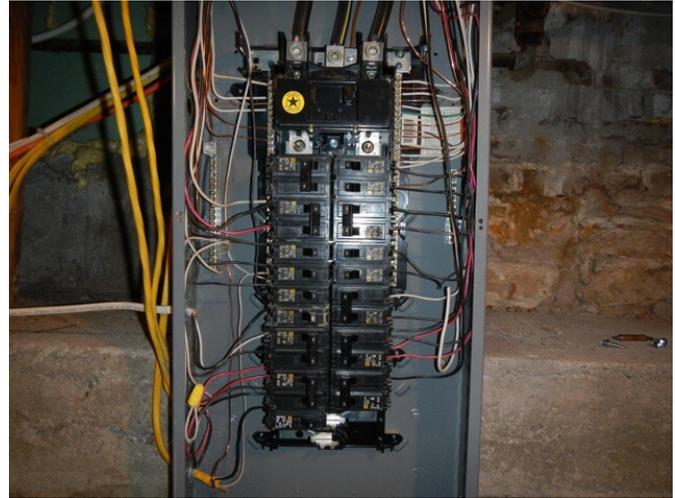
184: - The circuitry is not completely labeled. We recommend that each circuit be identified, allowing individuals unfamiliar with the equipment to properly operate it when and if necessary.

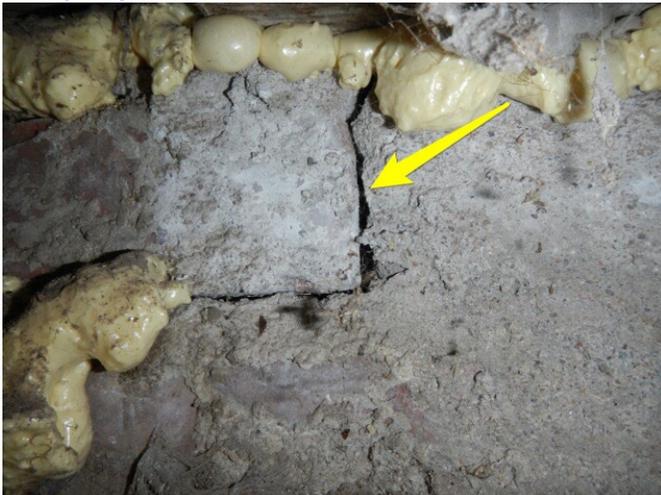
232: - There are small and/or moderate gaps at the brick mortar joints present. The small openings where exterior daylight is visible will allow wind, moisture and insect entry. Other than sealing the openings we observed no related conditions suggesting the need for immediate repair. This cracking should be monitored. If ongoing movement is observed, further review would then be recommended.

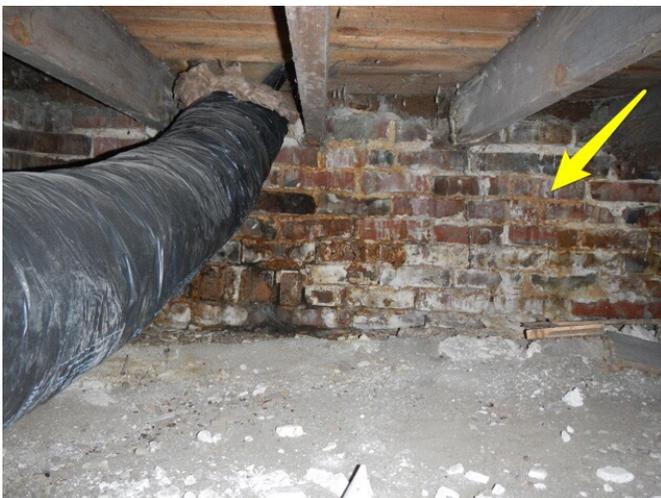
233: - The white powder on the basement walls is known as 'efflorescence' and is a result of moisture passing through and evaporating on the surface of the concrete. This causes no harm but indicates excessive moisture on the soil side of the walls.

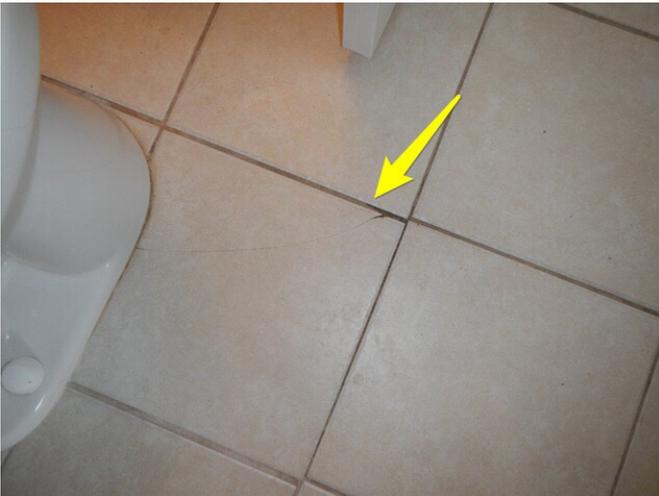
295: - [There are minor cracks in the floor tiles. These cracks appear cosmetic in nature and no action is indicated.](#)
