Property Inspection Report

LOCATED AT:
20 Year Old Home
Home Town, Nebraska 68889

INSPECTED ON:
Saturday, January 23, 2016

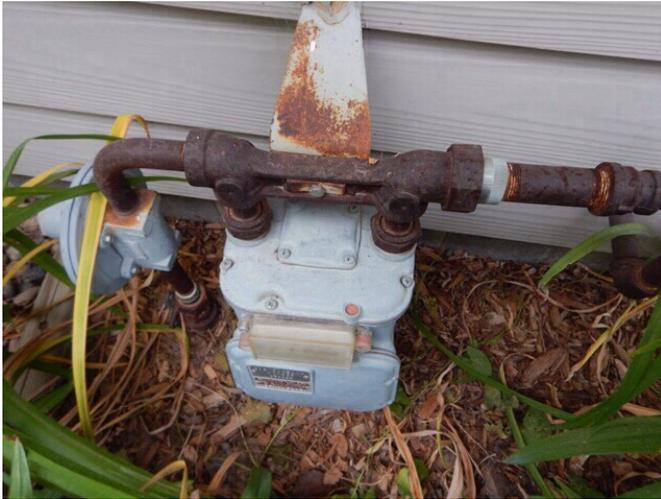
GAS PIPING

12: - Portions of the gas piping near the gas meter are corroded and rusted. We recommend they be painted to help preserve.

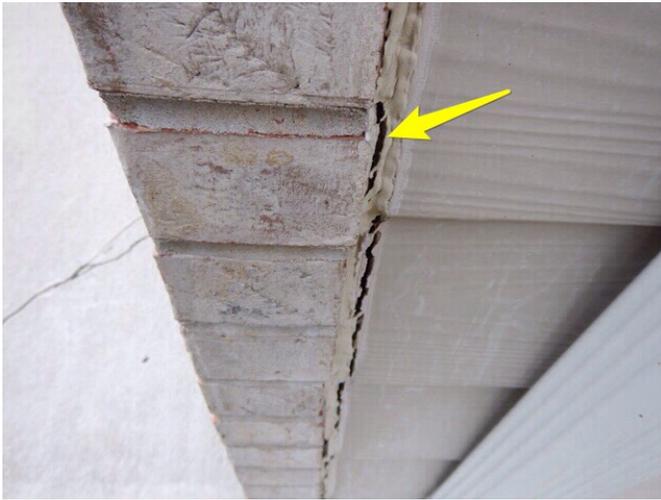
18: - In this case, the veneer has pulled away from the building and/or has become unbonded from the wood frame. This is largely an aesthetic consideration, but we recommend sealing or covering gaps to prevent moisture and pest penetration.

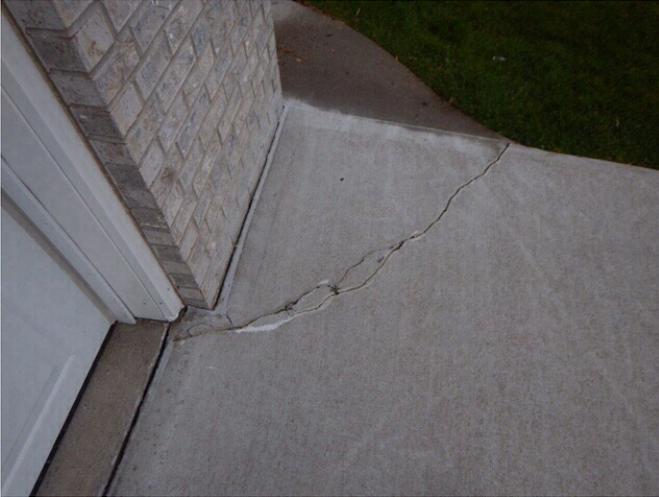
DRIVEWAY

26: - The minor cracks in the driveway are of a cosmetic nature. However, they do indicate movement in the soil and, over time, may develop into an aesthetic issue and/or a safety concern because of tripping hazards.

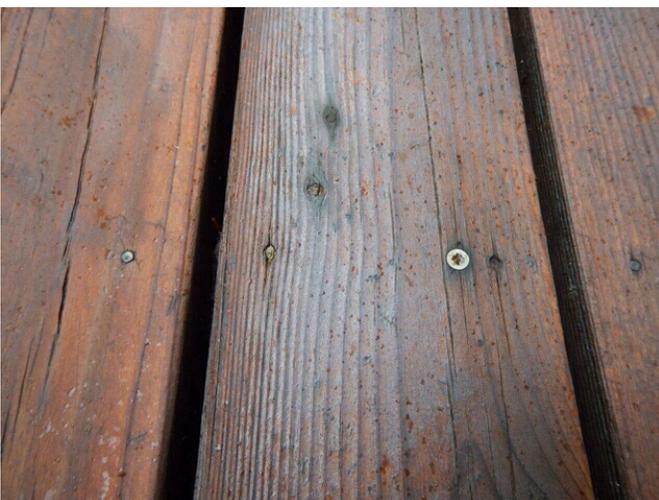
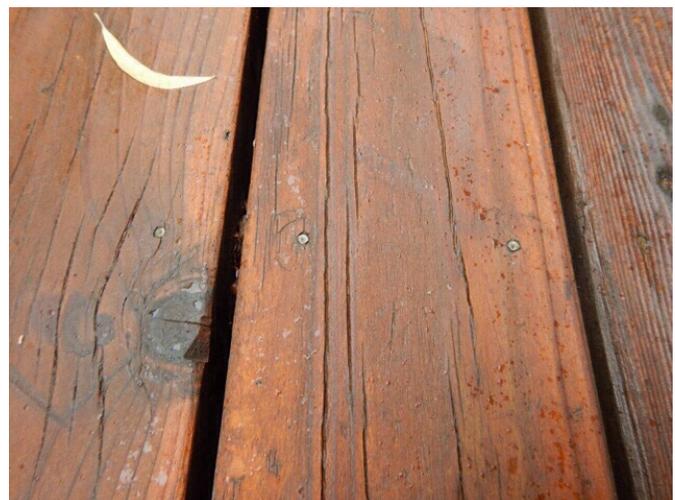
29: - Some of the decking board nails have backed out and are protruding. We recommend the nails be reset.

30: - A significant improvement in the construction of decks is possible through the use of galvanized screws now available specifically for this use. Rather than nails, these screws could be used for any future repairs or maintenance.

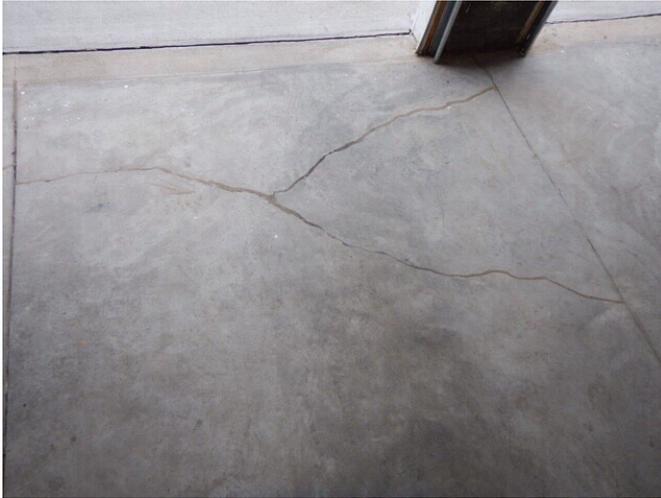
64: - There is cracking in the floor slab but there is no vertical displacement of any portion of the slab. No action is indicated.

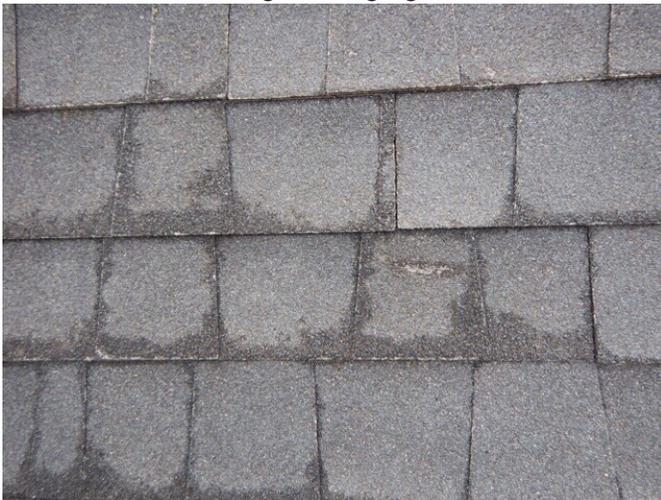
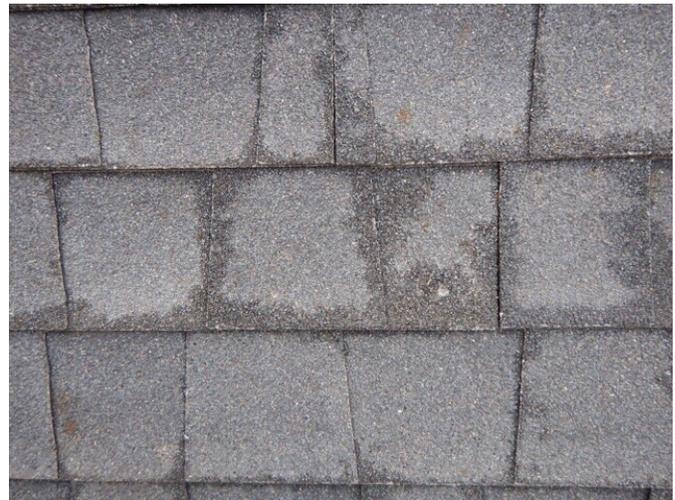
SURFACE

75: - Portions of the surface granulation are deteriorated and there are minor surface cracks developing. These are normal signs of aging and no action is needed at this time.

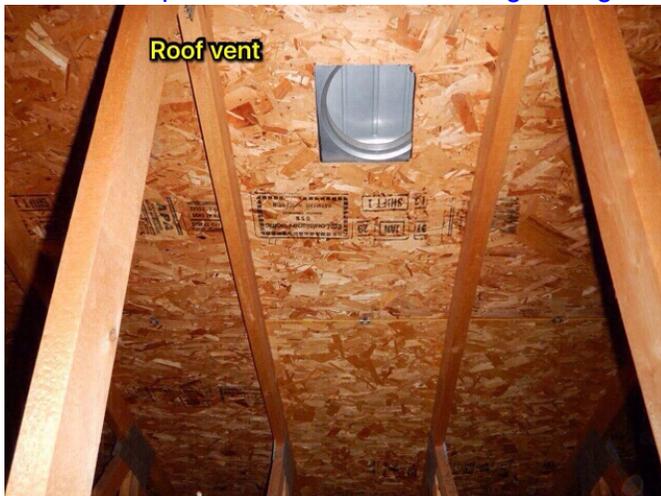
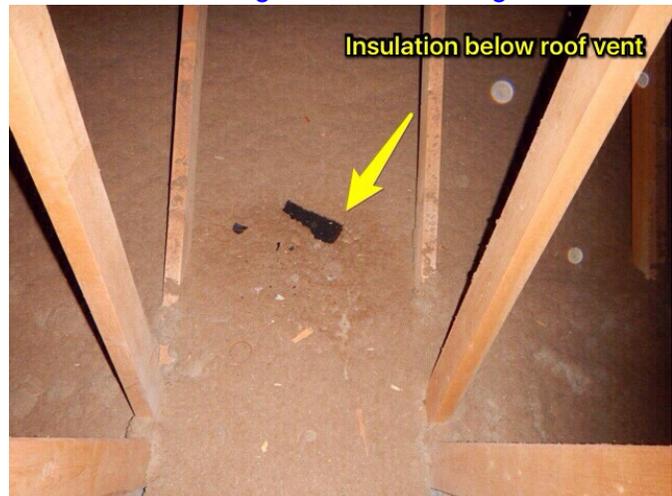
LEAK EVIDENCE

86: - There is evidence of active leakage. We recommend the exact source of moisture entry be located and necessary repairs performed to prevent additional leakage. Roof vents are known for allowing blowing snow into the attic space. We recommend a sheet of plastic be laid down to keep the moisture from soaking through the insulation and staining the interior ceiling.

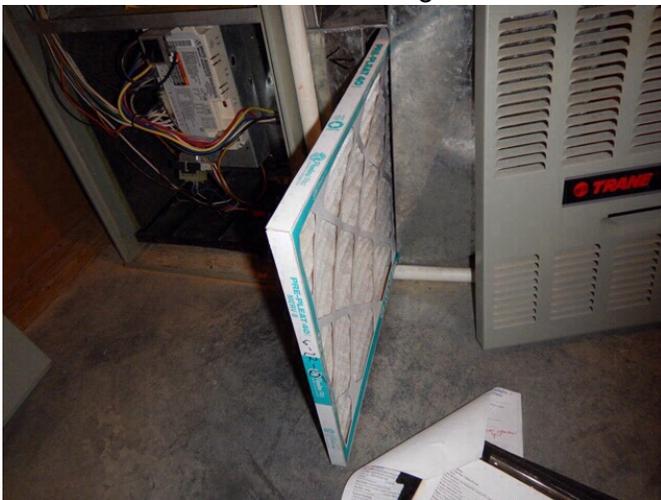
111: - The filter has accumulated debris which decreases its effectiveness and blocks air flow. This can dramatically decrease the efficiency of the heating system. We recommend the filter be removed, cleaned and replaced if necessary.

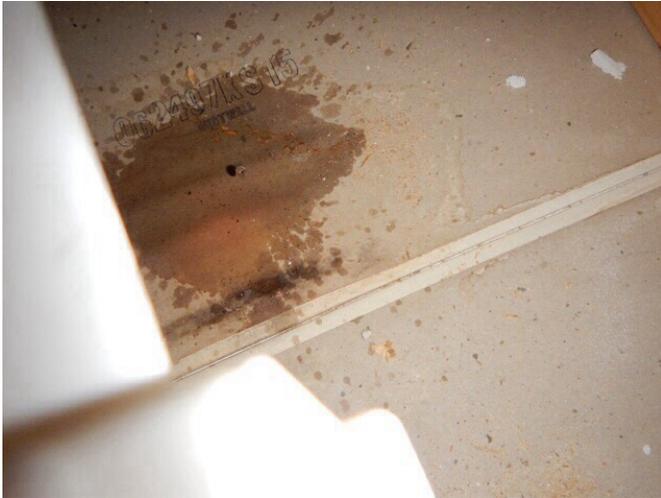
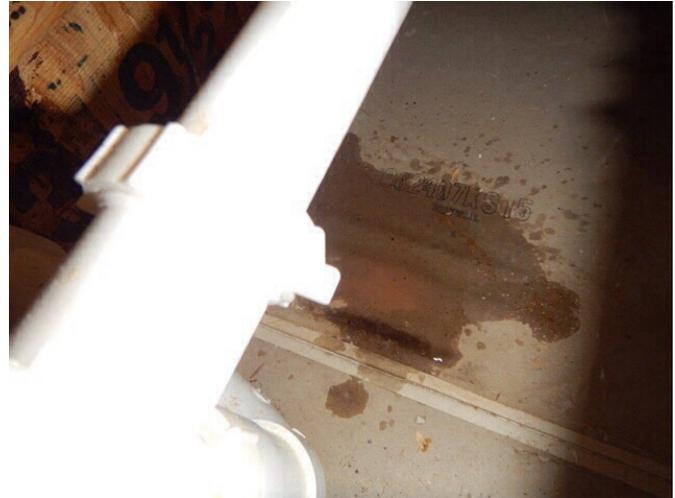
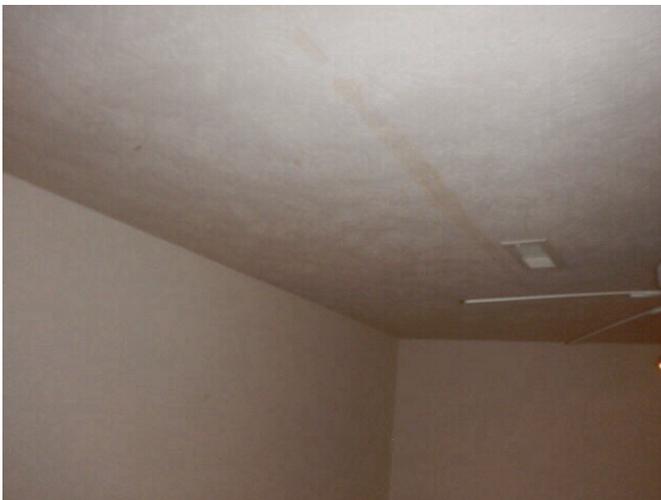
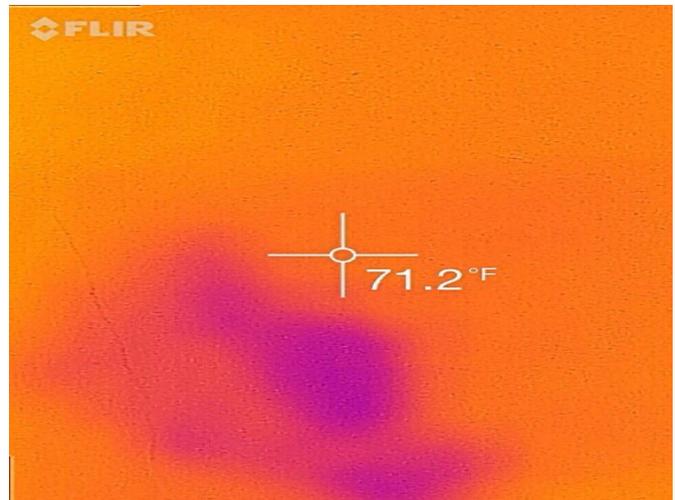
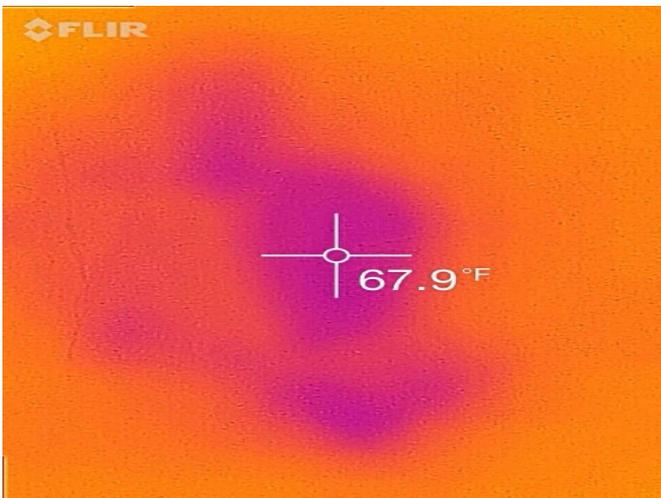
137: - There is a drain piping with active leakage at the whirlpool/hydrotherapy tub drain line. This leak has stained the basement ceiling and is a potential mold growth issue. The thermal image photos show the surface temperature of the basement drywall has changed due to the presence of the moisture. We recommend the piping in question be upgraded to prevent leaking.

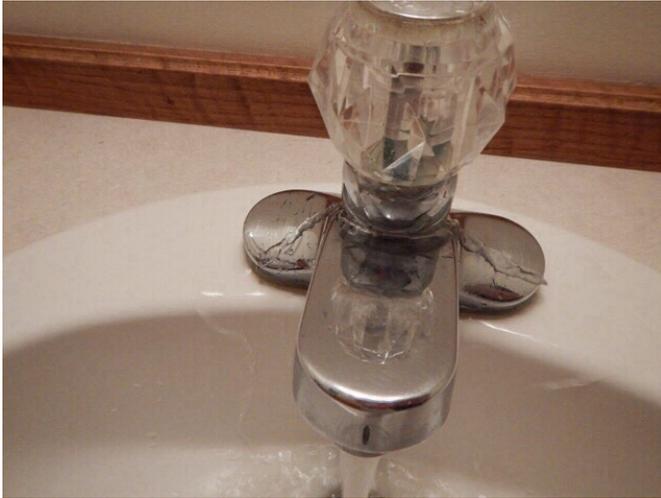
FIXTURES

246: - The sink faucet is leaking. We recommend that it be repaired or replaced.

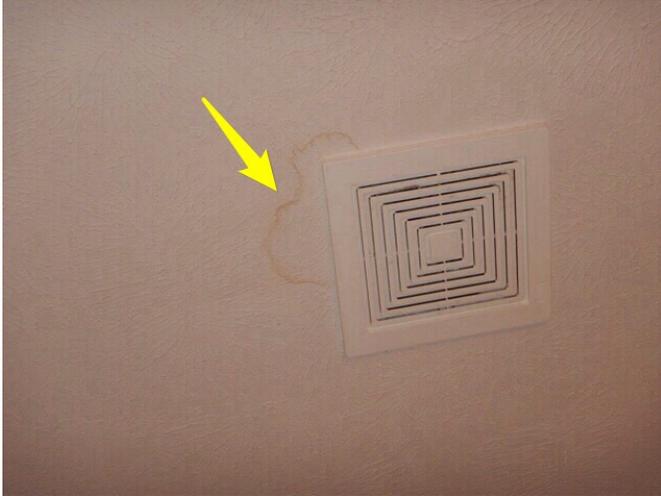
BATHROOM CEILING

257: - The ceiling is water stained, however, no evidence of moisture or leakage was observed. The source of the stain is condensation at the exhaust fan. Warm moist air entering the attic in the winter will form frost which melts onto the insulation and drywall ceiling.
