**Integrity Home  
Inspection &  
Testing LLC**

# Property Inspection Report

LOCATED AT:  
100 Year Old Home  
Our Town, Nebraska 68888

INSPECTED ON:  
Wednesday, January 27, 2016

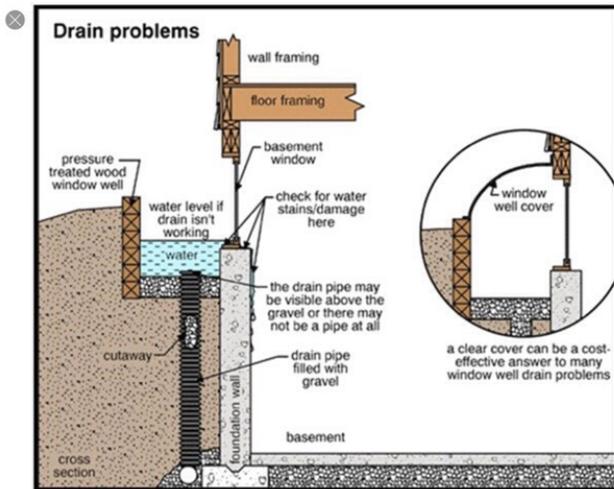
15: - Window wells require a weather cover to prevent moisture entry and possible flooding.

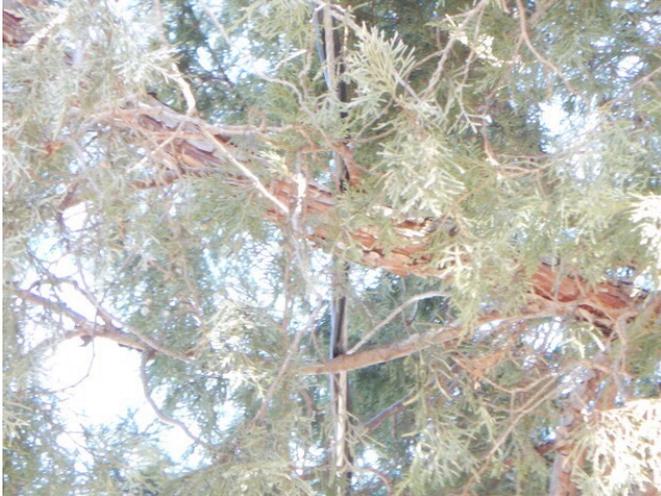
17: - The overhead service wires are deflected by the neighbors tree. We recommend the trees be trimmed clear of the wires or the service be reconfigured. To reduce shock hazard during this procedure, the work should be coordinated with the utility provider.

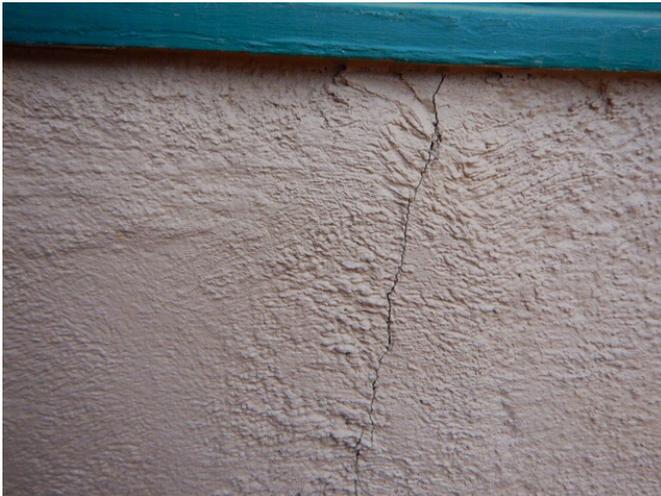
19: - The stucco exterior is in good condition, with a few minor cracks. These hairline cracks are typical and no action is indicated. They can be patched and sealed in the course of routine maintenance.

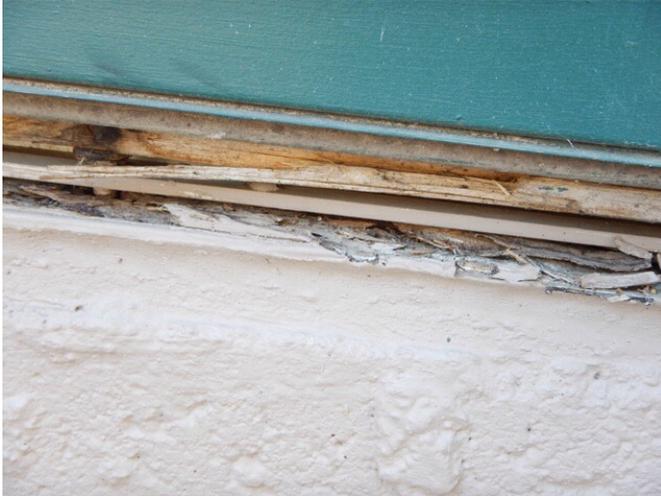
**20:** - The exterior doors appear to be properly installed and generally in serviceable condition, with exceptions noted below.

Note: The wood under the east laundry room door sill plate is showing dry rot. We recommend repairs or an upgrade.

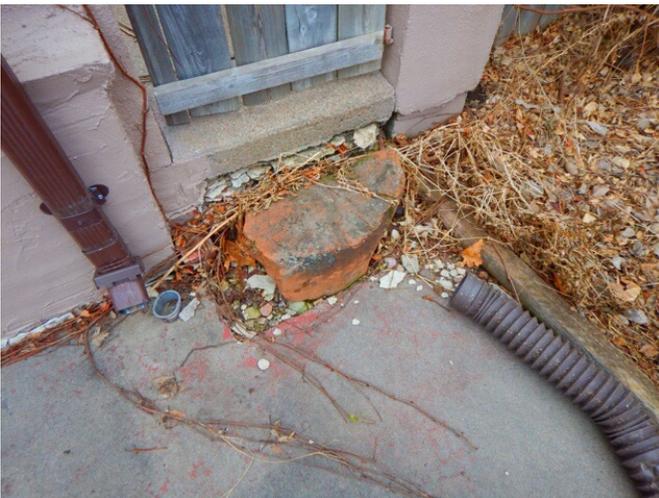
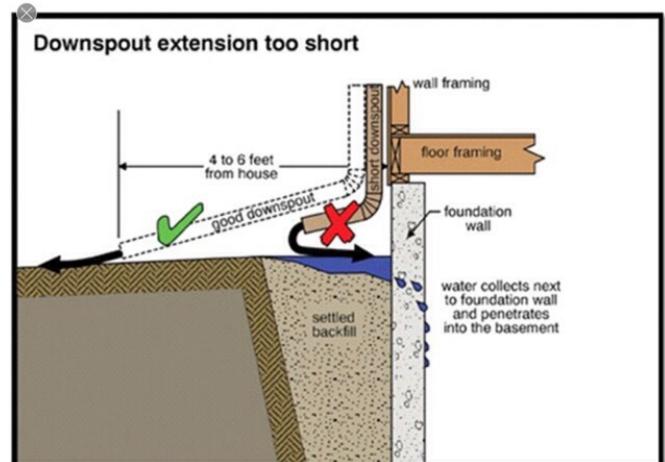
**25:** - Runoff water from the roof discharges next to the house. We recommend the downspouts be routed sufficiently away from the structure to prevent puddling, pooling, and saturation of the soil around the building.

**26:** - Recommend adding downspout extensions to move water away from the foundation wall. Keep all downspouts extended 5-6 feet and maintain the grade near the foundation wall to slope away approximately 1" for every 6 feet.

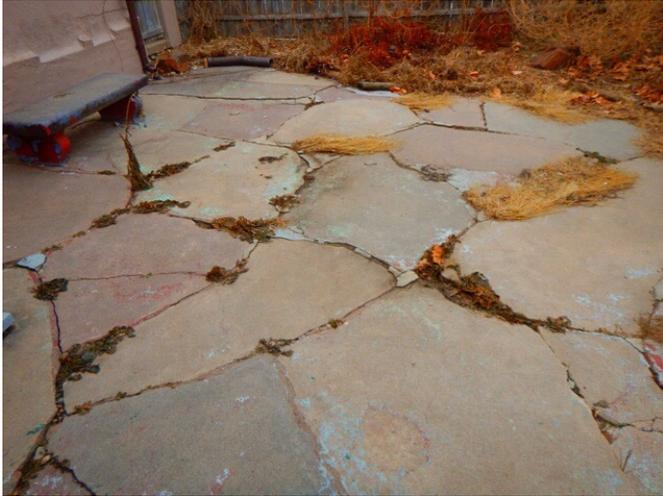
**30:** - The concrete patio surface has cracked and/or settled to the point that trip hazards exist and, in our opinion, it is no longer serviceable. We recommend it be removed, repaired, or replaced.

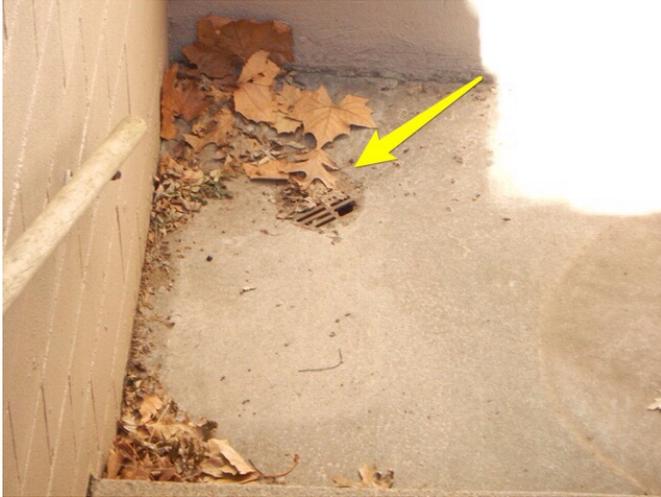
**31:** - The exterior stairs appear to be properly constructed and are in serviceable condition.

Note: Recommend keeping the exterior drain at the base of the stairs free of debris to allow proper drainage.

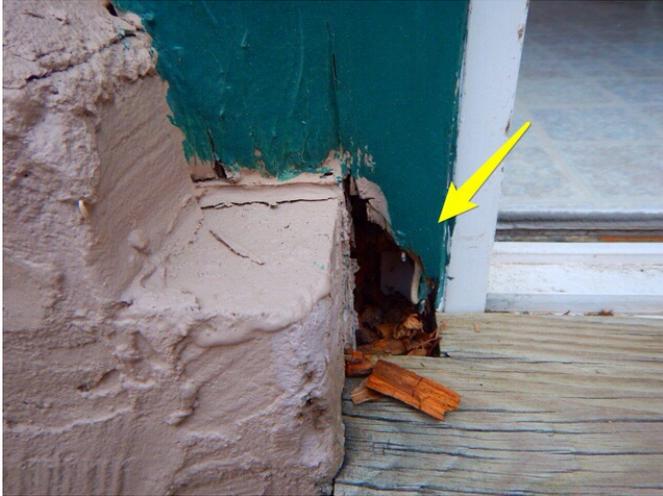
**39:** - The wood trim at the lower left outside corner of the west sliding door is showing dry rot. We recommend it be repaired or replaced.

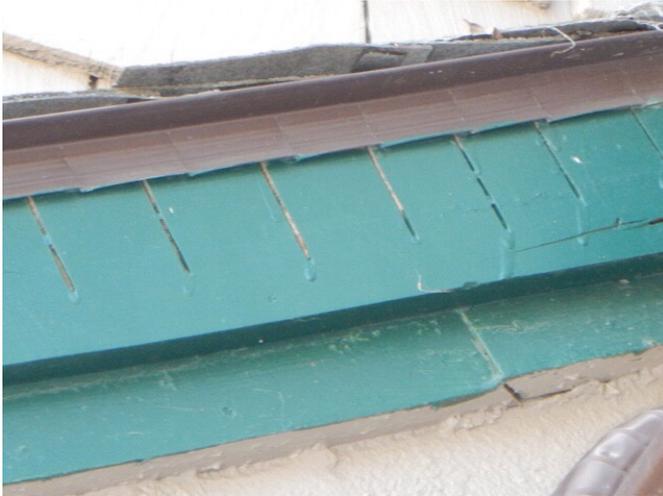
**40:** - The fascia appears to be properly installed and generally in good condition, with exceptions noted below. Note: The wood used on the arched fascia was cut to allow the wood to bend. When the paint is upgraded recommend sealing the openings to prevent moisture entry.

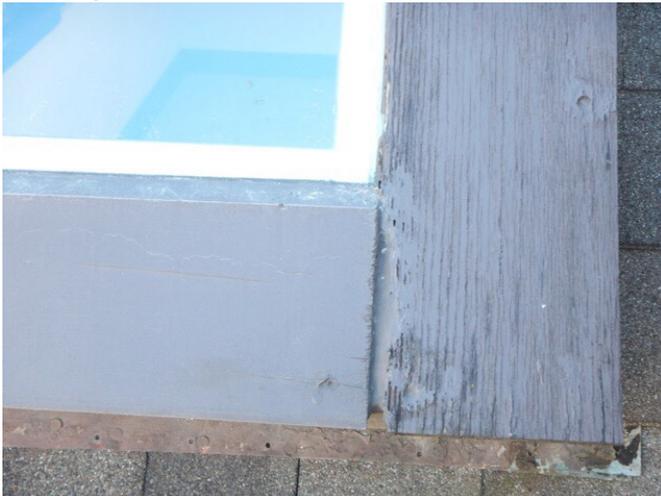
**42:** - The exterior paint is in fair to good condition but appears a bit 'tired'. There are no surfaces that need painting for other than cosmetic reasons.

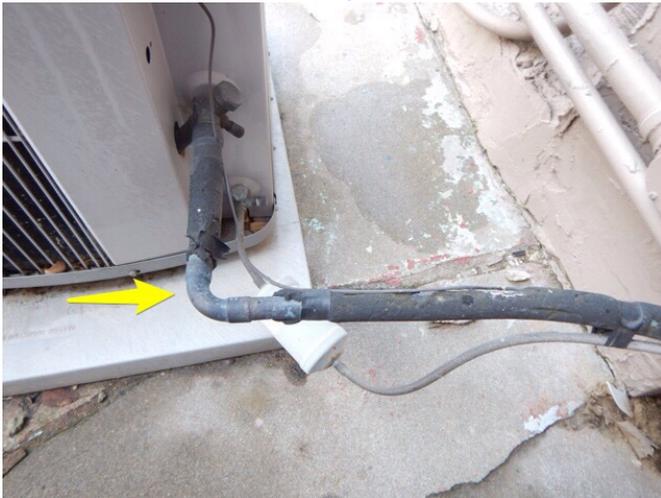
**61:** - Insulation is deteriorated and missing from a portion of the refrigerant lines near the condensing unit. We recommend that all missing insulation be replaced to increase energy efficiency.

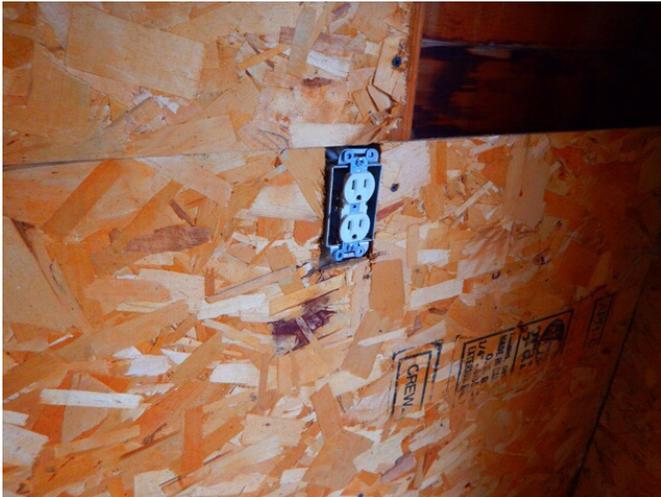
**69:** - There is no GFCI (ground fault circuit interrupter) protection for this area. For an increased margin of safety, we recommend the installation of a GFCI receptacle.

**70:** - One of the receptacles is missing its cover plate. We recommend it be replaced to reduce the risk of electrical shorts and hazardous shocks.

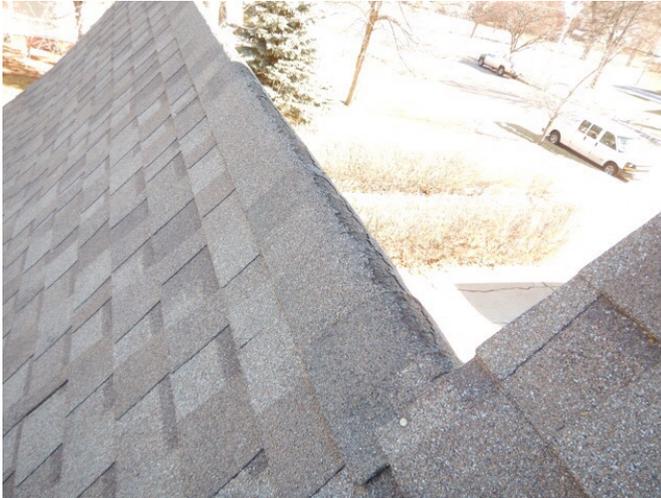
**87:** - The ridge shingle fasteners are exposed. This is not the recommended method of installation and indicates that the roof may have been installed by a non-professional. No problems were noted and no action is recommended.

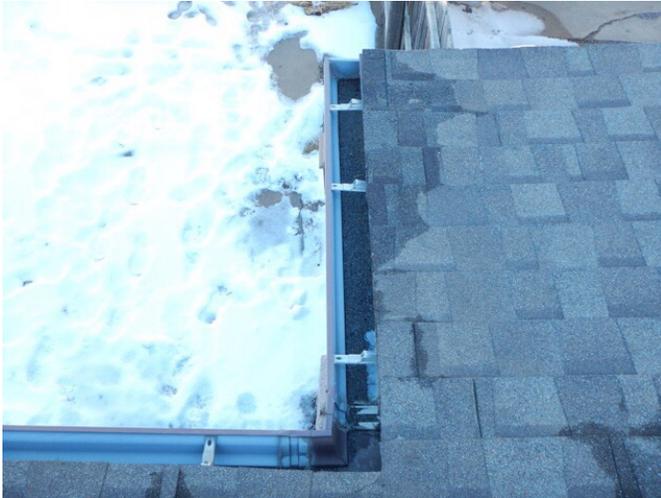
**88:** - Portions of the surface is showing granular loss, cupping and curling. The shingles are also showing minor surface cracks. These are normal signs of aging and no action is needed at this time.

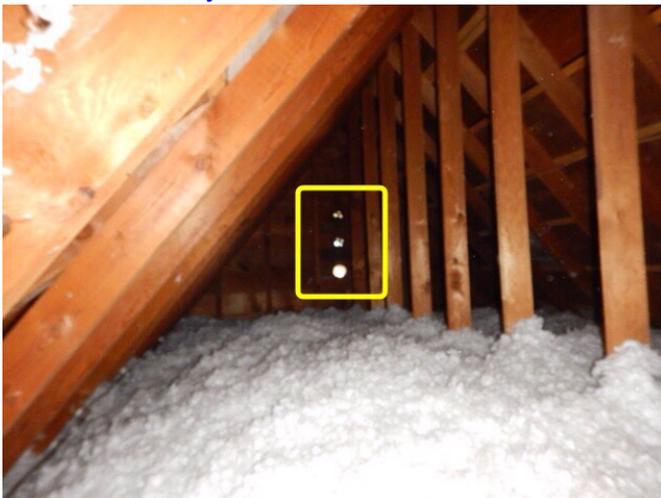
**105:** - Vents in the attic are unscreened, making possible entry by insects, birds, bats or squirrels. We recommend they be screened.

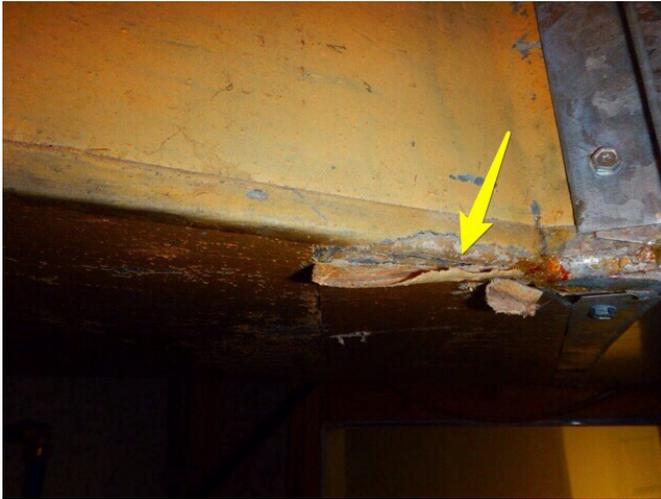
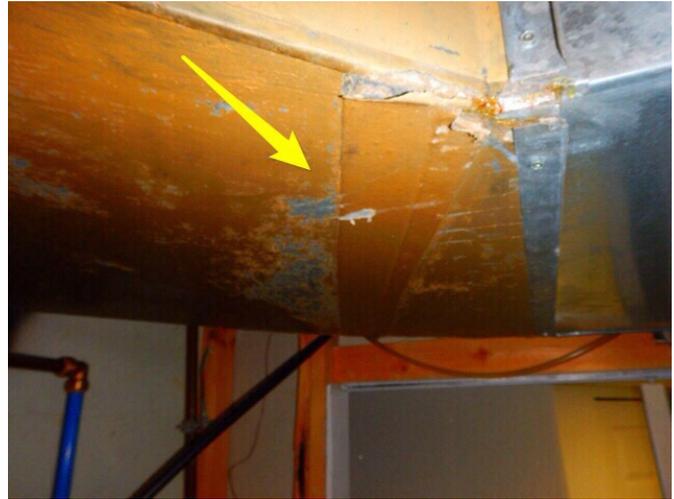
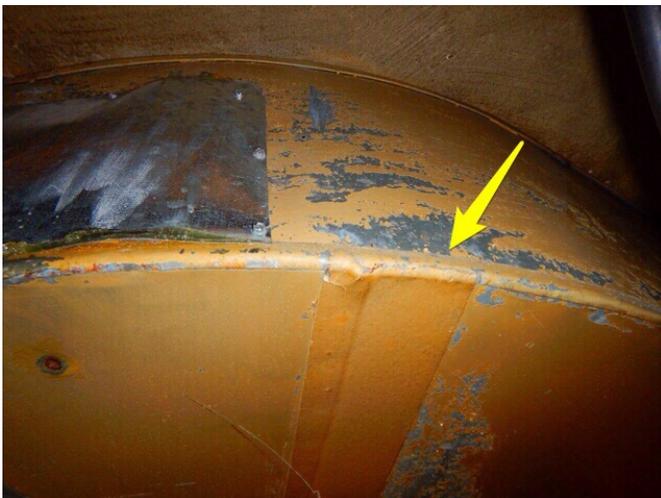
**126:** - The duct wrap in the furnace room is known to contain asbestos. The insulation is generally intact. Information regarding asbestos can be obtained from a licensed asbestos abatement contractor.

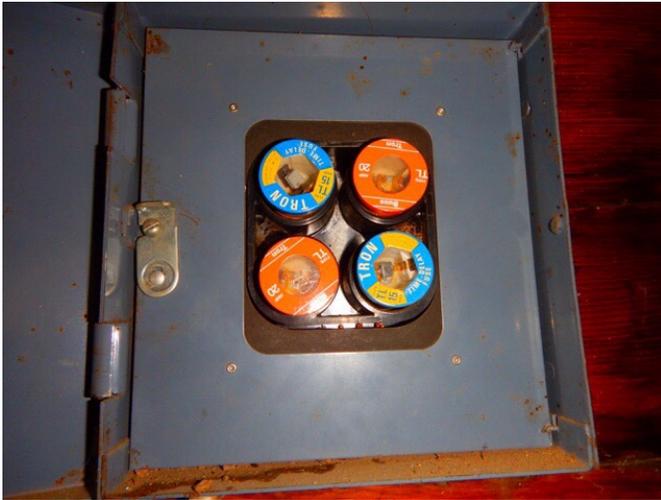
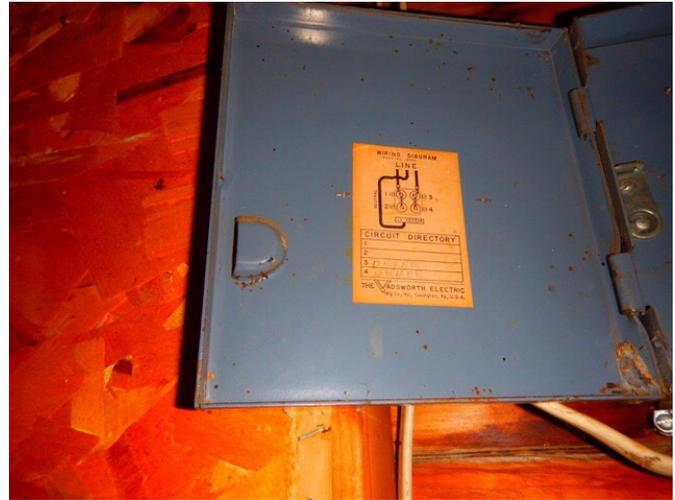
**183:** - An additional distribution panel, or subpanel, is located in the garage.

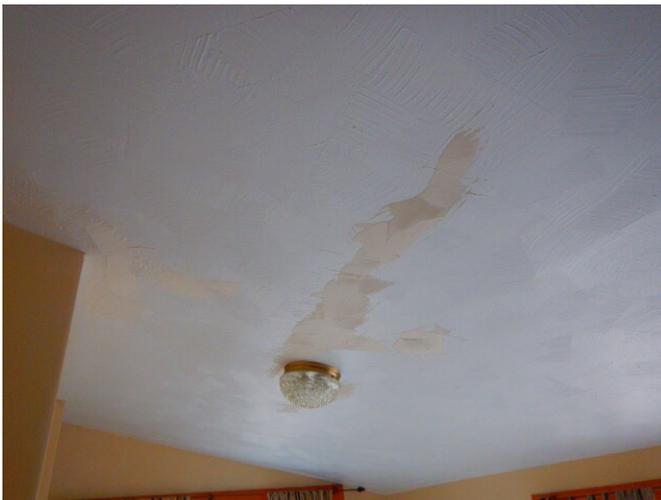
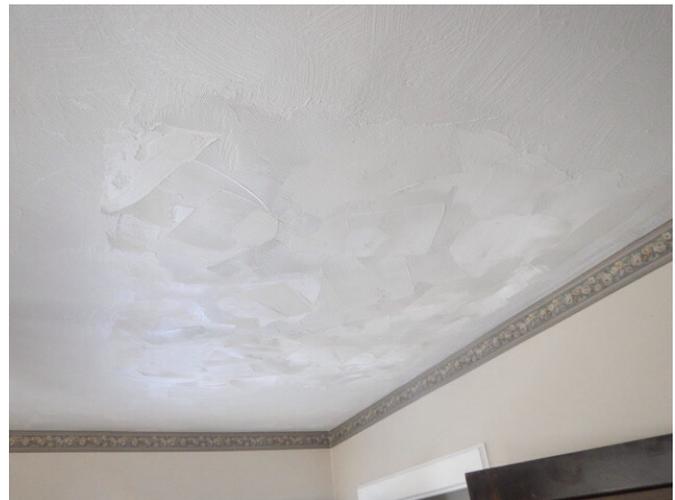
**212:** - The interior wall and ceiling blemishes are cosmetic and can be repaired in the course of routine maintenance.

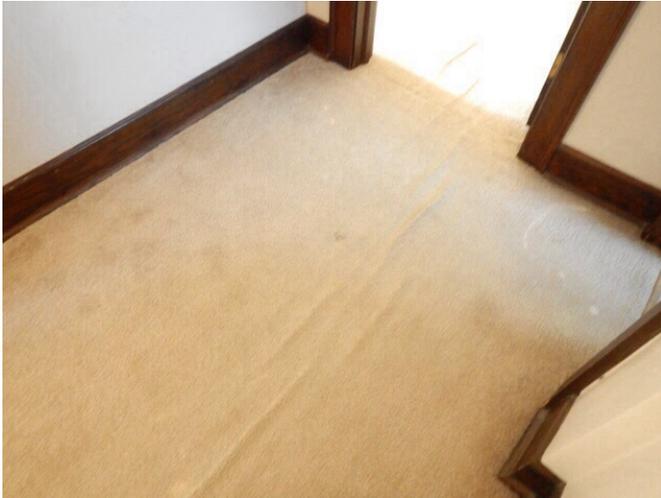
**Note:** At the entrance to the second floor bathroom the carpet appears to have a bleach type stain. The carpet is also wrinkled at several locations.

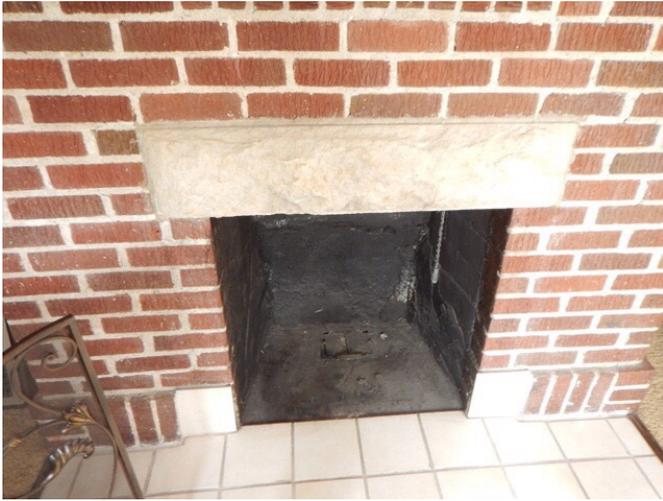
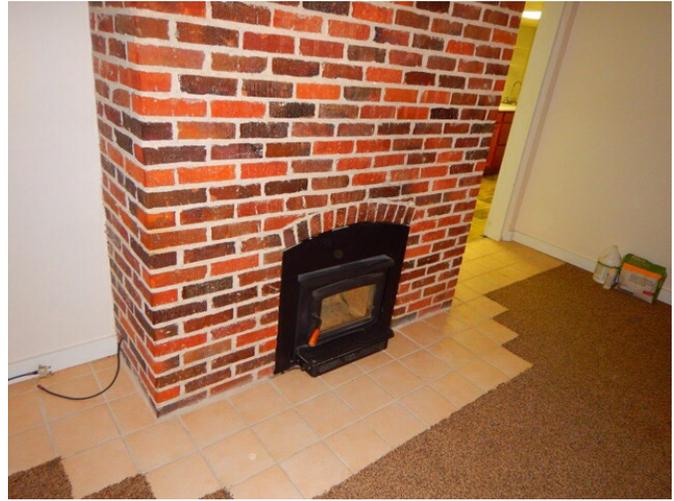
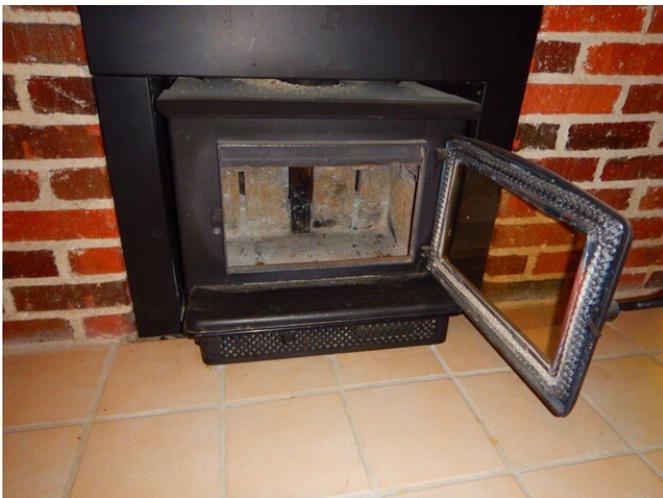
**220:** - At the time of the inspection insulation was packed at the damper opening. We believe it is unsafe to use the main floor fireplace. We recommend qualified personnel be retained to evaluate the fireplace and determine what corrective steps will need to be taken.

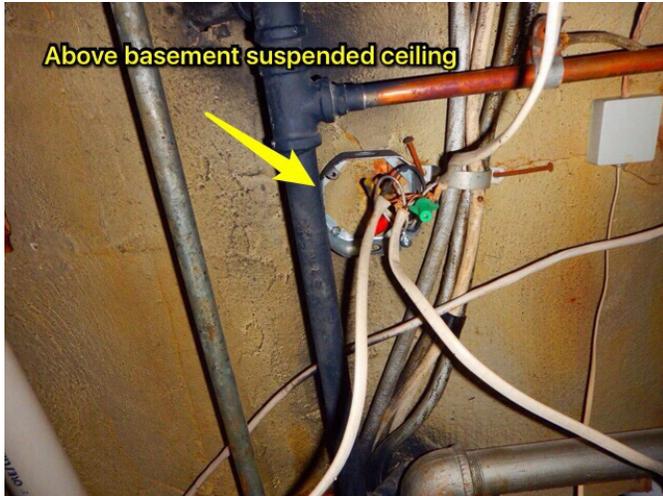
**232:** - Running splices, which are improper connections outside a junction box, were observed. We recommend connections be joined with approved connectors inside a junction box to prevent accidental contact or mechanical damage.

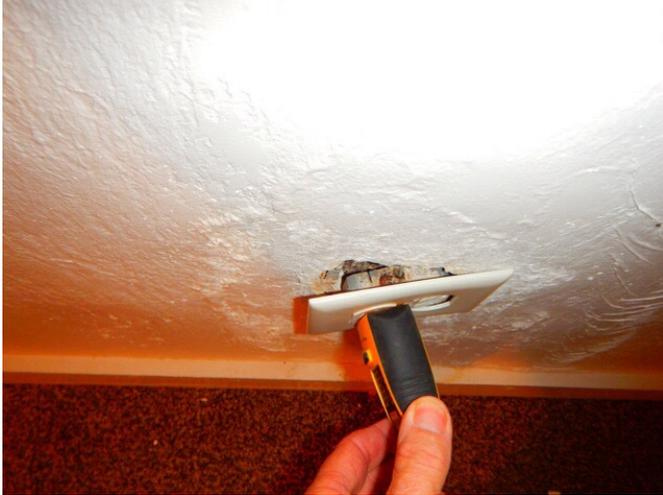
**235:** - The receptacle on the west wall of the basement family room is loose. For maximum safety we recommend that it be resecured.

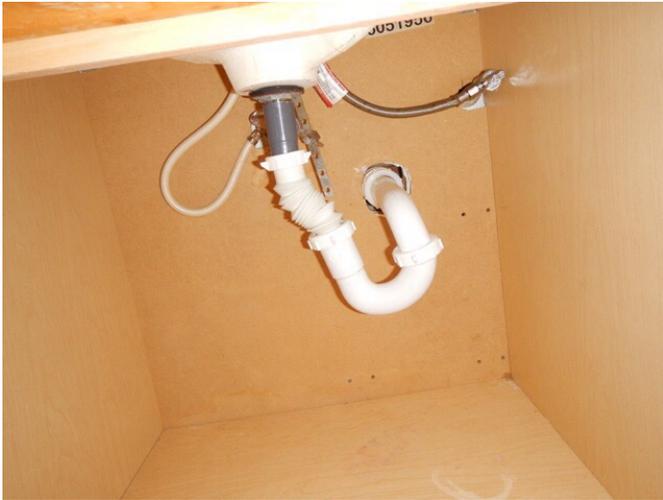
**303:** - The flexible rubber or plastic fitting used in the drain trap is nonconforming. The system is functional and modification would be considered optional.

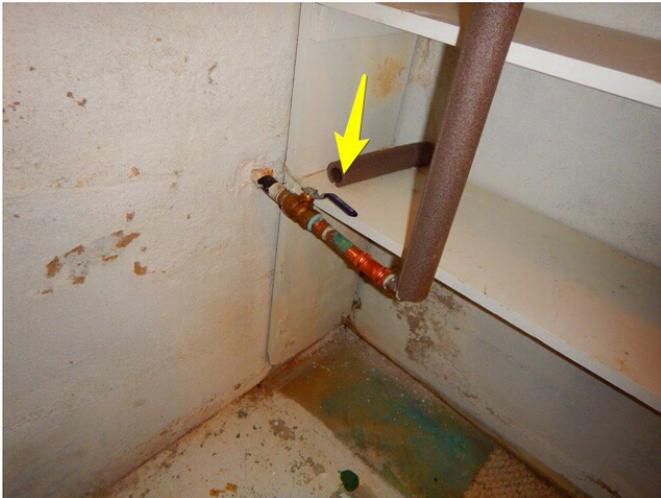
**349:** - The domestic water supply main shut-off valve is the blue handle posted in the basement pantry on the south wall.

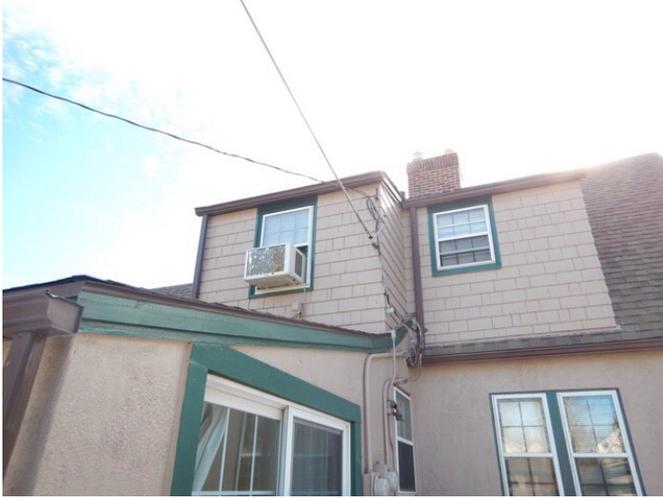
**350:** - The electric meter is outside on the rear of the building.

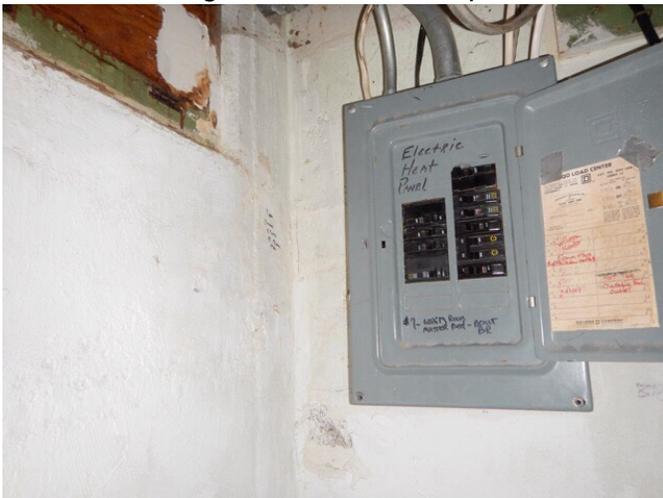
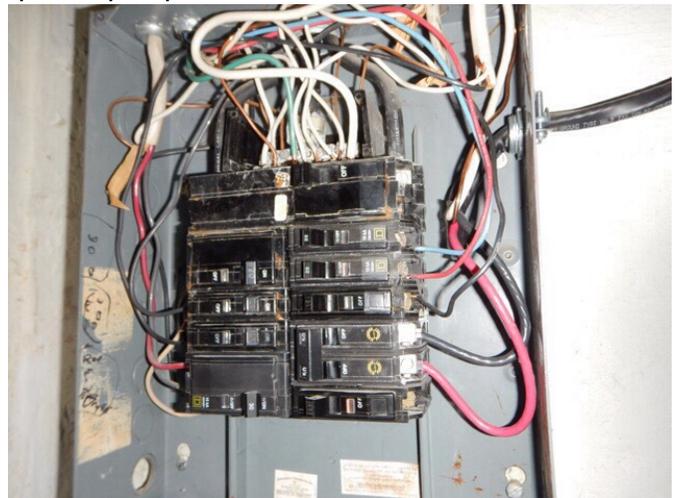
**351:** - The main electrical service panel is outside on the left-rear corner of the basement. The fuse panel located to the right of the basement panel controls the spa tub pump.

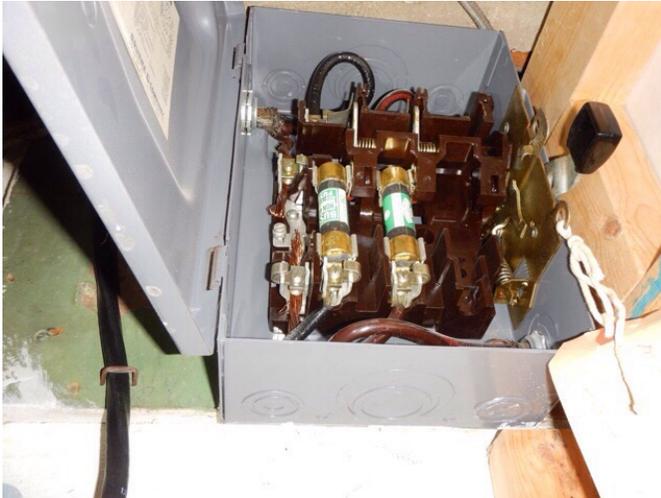
**352:** - The main electrical service panel is in the basement.
