Property Inspection Report

LOCATED AT:
114 Year Old Home
Your town, Nebraska 68880

INSPECTED ON:
Monday, January 23, 2017

Inspector, Larry Karschner and Joshua Methe
Integrity Home Inspections & Testing LLC

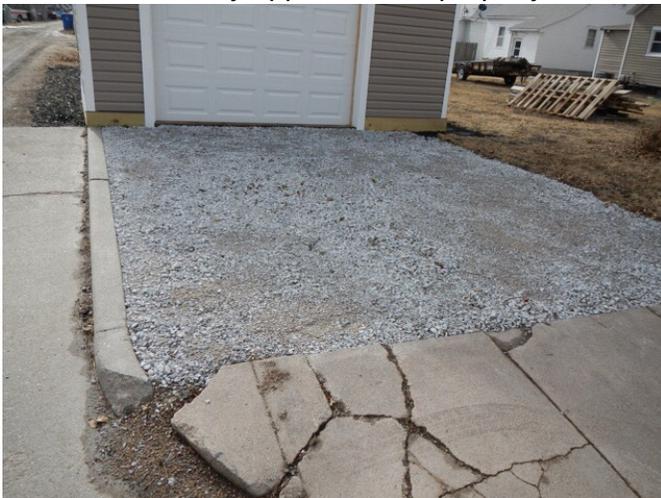
DRIVEWAY

28: - The driveway appears to be properly installed and is generally in good condition.

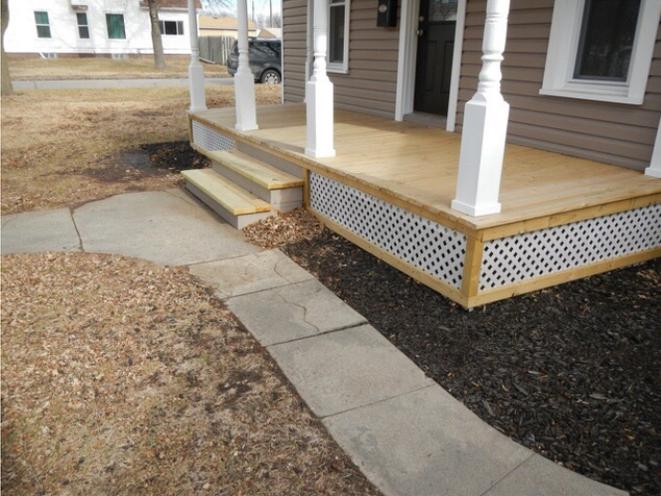
32: - The west porch deck appears to be properly constructed and generally in serviceable condition, with no need for significant maintenance or repair at this time.

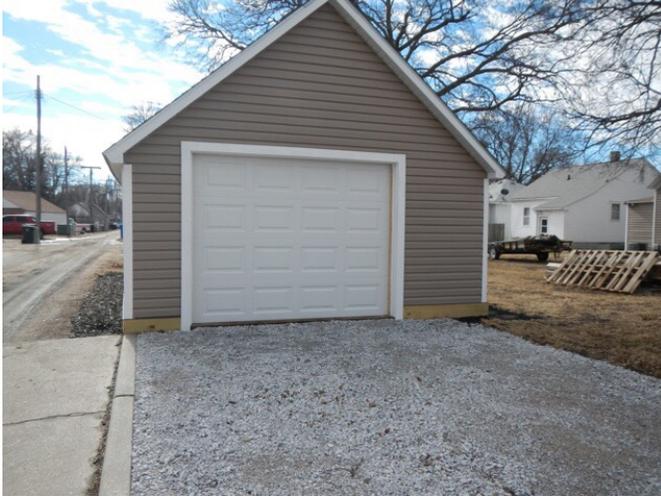
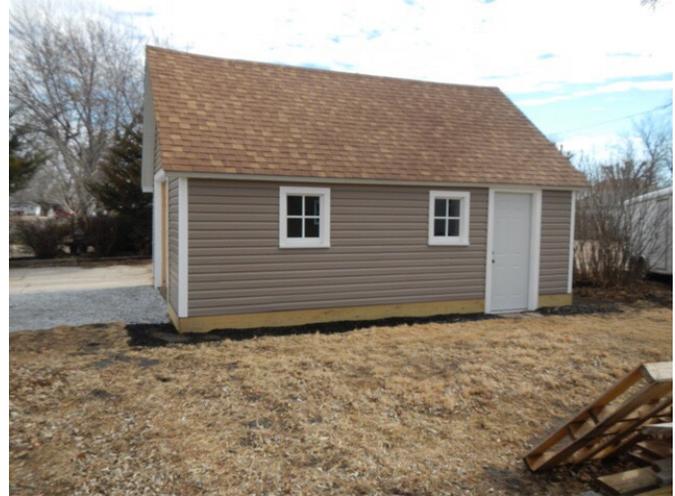
WALL FRAMING

64: - In the areas where the wall framing is visible, all components appear to be properly installed and generally in good condition. There is evidence the garage walls were upgraded. At the time of the inspection the floor was wet near the exterior walls.

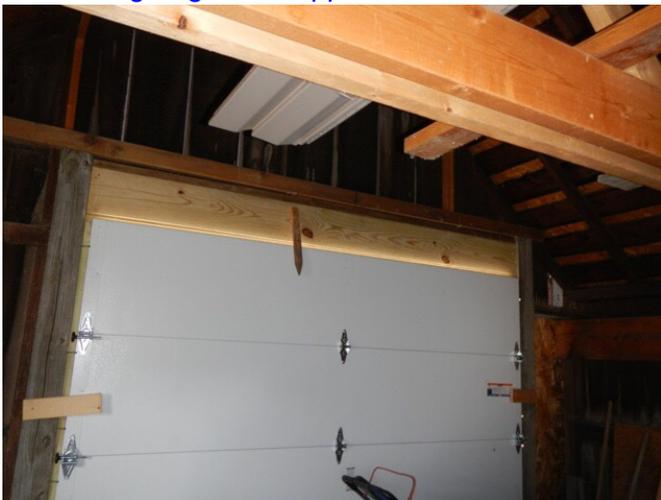
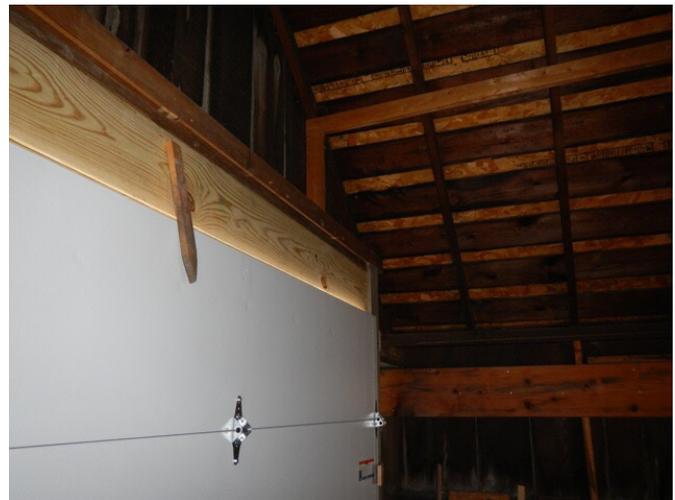
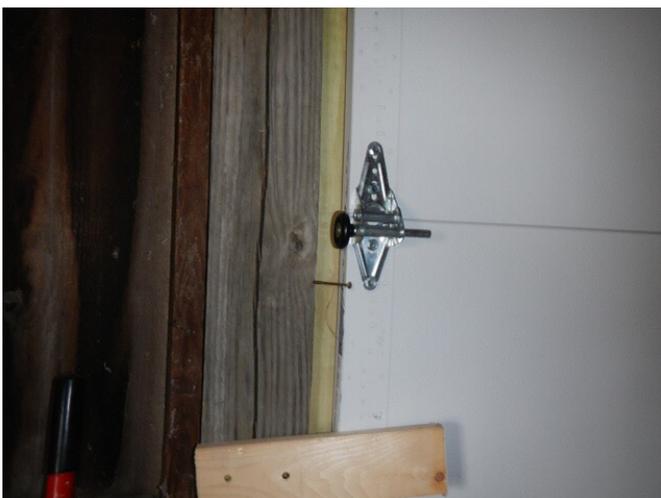
GARAGE DOORS

66: - The garage door appears to be under construction and not installed.

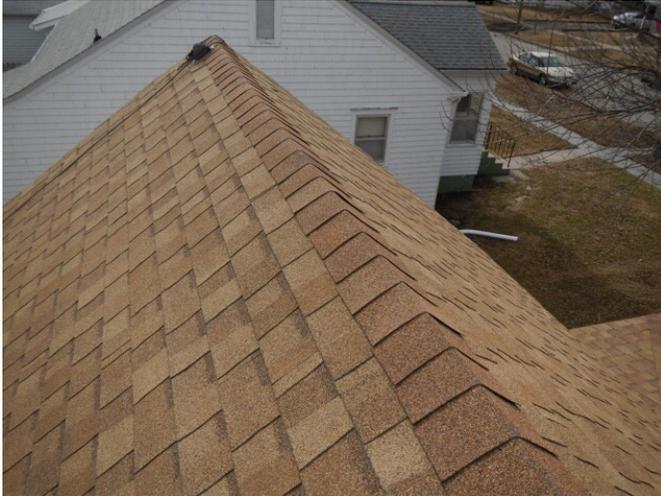
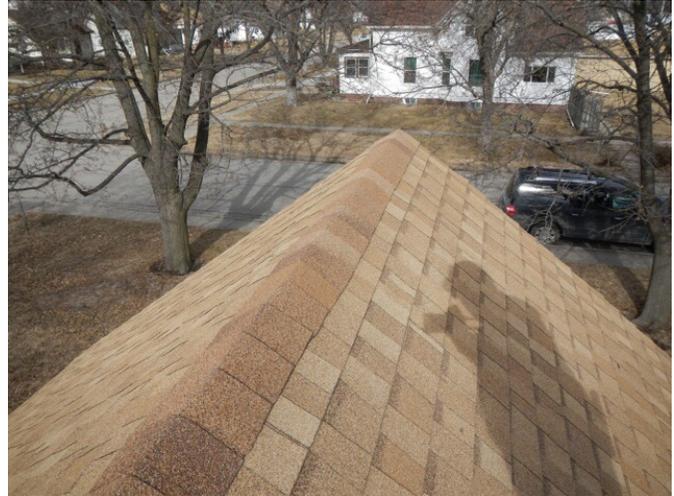
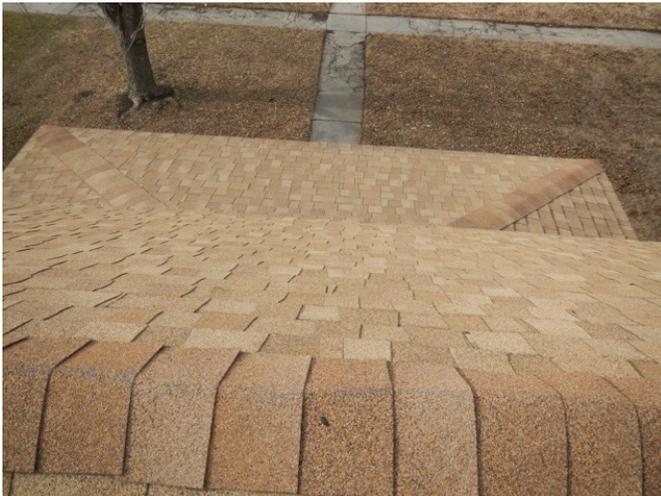
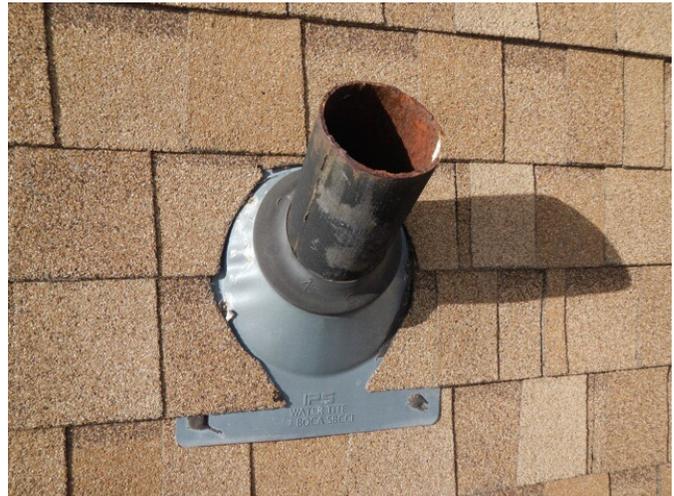
SURFACE

78: - The shingles show wear due to exposure but appear to have been properly installed and are in a condition deemed acceptable for their age. No action is indicated at this time.

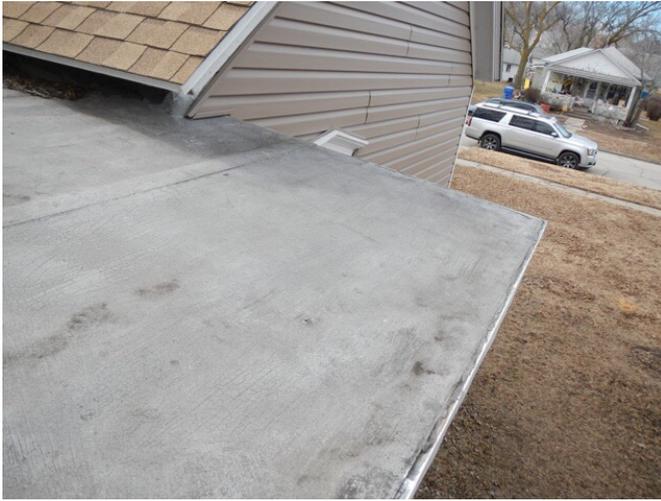
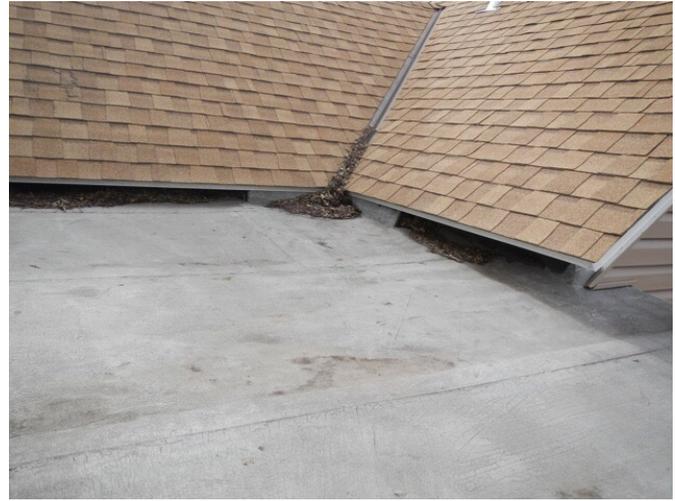
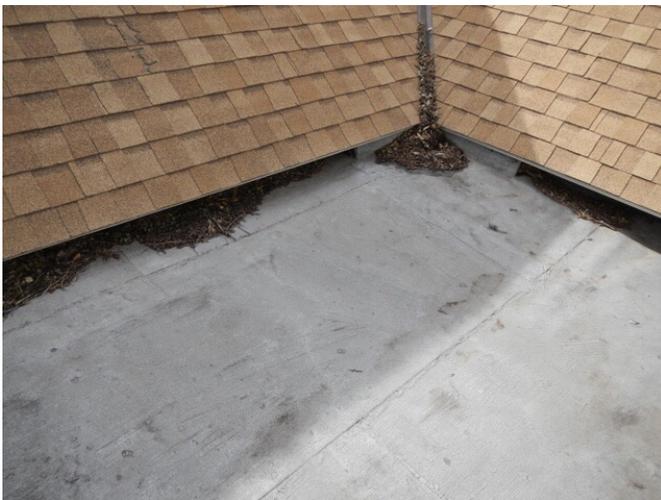
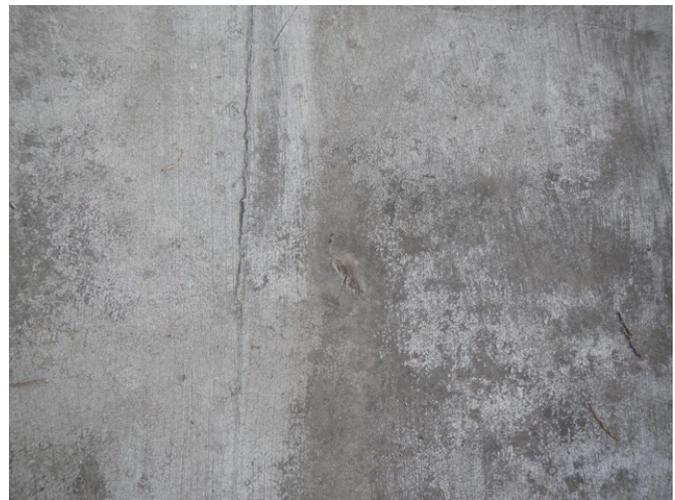
SURFACE (BUILT-UP)

87: - The roofing surface appears to have been properly installed and is in serviceable condition, with exceptions noted below. Attention to the items listed, together with routine maintenance, will keep it functional and maximize its useful life.

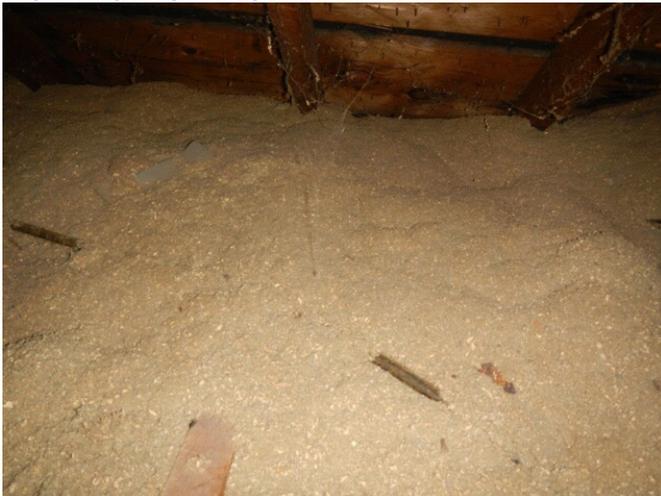
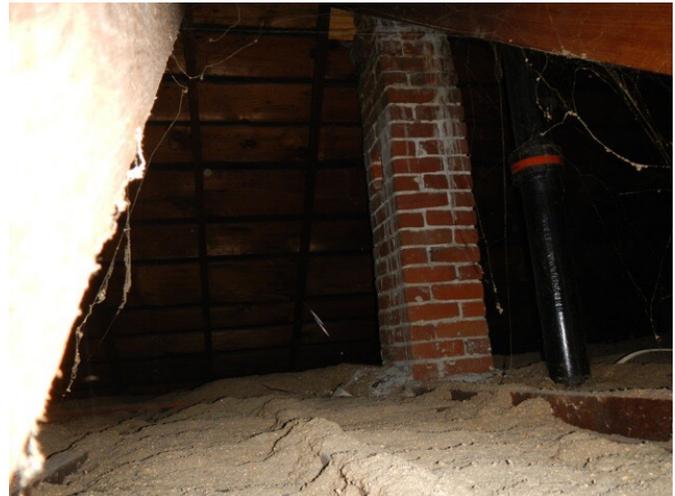
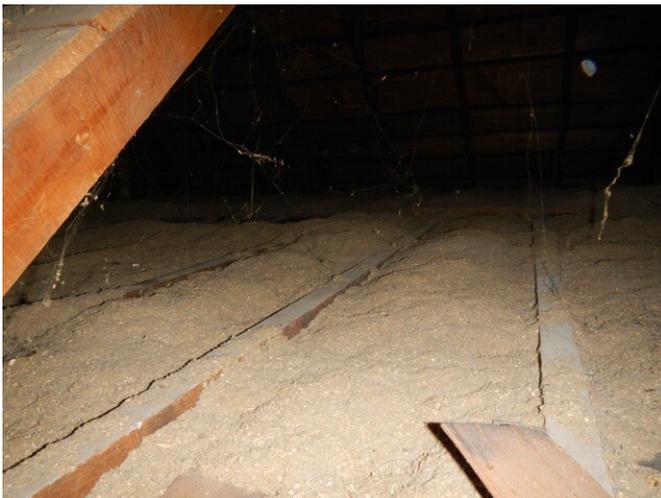
107: - The level of insulation would appear to provide an R-19 insulating value. This provides only moderate resistance to heat transfer and was the standard until recently. An insulation contractor could be consulted regarding upgrading.

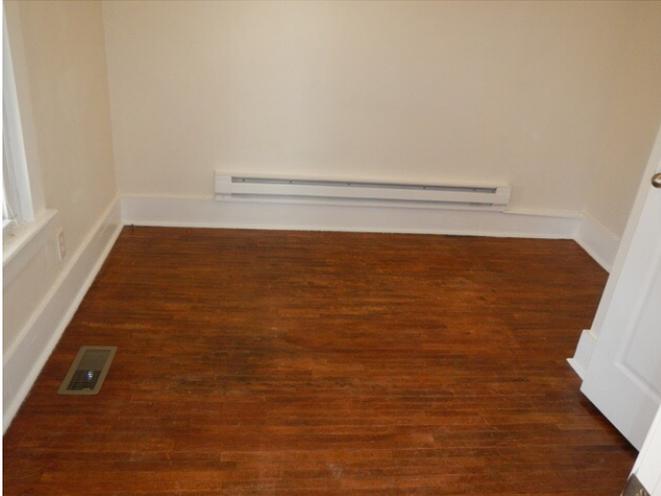
RESISTANCE HEATER

139: - The electrical resistance heater in the north west bedroom failed to respond to normal operating controls. We recommend it be repaired or replaced.

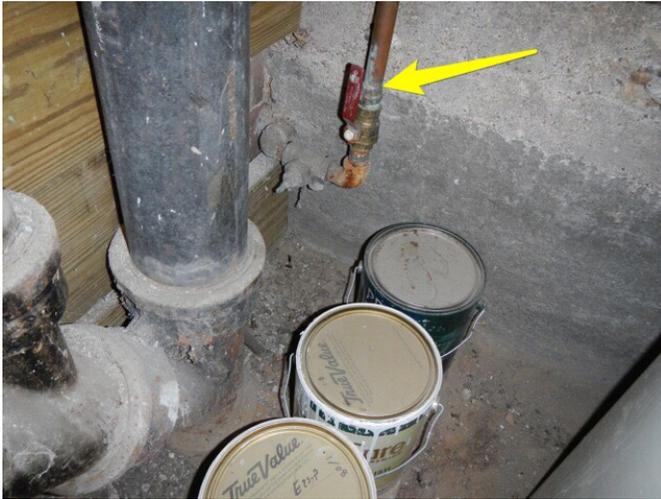
WATER SHUTOFF LOCATION

150: - The domestic water supply main shut-off valve is the red handle posted in the furnace room to the left of the water heater.

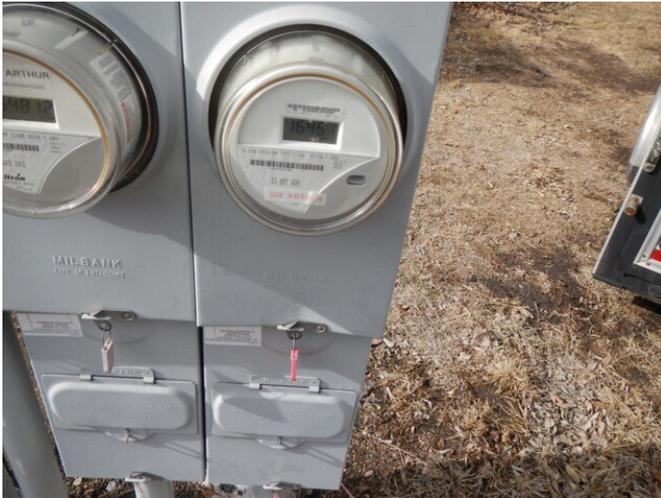
ELECTRIC METER

- 179: - The electric meter is located on a utility pedestal in the alley.

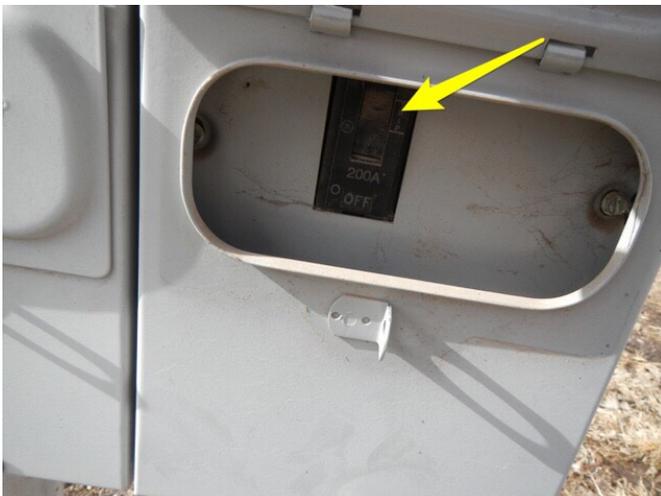
MAIN DISCONNECT

- 181: - The main disconnect is incorporated into the electrical service panel.
- 182: - The main electrical service disconnect is located in a weathertight enclosure next to the electric meter.

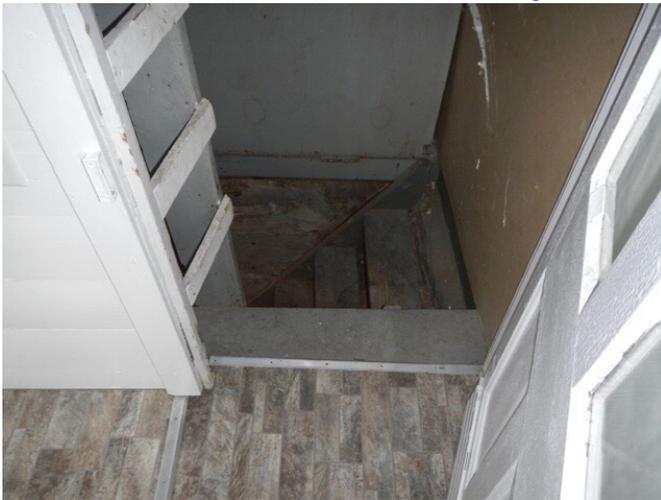
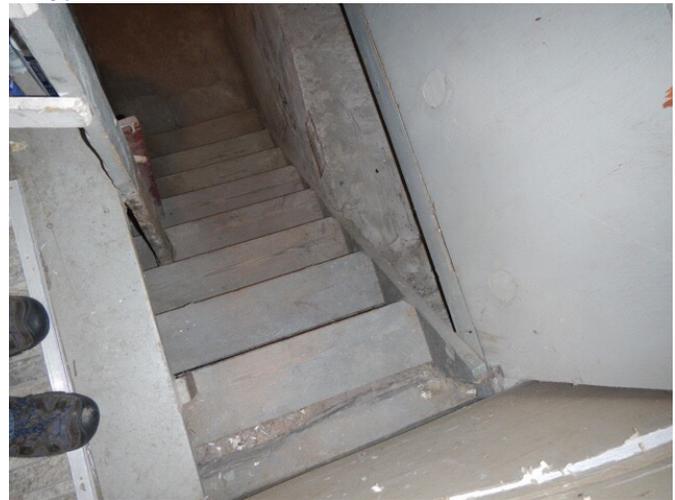
STAIRS

215: - The cellar stairs are nonconforming. This is typical of most cellar stairs.

216: - There are no railings where needed at the cellar stairs. As a safety measure, we recommend that railings be installed.

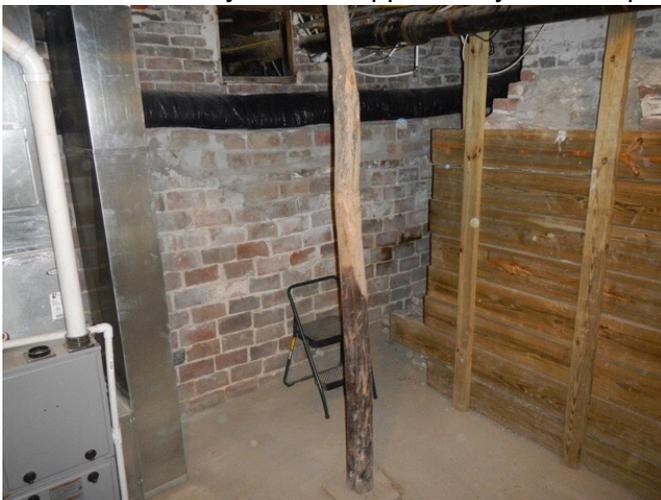
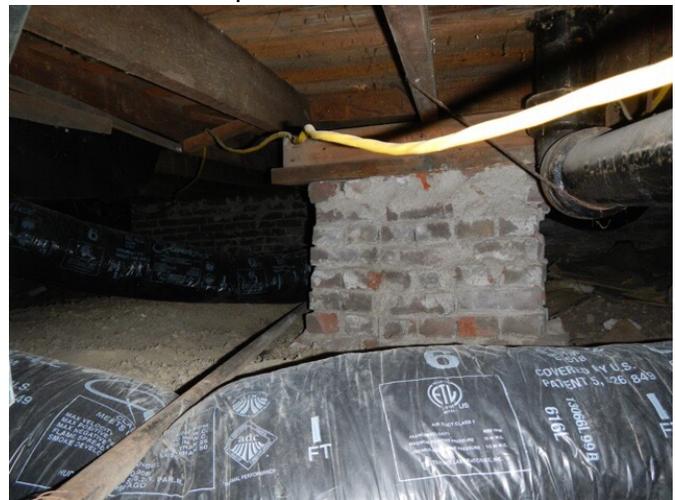
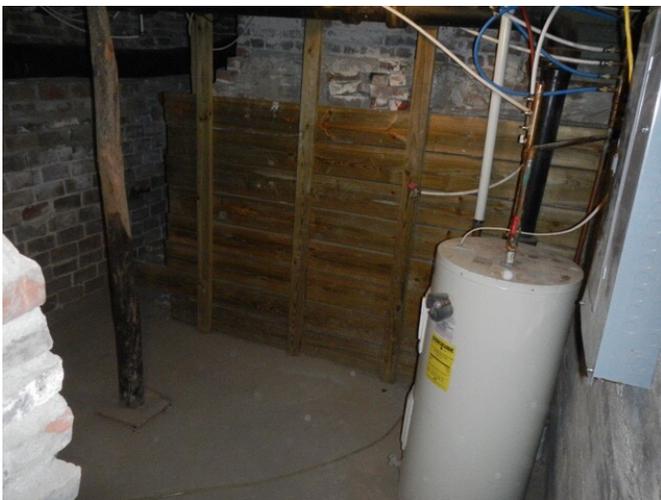
POSTS

237: - The floor system is supported by wooden posts set over concrete pier blocks.

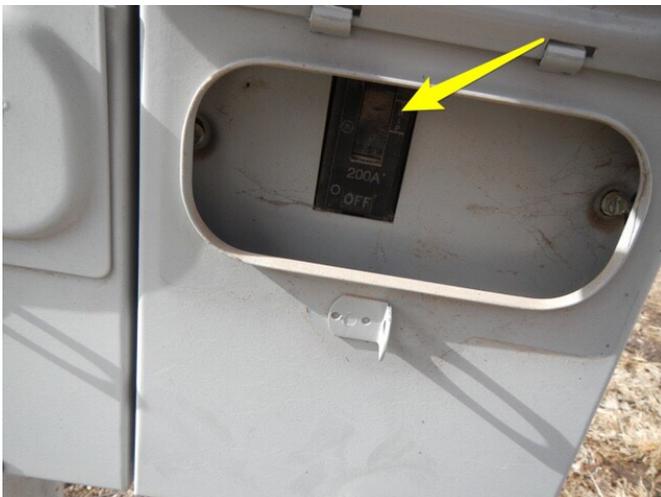
318: - The main electrical service disconnect is located in a weathertight enclosure next to the electric meter.
