Property Inspection Report

LOCATED AT:
20 Year Old Home
Home Town, Nebraska 68889

INSPECTED ON:
Saturday, January 23, 2016

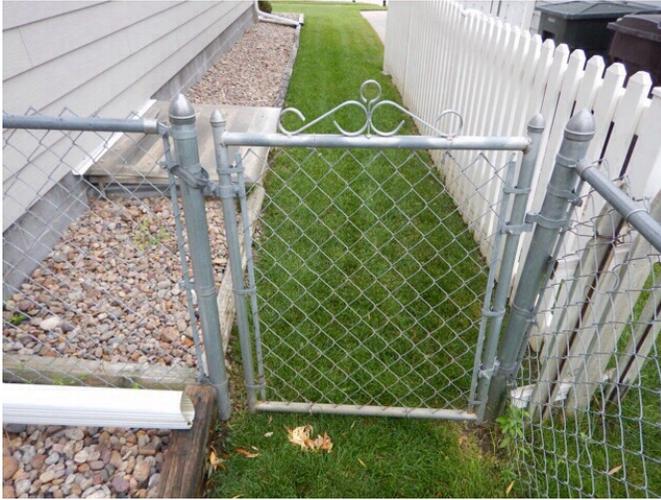
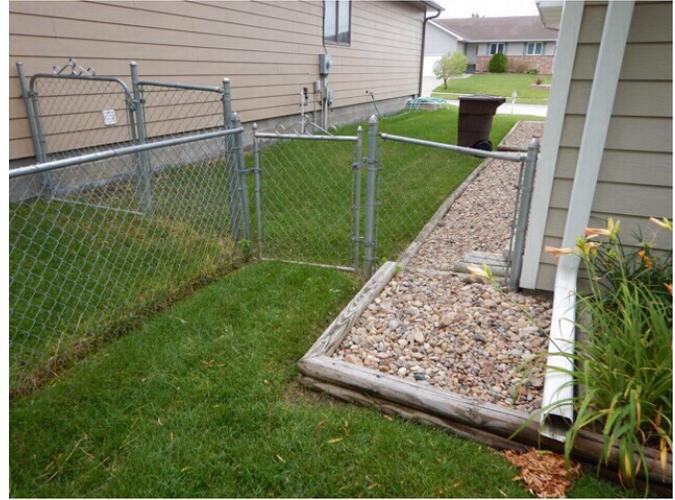
FENCING

31: - The fences appear to be properly installed and in serviceable condition.

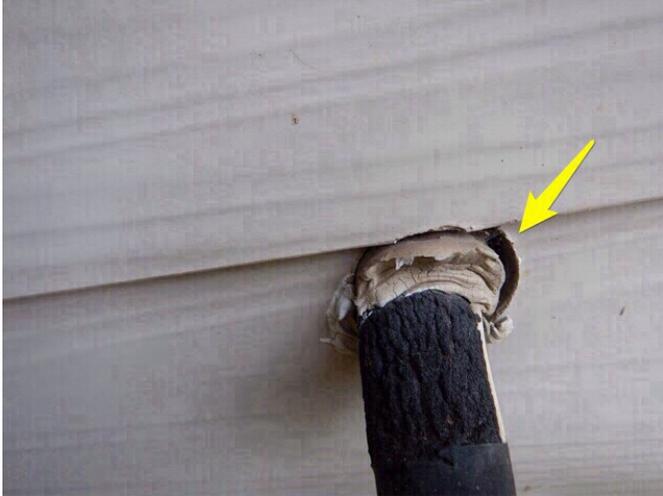
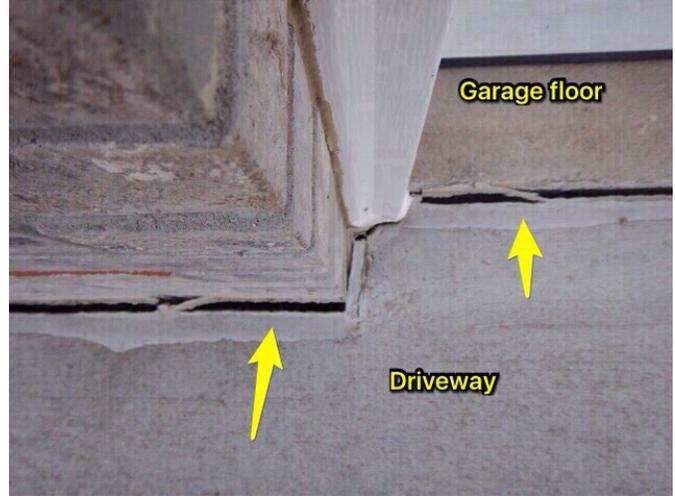
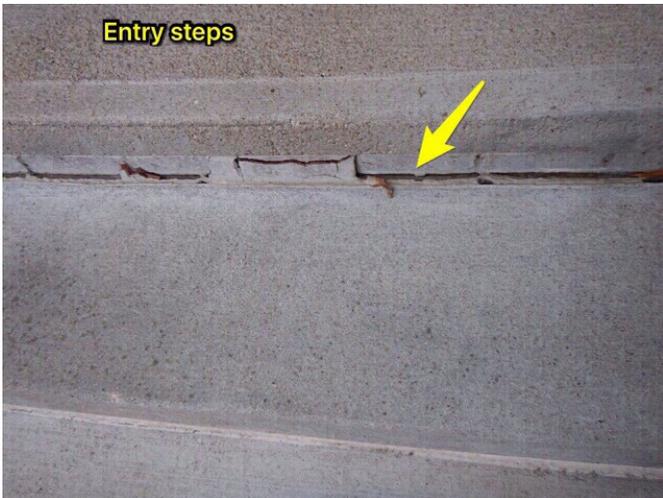
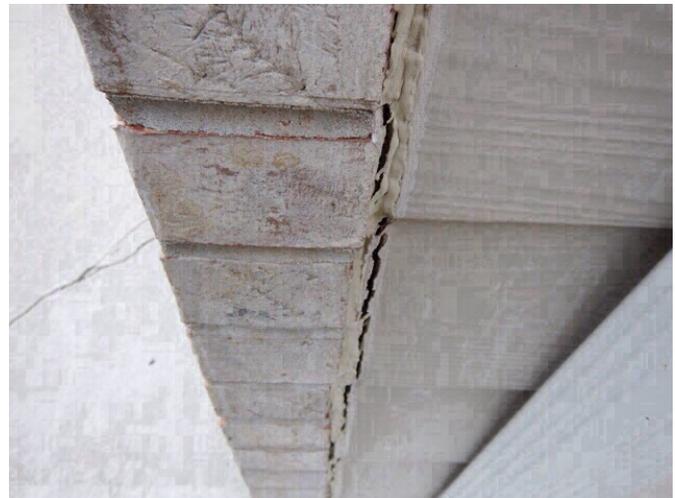
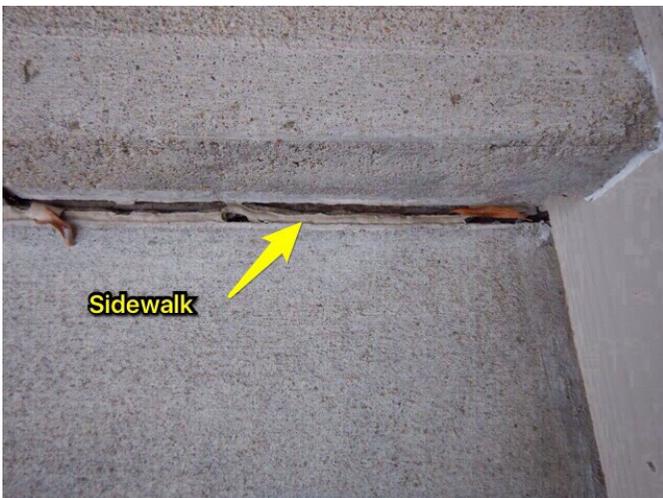
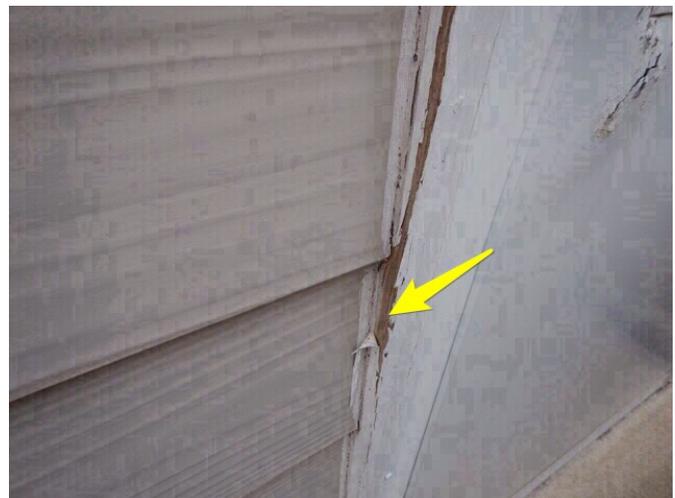
GENERAL COMMENT

38: - As preventive maintenance, caulking and sealing the gaps in the exterior of the building around the doors, windows, plumbing and electrical entry points will help prevent heat loss, cold air infiltration and moisture entry.

39: - If caulking is needed for maintenance of any flashing or exterior trim, we suggest a high quality urethane sealant such as 'Sikaflex'. Latex, butyl, oil based, silicone or 'architectural grade' sealants should be avoided.

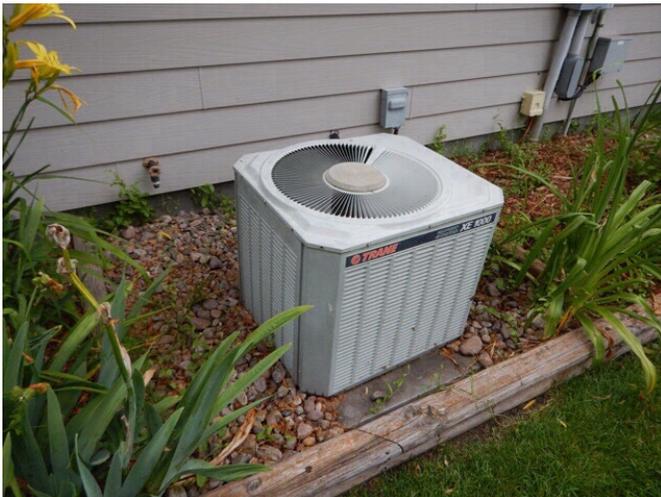
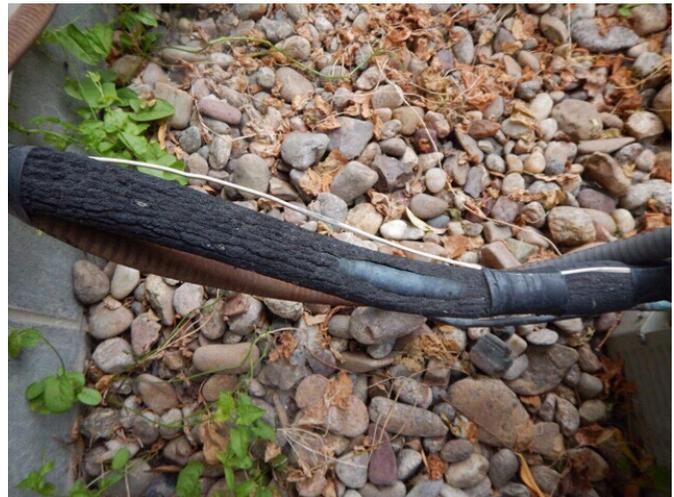
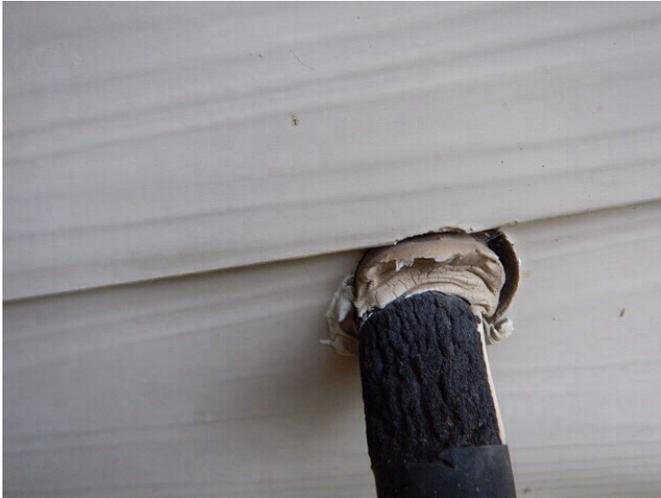
43: - Estimated to be approximately 19 years old

44: - Manufacturer: Trane

- 45: - Condenser location: Rear of structure
- 46: - Electrical disconnect location: Adjacent to condensing unit
- 47: - 2 ton

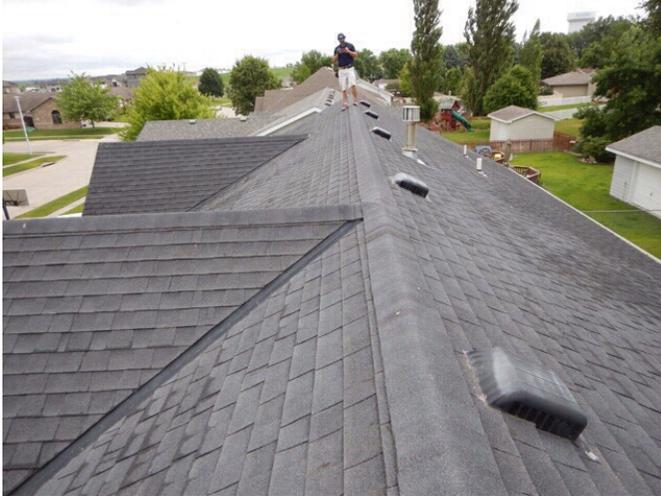
INSPECTION METHOD

73: - Our inspection of this roof was conducted from the roof surface. The inspector walked upon the surface and visually examined the accessible roofing components.

74: - Due to wet conditions which made it unsafe to walk the roof, we were unable to conduct a complete physical inspection. Our comments are, therefore, based upon limited visual observations.

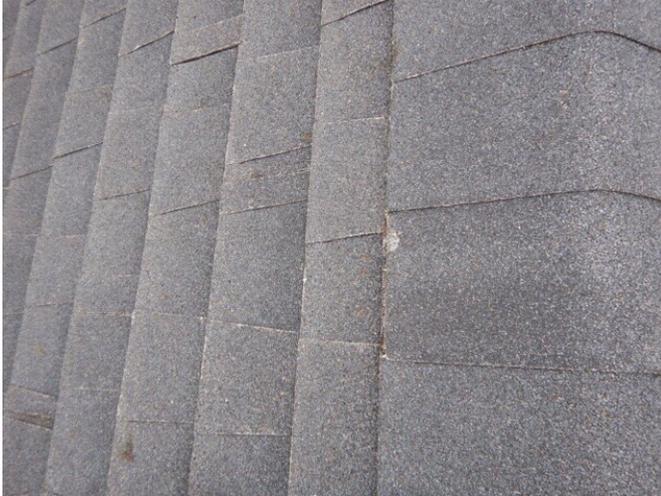
75: - Portions of the surface granulation are deteriorated and there are minor surface cracks developing. These are normal signs of aging and no action is needed at this time.

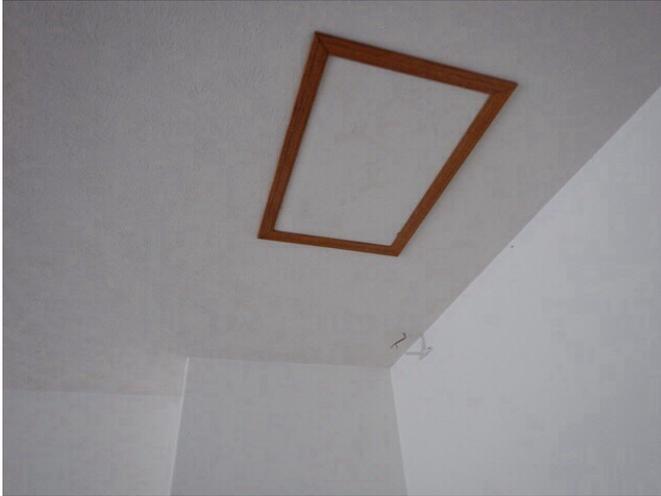
ACCESS/ENTRY

83: - The attic access is located in the garage.

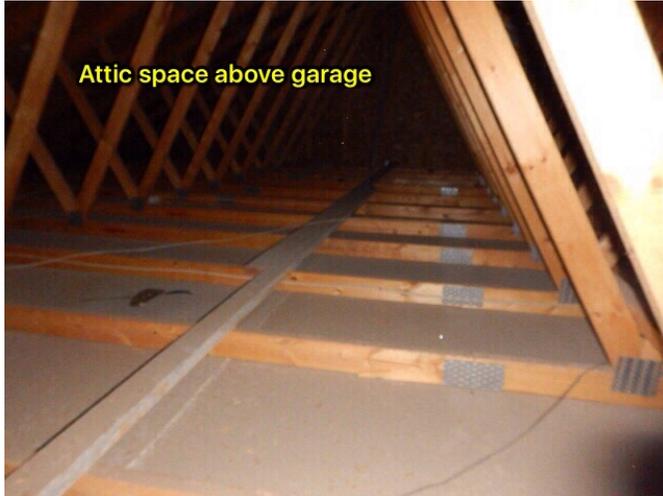
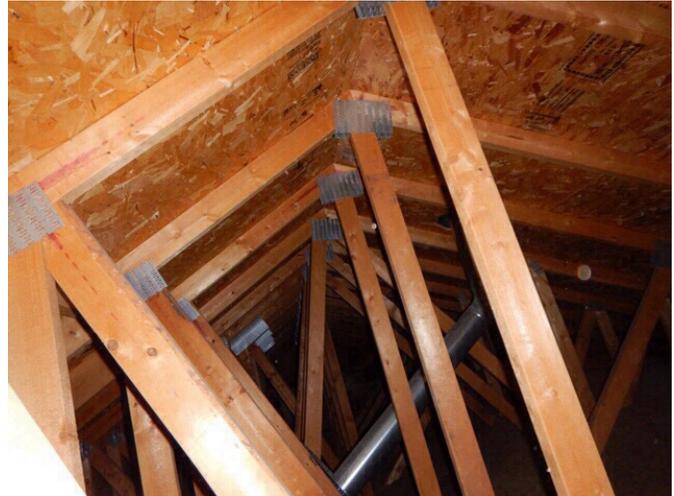
88: - The roof sheathing is 'OSB' - Oriented Strand Board, nailed solidly across the rafters.

89: - The roof sheathing appears to be properly installed and in good condition.

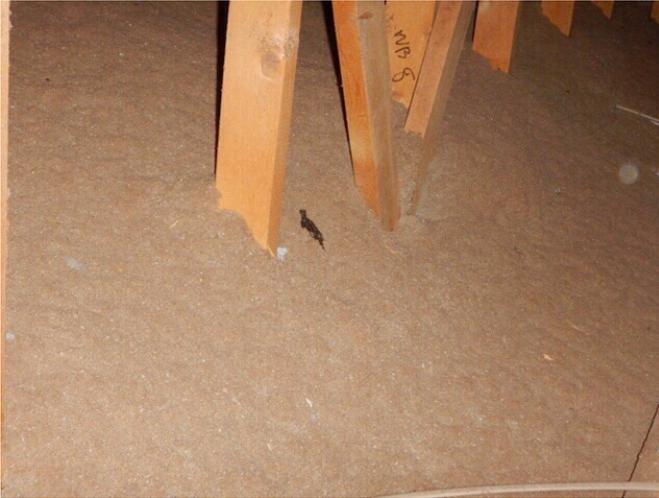
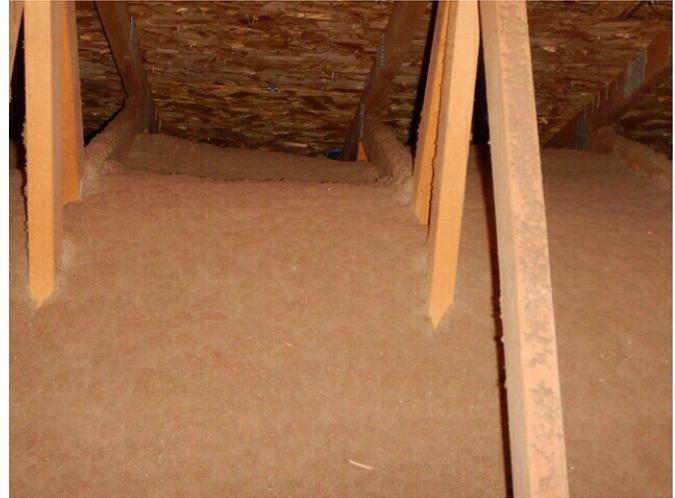
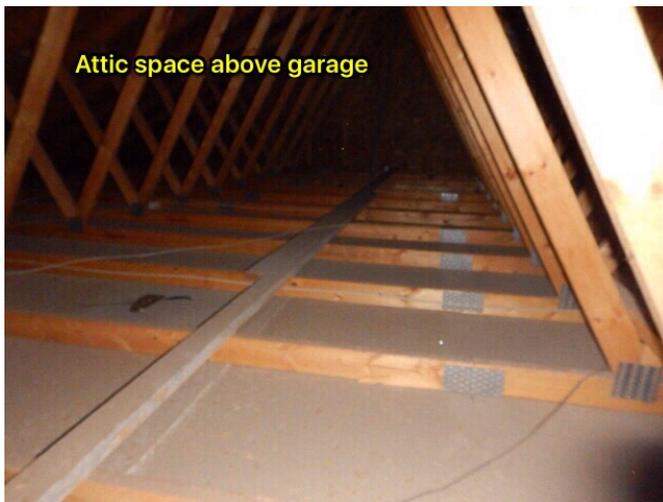
ATTIC INSULATION

95: - The attic has blown-in cellulose insulation.

96: - The level of insulation would appear to provide an R-22 insulating value. This provides good resistance to heat transfer and is heavier than average. Attic insulation over the garage area is not provided. The installation of insulation above a non-living space is not required.

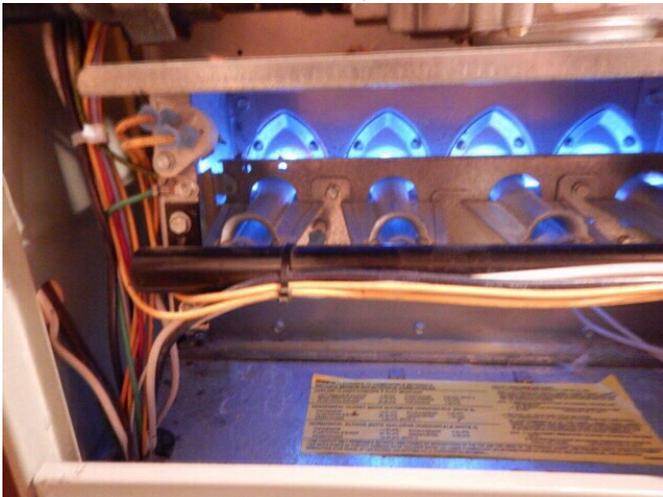
BURNERS

106: - The burners were inspected and found to be clean and in good working order.

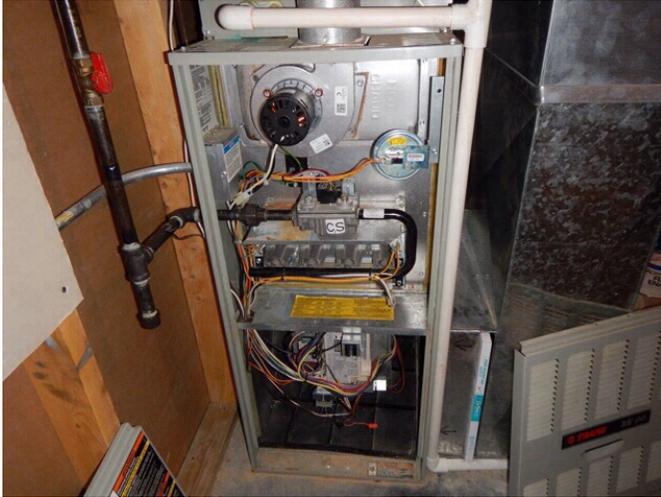
IGNITION SYSTEM

108: - The heating unit is equipped with an electronic ignition system, which is an energy saving feature that allows operation without the need for a continuously burning pilot light.

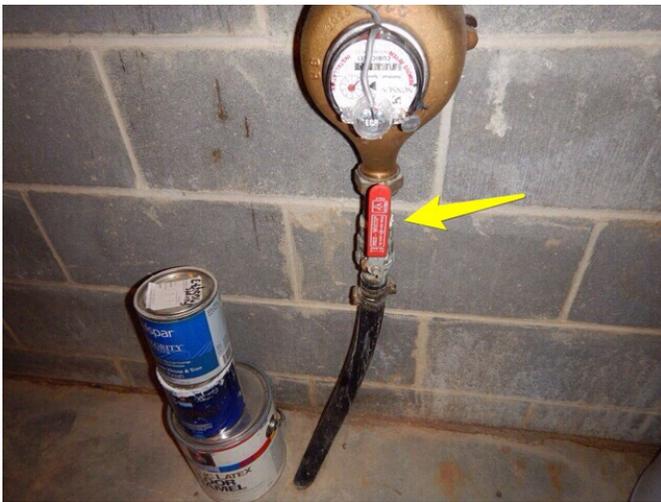
WATER SHUTOFF LOCATION

- 132: - The domestic water supply main shut-off valve is the red handle located in the furnace room to the left of the water heater.

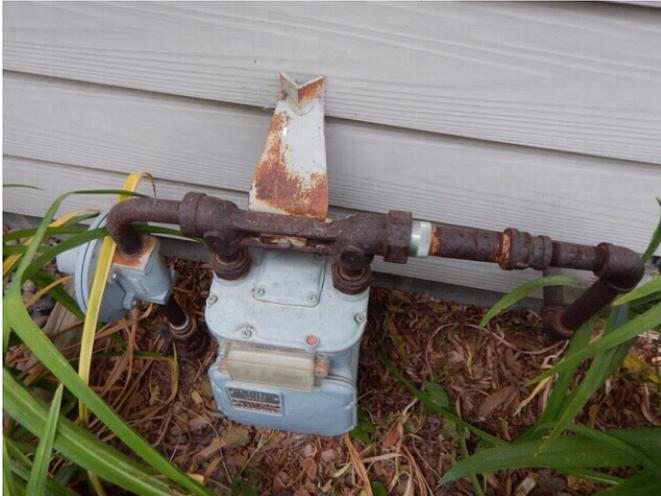
GAS METER LOCATION

141: - The gas meter is outside at the rear of the building. The main gas supply shutoff valve is located on the riser pipe between the ground and the meter. This valve should be turned 90 degrees (either way) in order to shut off the gas.

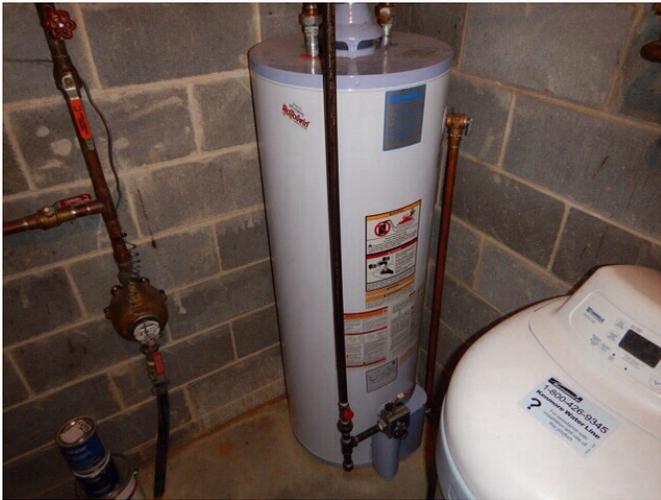
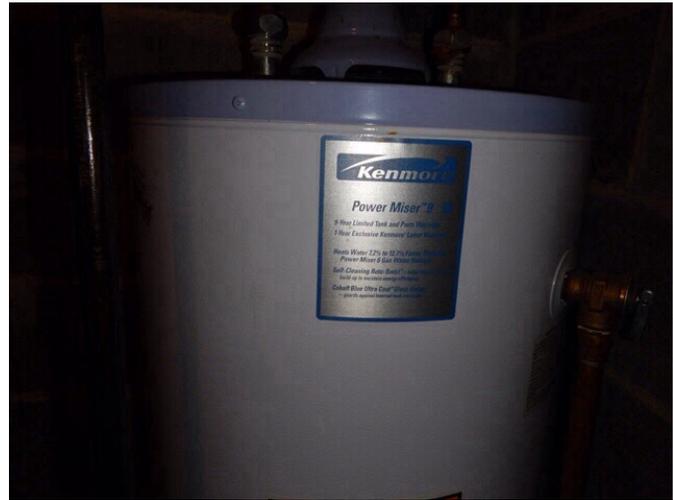
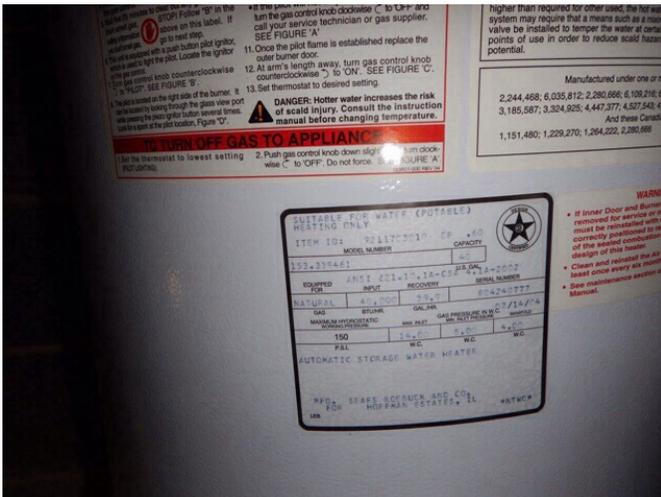
143: - Location: In the basement

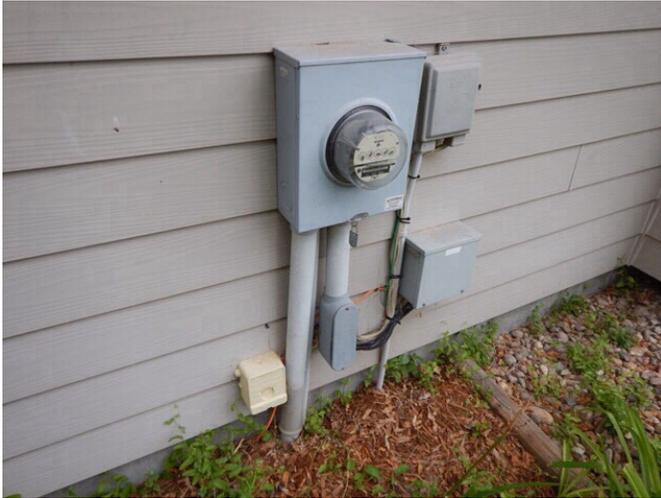
ELECTRIC METER

160: - The electric meter is outside on the side facing east.

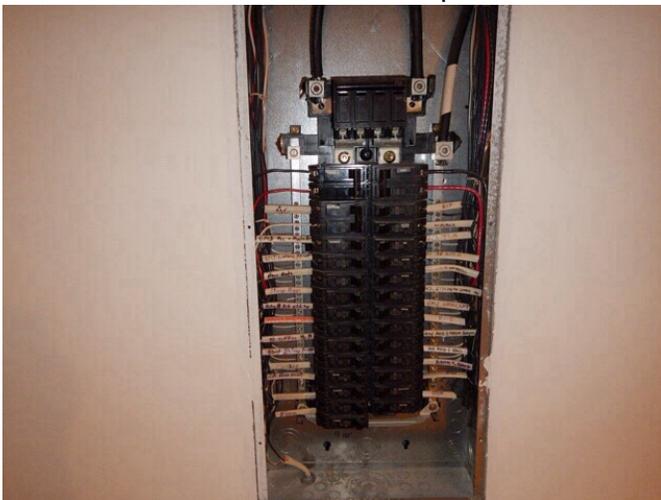
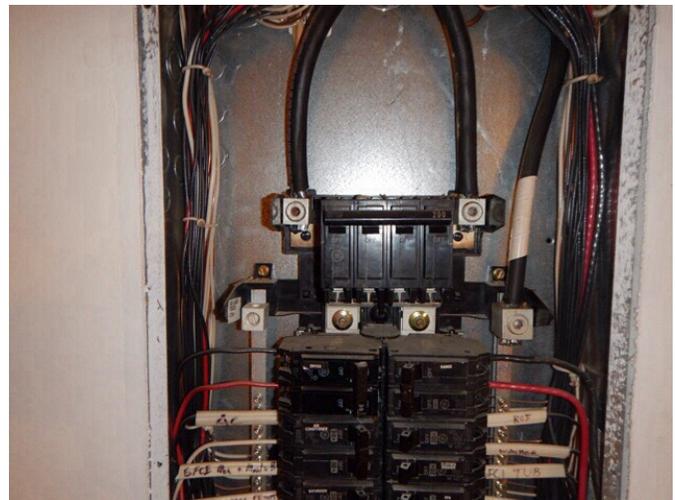
MAIN SERVICE

161: - The main electrical service panel is in the basement.

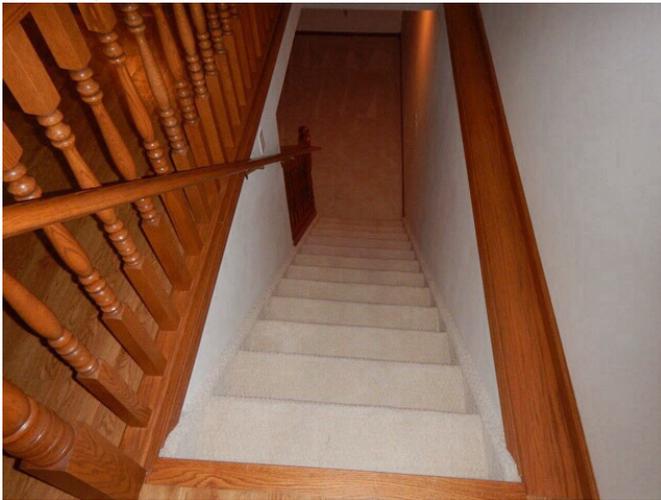
STAIRS

188: - The stairs were used several times during the inspection. The various components appear to be properly installed and no deficiencies were noted during use. The handrails were securely attached.

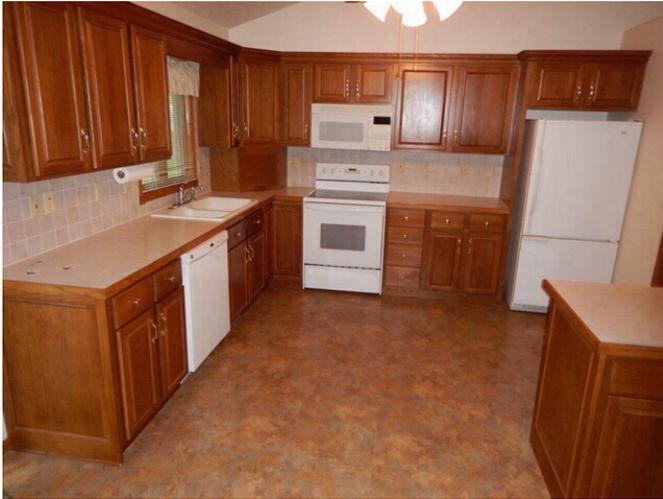
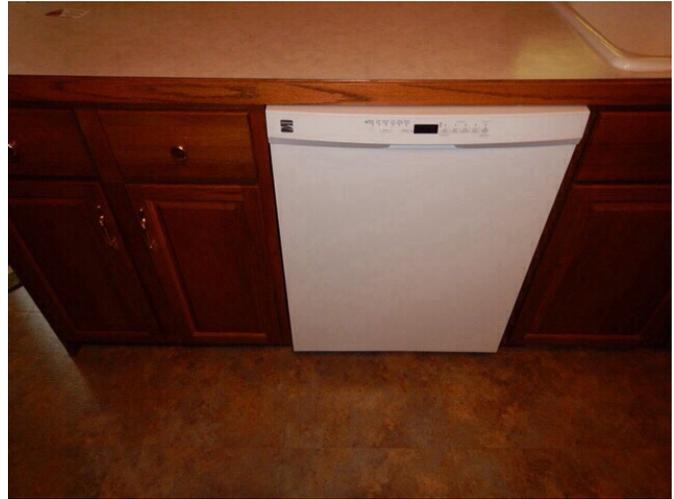
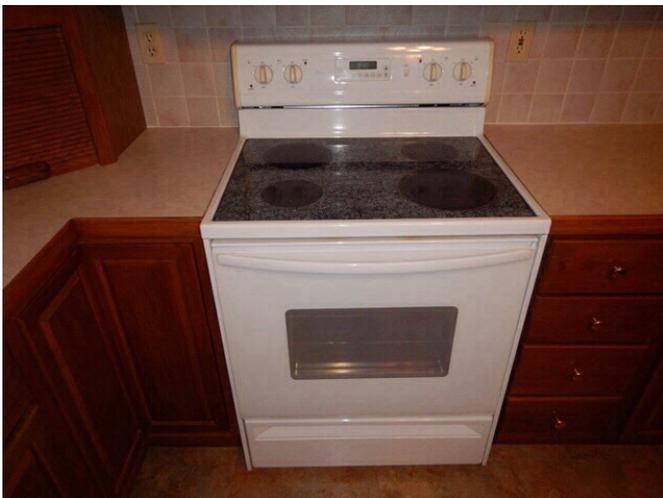
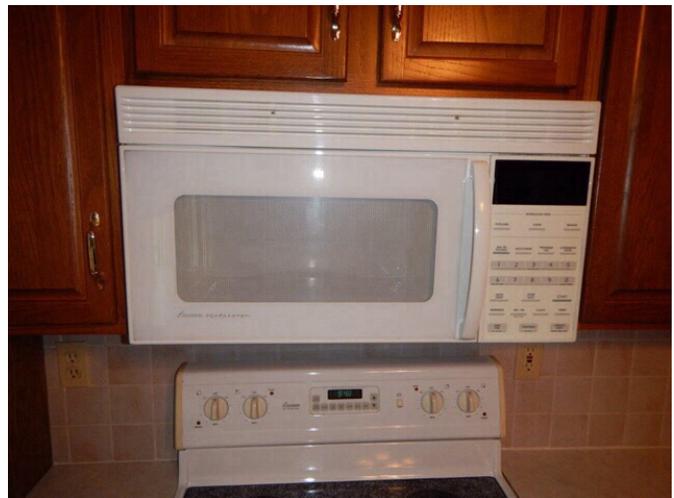
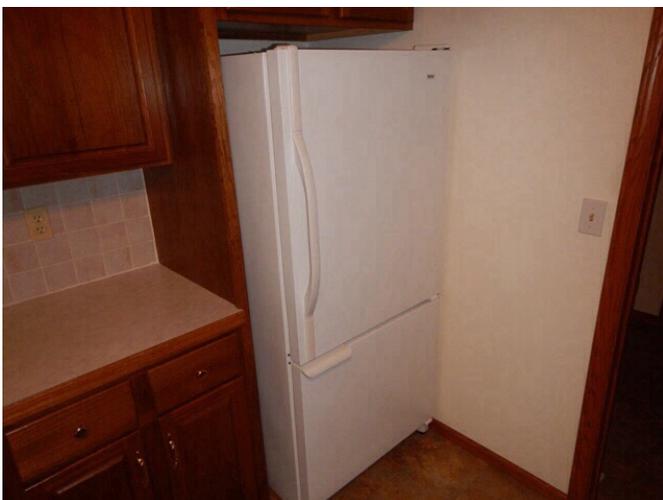
APPLIANCES: OVERALL

237: - All appliances were tested using normal operating controls and were found to be in satisfactory working condition.

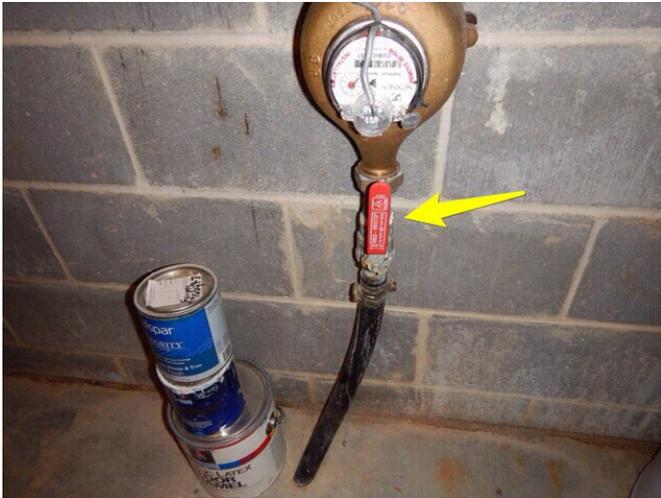
301: - The domestic water supply main shut-off valve is the red handle located in the furnace room to the left of the water heater.

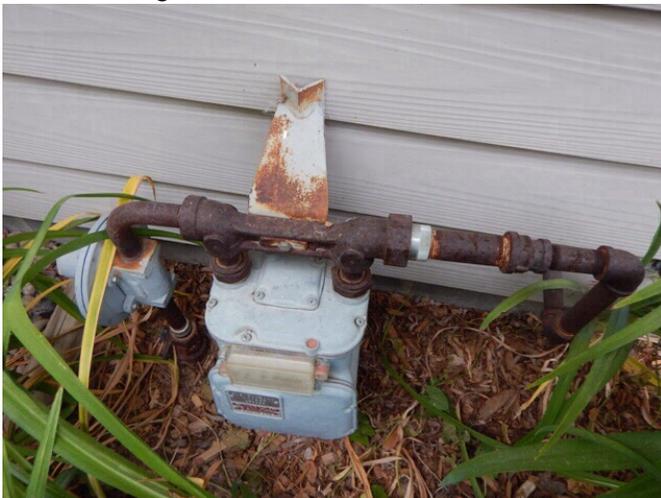
303: - The gas meter is outside at the rear of the building. The main gas supply shutoff valve is located on the riser pipe between the ground and the meter. This valve should be turned 90 degrees (either way) in order to shut off the gas.

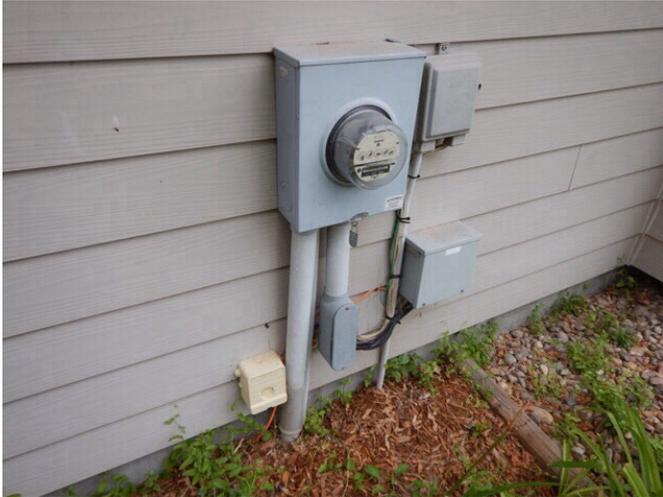
ELECTRIC METER
ELECTRICAL SYSTEM

304: - The electric meter is outside on the side facing east.

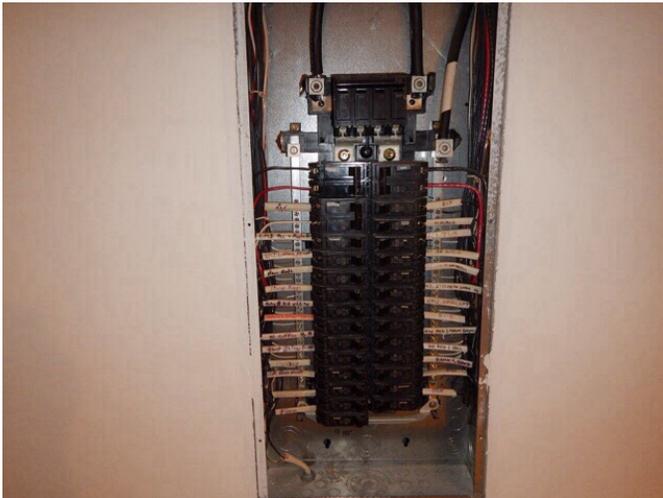
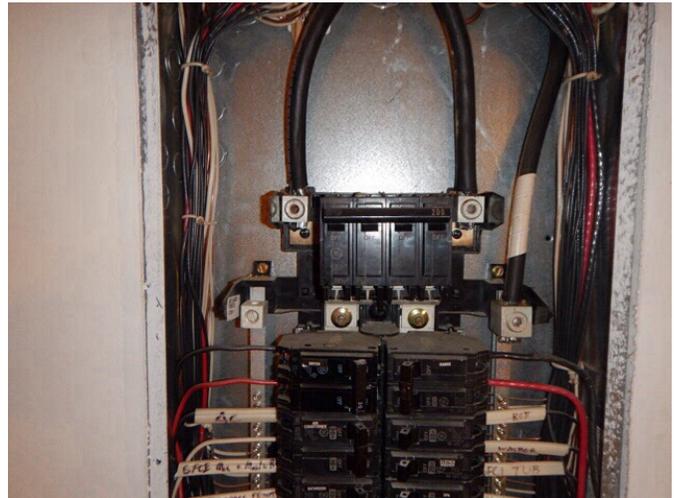
MAIN SERVICE
ELECTRICAL SYSTEM

305: - The main electrical service panel is in the basement.
