Flat Roof Inspections

Introduction

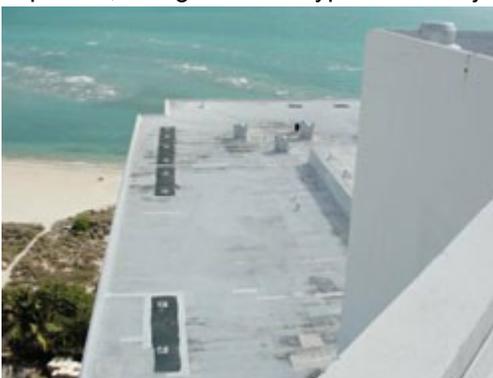
Figure 1: Ocean front condo with very low parapet wall on a flat roof system. Roofs like this can cool very quickly shortly after sunset, if there is wind coming off the water.

Wind can also affect the time at which the scanning window opens and the length of time the window stays open. We conduct a number of roof inspections close to and on the ocean. Some of these roofs have very low to no parapet walls (Figure-1). Under these conditions, roof surfaces cool very quickly, especially when the sun goes down. As can be expected, being on these types of roofs just before sunset is the ideal time to start scanning.

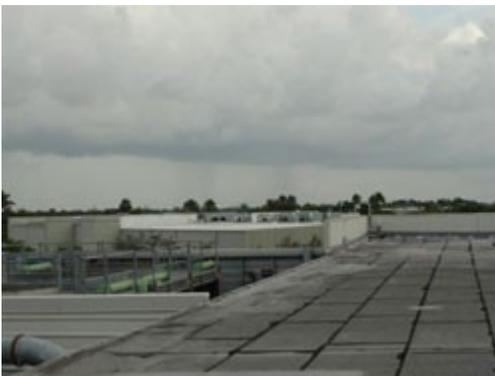
Figure 2: Overcast skies with rain showers around job site created an early and short-lived scanning window on this roof. Scanning took place between 3:30 PM and 5:30 PM.

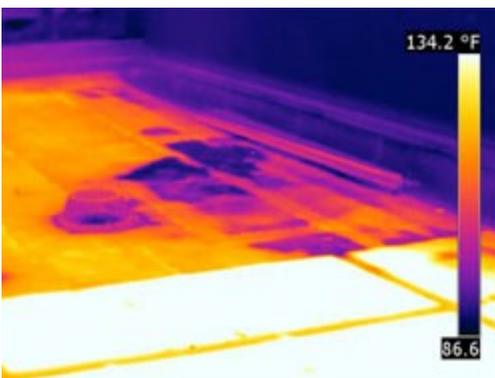
Figure 3: Thermogram showing cold anomaly marking trapped moisture in roof between penthouse wall and roof drain. Image was captured at 11:30 AM while the roof was heating up. Note hot thermal signature (>130-degrees F) from traffic pads in foreground on thermogram.

Scanning under cooling conditions generally produces best results, as shadowing and time delayed warming of roof sections is avoided. However, scanning under warming conditions can be done with remarkably good results, as long as the roof area is open and not blocked by objects that produce shadows (Figure-3). Also required is a non- reflective roof surface and plenty of solar loading.

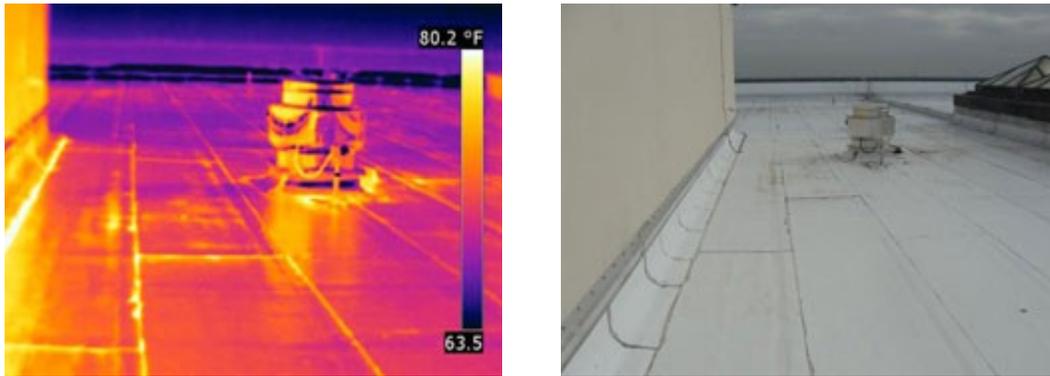
Figures 4: White modified torch-down roof membrane that is highly reflective when imaged. Note hot thermal signature produced by penthouse wall and roof exhaust fan, while a cold pattern dominates background from the sky's reflection

The roof surface material provides protection to the roof system. It is also what is observed with a thermal imager during a roof survey. Two aspects must be considered when viewing a roof surface; emissivity and mass. Surface materials such as gravel, smooth built-up asphalt roof plies, granulated modified bitumen, some older EPDM roofs, and most single-ply PVC / TPO materials (some are somewhat reflective when new, but over time they scan fairly well) provide excellent imaging with both short/mid- and long-wave thermal imagers. Low emissive (low-E) roof surfaces include aluminum coated roof surfaces, metal panels, some EPDM membranes with high graphite content, and the newer white, smooth, torch-down modified membranes (Figures-4).

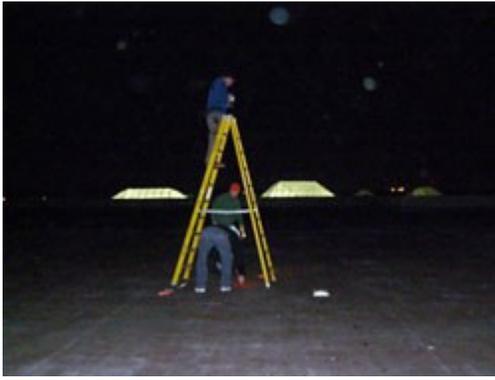
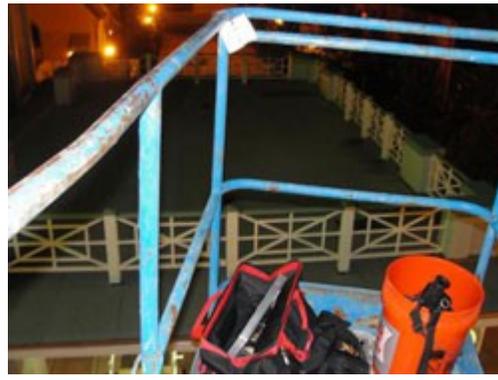
Figures 5: Using ladders and aerial lifts to overcome reflection and hard- to-reach roof areas can be time saving and dictate the success of a job.

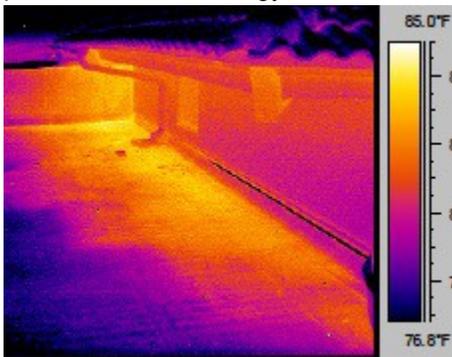
Figure 6: Anomaly on roof surface located below an overhanging soffit and the corner of a parapet wall.

Other types of reflections that can produce false thermal anomalies are derived from roof mounted piping, penthouse and vertical walls, overhanging soffits, roof mount equipment (exhaust fans, AC units), and other features that trap and/or produce thermal energy on the roof surface (Figure-6).

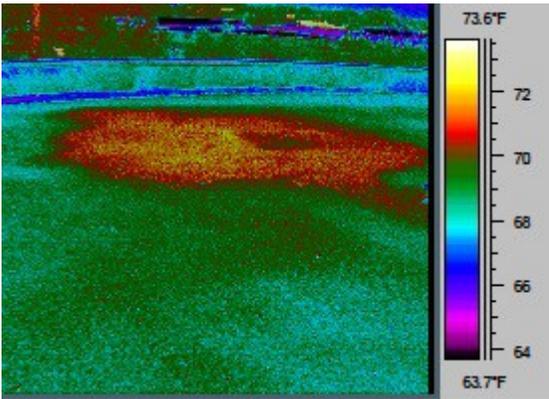
Figure 7: A circular shaped thermal anomaly that mimics an area of flood coated asphalt used to make a roof repair. Gravel covering this area makes it less obvious to spot during a survey, but walking over this area reveals a built-up section of roof. Another obvious indicator for this not representing trapped moisture is that the roof insulation is board stock perlite, that if wet, should show a straight edge boundary at least in part, on some area of the anomaly.

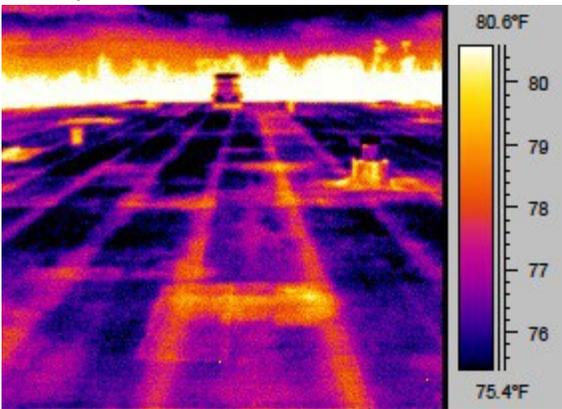
Figure 8: Thermal anomalies associated with poorly sealed roof membrane laps. This roof suffers from numerous blisters that are forcing laps to open and allow surface water to migrate into the inter-ply system of the roof.

Even though most roof surfaces are non-absorbent, their layering characteristics between base-sheets, inter-ply, and cap sheet can trap and hold moisture. Poorly sealed laps, failing flashing details, and surface moisture trapped in the roof system during installation are the main causes of this defect. In extreme cases of interply moisture, surface blisters will develop on a roof. Inter-ply moisture can be observed with a thermal imager and appears as linear anomalies that parallel roof laps.

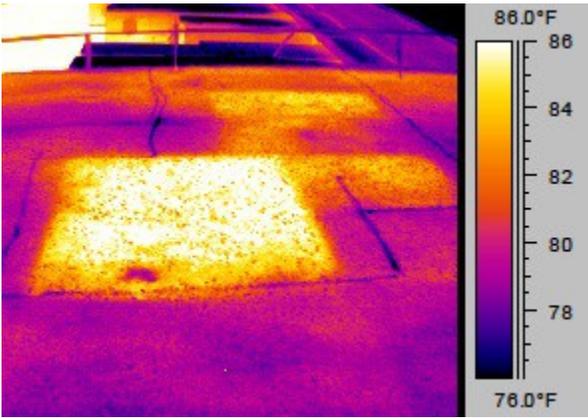
Figure 9: Thermal anomaly of wet fiberglass insulation showing classic board pattern anomaly. Note the contrasting levels of heat of the boards in the foreground versus those in the background; correlating to the varying amounts of moisture present in the insulation.

Thermal anomalies that arise from board insulation are the classic square-shaped and window-pane patterns (Figure-9). Depending upon the absorbency and amount of infiltrated water, the patterns will have slight variances in their appearance, especially poly-iso board, which when new, holds little water, but with age produced strong anomalies at the edges of the boards (Figure-10). Other thermal patterns associated with poly-iso board can be rather nondescript or blotchy, possibly highlighting the wet backing paper present on the top side of this insulation.

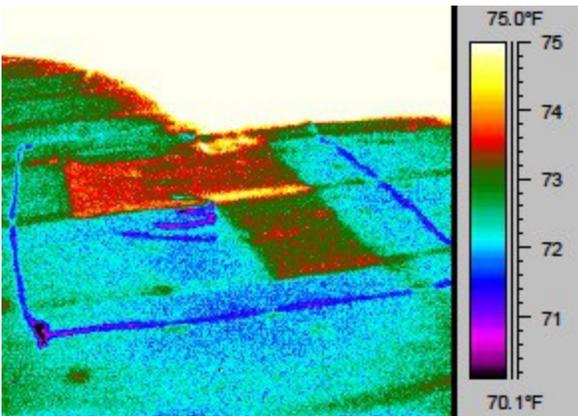
Figure 10: Thermal anomaly associated with wet poly-iso board. Note the strong thermal signature along the edges of the board.

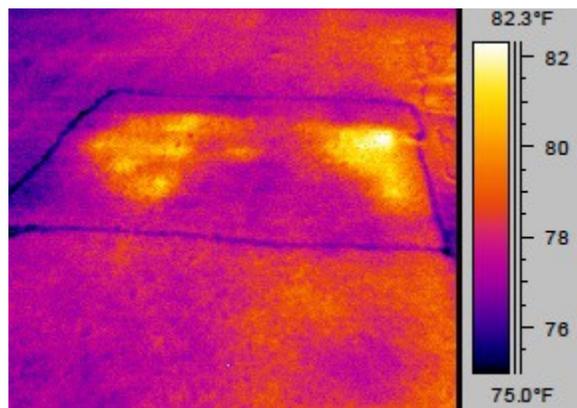
Figure 11: Thermal anomaly associated with wet perlite board. Although the anomaly does not completely depict a square board, the right part of the anomaly shows a 90-degree square corner; a dead give-away of wet board insulation.

When scanning roofs with board insulation, thermal anomalies, as a general rule, will have well defined straight edge patterns. The anomaly may not be completely developed into a 90-degree corner-edge shape, but some part of the anomaly should appear straight (Figure-11). If you are observing something different, it is possible that other factors are causing the anomaly rather than moisture. It is possible that a different type of insulation material is present, possibly installed during a roof repair. Furthermore, reroofing and phased assembly of large roof sections can create completely different roof assemblies that tie-in to one another.

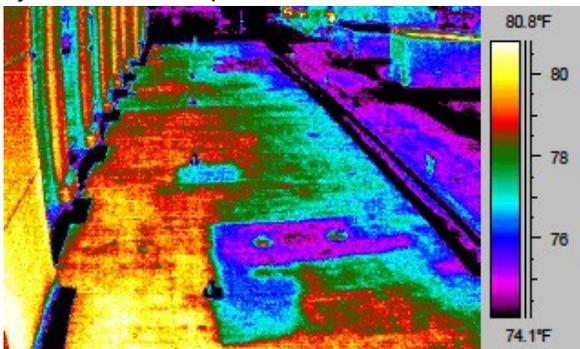
Figure 12: Typical thermal pattern of roof with newly installed LWIC.

Even with these built-in drying features, newly installed LWIC roof systems are challenging to survey because of the numerous thermal anomalies found that depict varying levels of inherent moisture (Figure-12). We have limited success scanning new LWIC roofs to track down known leaks. The best method we have found is to adjust the level and span on our camera to tune out background thermal noise and hunt for the strongest thermal anomalies (Figure-13). This is extremely difficult scanning and is not recommended in most cases. Generally, when asked to scan new LWIC roof systems we are upfront with our client and discuss the limitations of using infrared technology.

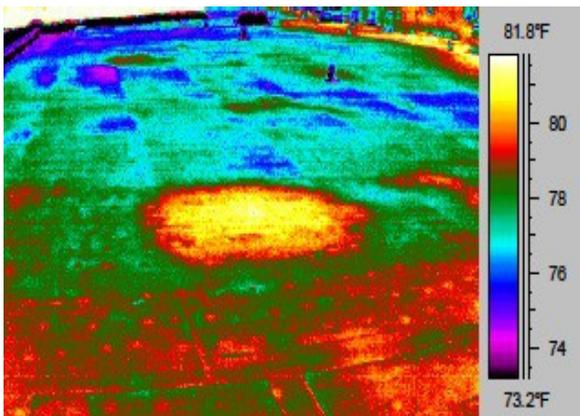
Figure 13: A strong, circular shaped thermal anomaly that marks a roof leak, amongst a diffused warm thermal pattern typical on newly installed LWIC roof system.

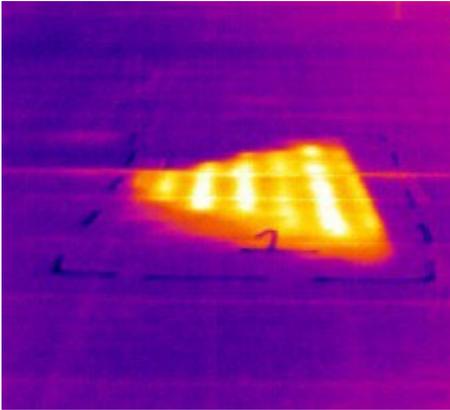
Figure 14: Banded thermal pattern of wet perlite insulation over a corrugated metal roof deck with air conditioned spaced below.

The deck is the main support and foundation to the roof system. Most common deck types found in roof construction include structural concrete (either poured or pre-cast), corrugated metal, wood sheathing, gypsum, LWIC concrete, tectum panel/planks, and newer composite panels like Dens-Deck and high-density gypsum-like panels. Wood and gypsum-based decks can hold moisture and may influence thermal anomalies. Corrugated metal decks can act as heat sinks and provide striking thermal patterns on a roof if there is a sharp contrast between interior and exterior temperatures (Figure-14).

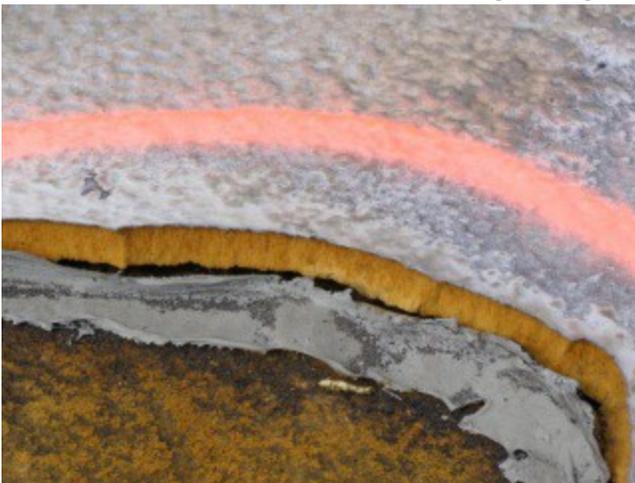
Figure 17: A too-thin final foam layer installed over, a most likely moist surface, lead to wide-spread blistering and layer separating. Silicon was used as a temporary repair but that too has failed to stop the foam layer from separating.

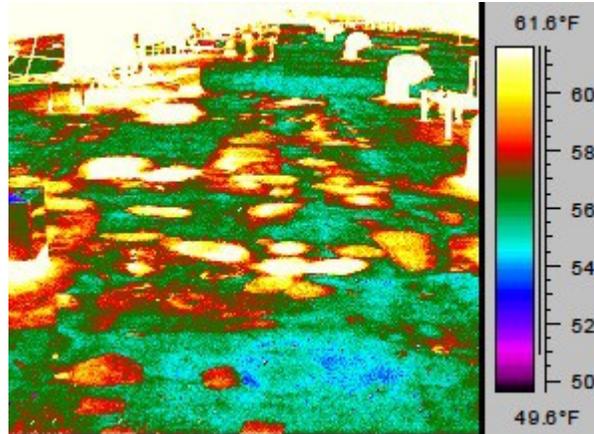
Figure-18: Typical thermal pattern of trapped moisture in SPF system; round shaped anomalies that coalesce with one another.

Water intrusion can occur in SPF systems. Thermal patterns appear as small round anomalies and progress in size and coalesce as moisture intrusion intensifies (Figure 18). If de-bonding between foam layers is present or intact blisters are observed, water can migrate and be trapped in these places. Trapped inter-layer moisture appears as large amorphous anomalies, while air and water-filled blisters can be difficult to detect. Because of the trapped air in the blister they warm and cool quickly and therefore have short-lived thermal signatures. We have seen large amounts of water trapped in blisters that have very weak thermal anomalies yet when stepped on warm water evacuates. Therefore, it is important to walk over anomalies and feel for trapped moisture (care should be taken on blisters as to not break them open and allow water to enter the roof system).

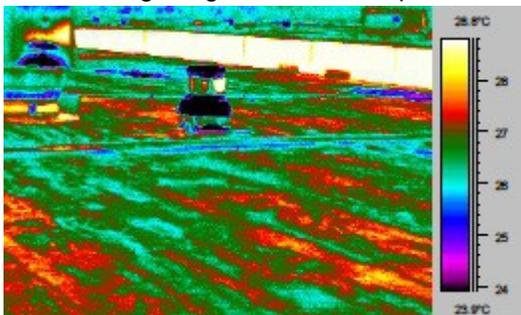
Figure 19: Thermal pattern of inter-ply moisture trapped between two roof systems with no separating insulation layer.

Thermal patterns associated with recovery roof systems vary from classic thermal patterns associated with wet insulation of the new roof, to very chaotic thermal patterns created by trapped moisture between the two roof systems that lack an absorbent separation layer (Figure-19). These anomalies are very difficult to resolve and pinpoint the exact location of trapped moisture.

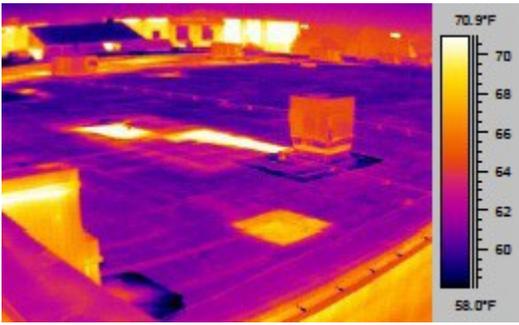
Figure 20: Strong and weak thermal anomalies on a roof surface. The large anomaly in the background shows two strong anomalies (upper roof moisture) superimposed over a broader and weaker one (lower roof moisture).

Finally, old trapped moisture in the lower roof system can sometimes be detected with a thermal imager. Depending upon the original insulation material, anomalies may appear as faint or shadowy signatures. When trapped moisture occurs in the lower and upper roof systems, the lower trapped moisture usually produces a weak thermal signature that contrasts with a stronger signature of the top roof moisture (Figure-20).
